Queensbury Tunnel Study

0451189 | Final v2

April 2021

Highways England - Historical Railways Estate

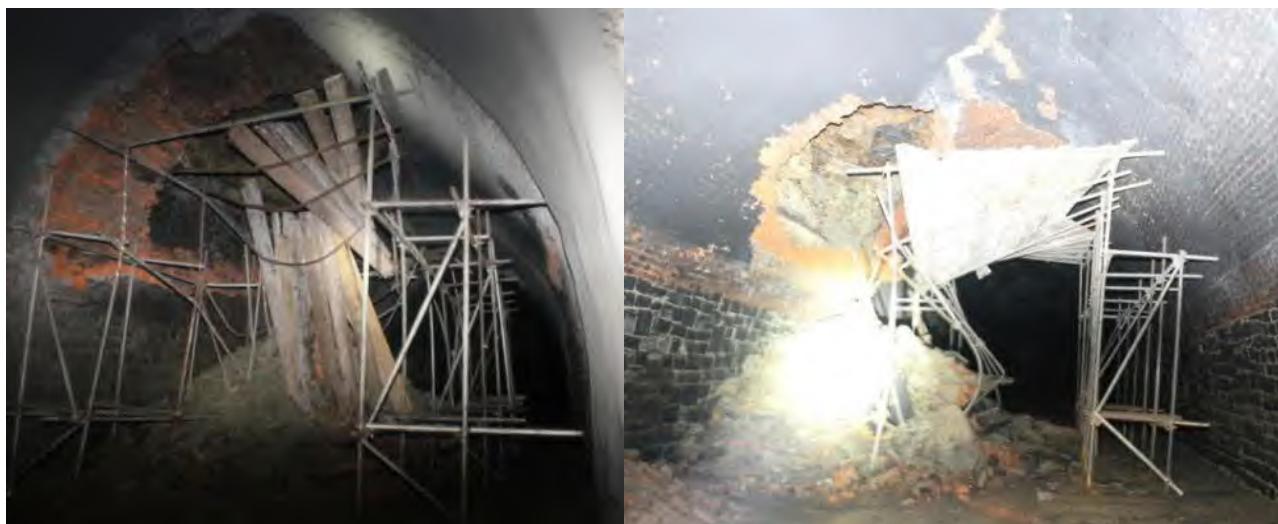
*Figure 2: Collapses at tablets 90 (left) & 98 (right)*

During 2013 and 2014, there were two major collapses in the tunnel lining, between Shafts 3 and 4. On both occasions the brick lining and rock behind collapsed into the tunnel. The force of the collapses crushed the temporary scaffold platforms, that had been placed there in 2012, to prevent falling brickwork hitting anyone walking underneath, making the areas virtually impassable. The platforms were not designed to contain localised ground collapses.

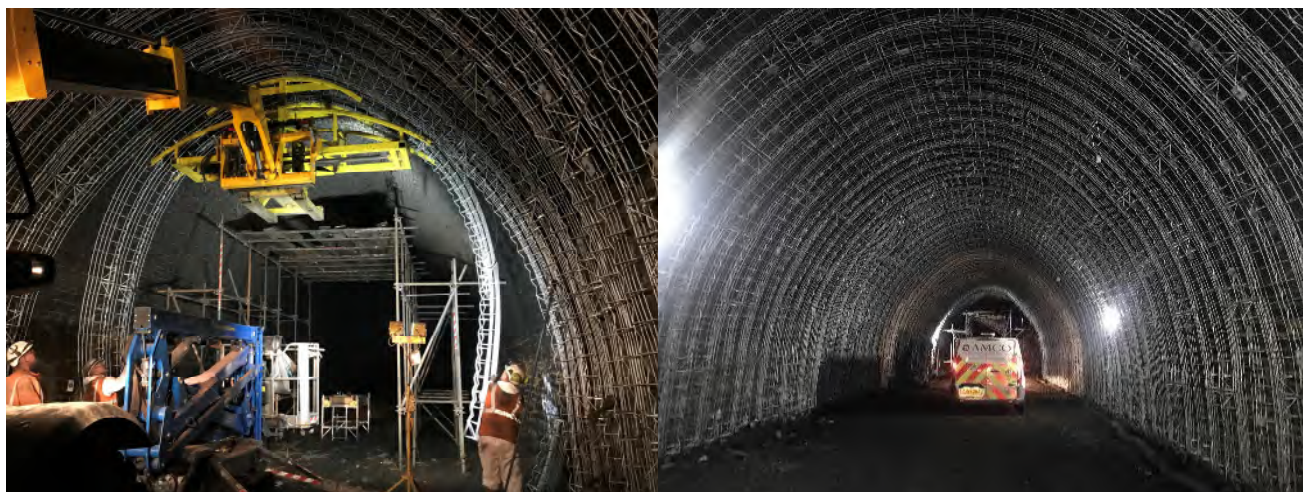
Figure 3: RAM Arch Installed at Queensbury Tunnel

For the safety of operatives working in the tunnel, RAM Arch has been utilised to temporarily secure areas of suspected poor brickwork in the lining, particularly between Shafts 3 and 4 where the two major collapses have occurred. It has also been installed to the shaft support structures of Shaft nos. 8, 6, 4 and partial installation at Shaft no. 3, to temporarily secure the base of the shaft and to protect the workforce from any falling materials from the shaft linings. In its basic form it is galvanised steel bars forming a mesh, bent to a radius and fixed to the tunnel lining. The spacing of the bars is sufficiently tight to prevent loose bricks falling from the lining on to operatives working or passing below. During the installation of RAM Arch, operatives remain safely underneath the mesh so are protected from the risk of collapsing brickwork. The RAM Arch comes in 2.2m long panels with a 1.3m width and subsequent panels are fixed on top of the existing with a 300mm overlap. Each advance is therefore 1m and using this method the tunnel can be safely secured. Each joint going around the curve of the RAM Arch has an expandable joint. The RAM Arch is therefore jacked outwards to ensure that the mesh is in intimate contact with the lining. RAM Arch is resin fixed to the masonry lining using 450mm long, 25mm diameter steel bars, generally at 1m centres both horizontally and vertically.

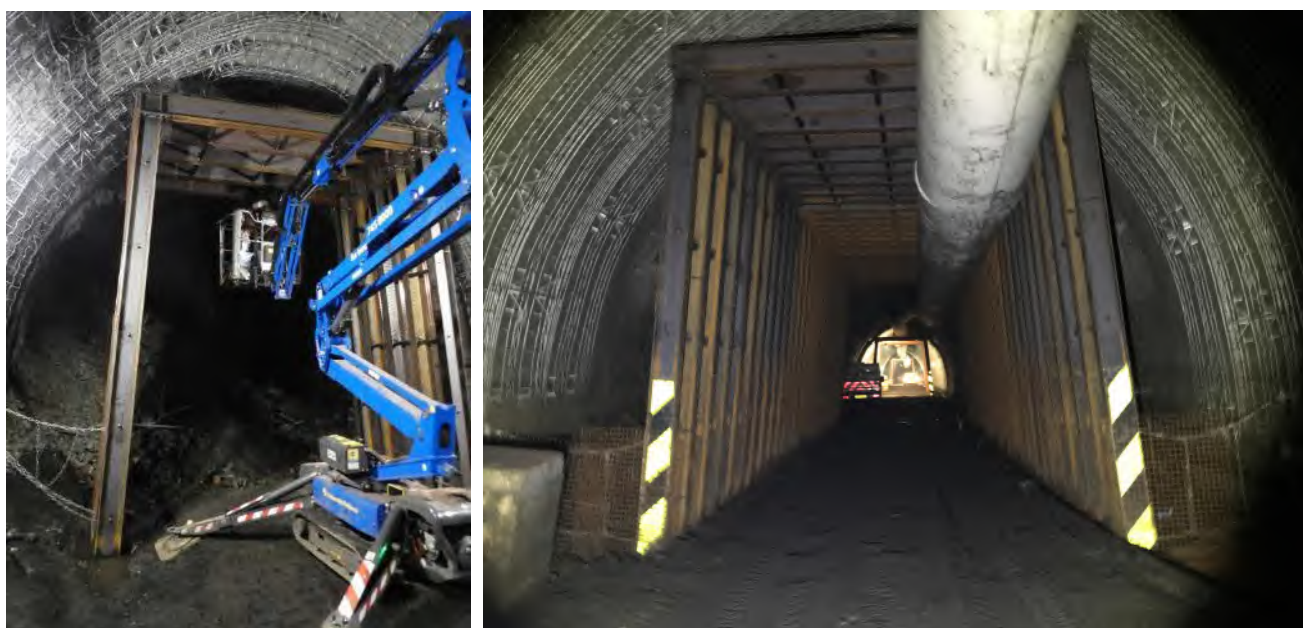
Figure 4: Colliery Arches Being Installed at Queensbury Tunnel

In order for the Contractor to safely navigate through the two major collapse areas, more substantial temporary works were required. Amco-Giffen proposed the use of 'colliery arches' to achieve safe passage through the collapse areas. The colliery arches were formed using Universal Beams, with a 4m long roof beam and 5m high splayed legs, the frames are set at 0.6m centres with connecting Circular Hollow Section struts. Mesh panels were then used on the outside of the frames to prevent smaller debris from falling through the gaps.

A total of 72no. colliery arch frames were utilised between tablets 90 and 99. 28no. at tablet 90, the location of the first collapse, 14no. at tablet 93 where a significant bulge in the upper haunch of the lining rendered RAM arch impractical and potentially unsafe to install, and 30no. at tablet 98, the location of the second collapse.

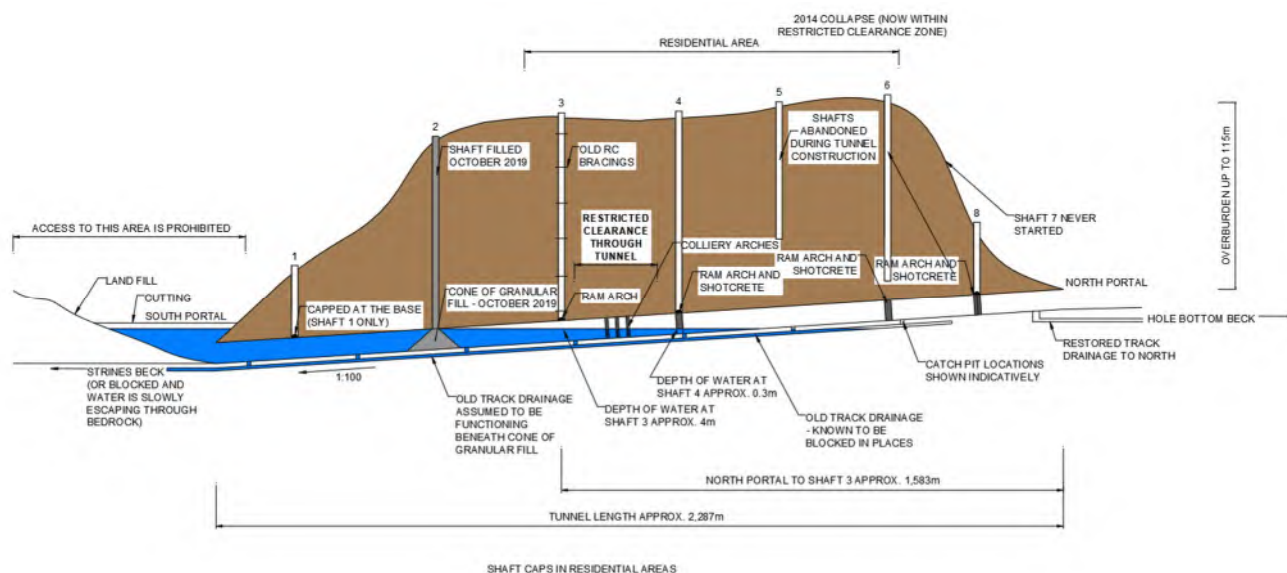
Figure 5: Schematic Long Section Through Tunnel (Current Arrangement)

The following table summarises the current condition of the tunnel lining for the currently accessible section from the north portal to Shaft 3.

Tablet	Condition
0 – 5	Minor patches of spalling stonework which has been dressed back.
5 – 6	Missing brickwork dressed back and RAM Arch installed to haunches and crown.
6 – 8	Few defects.
8 – 9	Location of Shaft 8. Missing brickwork dressed back with RAM Arch installed and 250mm of spray applied concrete added later.
9 – 26	Missing and spalled brickwork dressed back with RAM Arch installed to crown at tablet 11 for approx. 3.0m.
26 – 27	Location of Shaft 6 (which did not reach the tunnel). RAM Arch installed and 250mm of spray applied concrete added later.
27 – 42	Few defects. Missing and spalled brickwork dressed back.
42 – 71	Missing and spalled brickwork starts to become more extensive with fractures in the haunches and crown.
71	Existing crash deck present with bulge to down haunch.
71 – 77	Several areas of spalled brickwork, deformation of the arch profile and fractures to the haunches and crown.

77	Existing crash deck in place with bulge to up sidewall and haunch.
77 – 80	Deformation of the arch profile. Bulge and fracture to up haunch at tablet 79.
80 – 81	Location of Shaft 4. RAM Arch installed and 250mm of spray applied concrete added later.
81 – 90	Potentially unstable zone of tunnel. Areas of spalling and missing brickwork have been dressed back. Majority of the tunnel lining has had RAM Arch installed.
90 – 91	Location of collapse. Colliery arches installed with mesh panels on the outside.

91 – 93	Potentially unstable zone of tunnel. Areas of spalling and missing brickwork have been dressed back and RAM Arch installed.
93 – 94	Location of significant bulge to up haunch. Colliery arches installed with wooden packing beneath the bulge.
94 – 98	Potentially unstable zone of tunnel. Areas of spalling and missing brickwork have been dressed back and RAM Arch installed.
98 – 99	Location of collapse. Colliery arches installed with mesh panels on the outside.
99 – 100	Potentially unstable zone of tunnel. Areas of spalling and missing brickwork have been dressed back and RAM Arch installed.
100 – 105	Few defects. Missing and spalled brickwork to crown dressed back.
105 – 106	Location of Shaft 3. See section 3.1.3 for details.

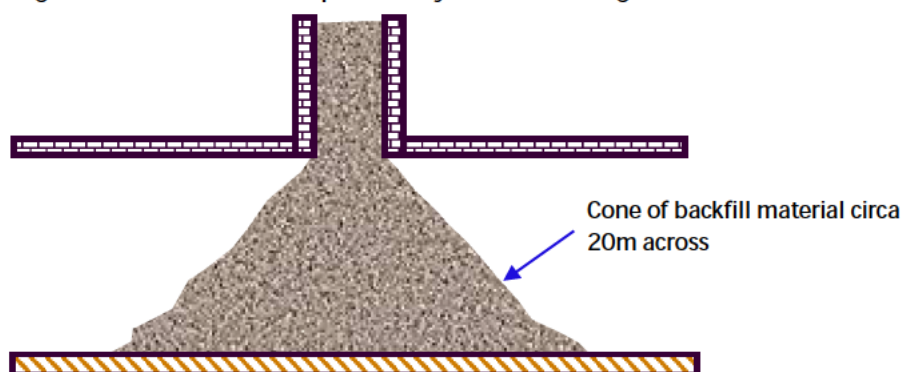
Figure 7: Presumed cone of 6N fill below Shaft No.2

Shaft 2 is a masonry lined shaft 2.75m in diameter and approximately 34m in depth. The shaft top is located in open ground adjacent to a minor road south west of Queensbury. Shaft 2 has been backfilled, as an emergency measure to prevent collapse, with 6N granular fill that has been poured in from the ground surface with no provision to restrict its flow into the tunnel, or provide any compaction as the backfilling progressed up the shaft. It is therefore thought that a cone of material as depicted in the following figure will be forming a blockage within the tunnel that will need to be removed before the tunnel can be used. This presents obvious health and safety risks in that removal of the granular infill from within the tunnel would leave the shaft and tunnel linings unsupported and would subsequently loosen the backfill within the shaft, potentially resulting in an uncontrolled ingress of the backfill and potentially the shaft lining too.
