Map 21: Shipley - Leeds-Liverpool Canal Mainline from Gallows Bridge to Dockfield Road SOUTHDOWN ROAD Glovers Wharf (rear, key unlisted building) Junction Mills (key unlisted building Dockfield Mills (key unlisted building). 68a and 68b Briggate (key unlisted building) Junction Bridge (Grade 11 Listed)

Map 21: Shipley - Leeds-Liverpool Canal Mainline from Gallows Bridge to Dockfield Road

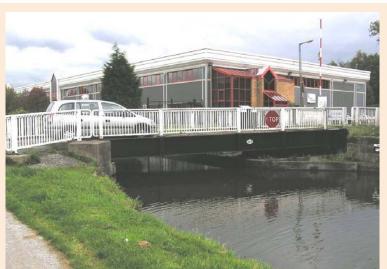
The modernised Oak Lane Bridge, with modern factory premises (outside the conservation area) in the background.
