River Worth Art, Interpretation and Access Waymarking Map

River Worth Project Access Improvements

River Worth Project Riparian Habitat Improvements

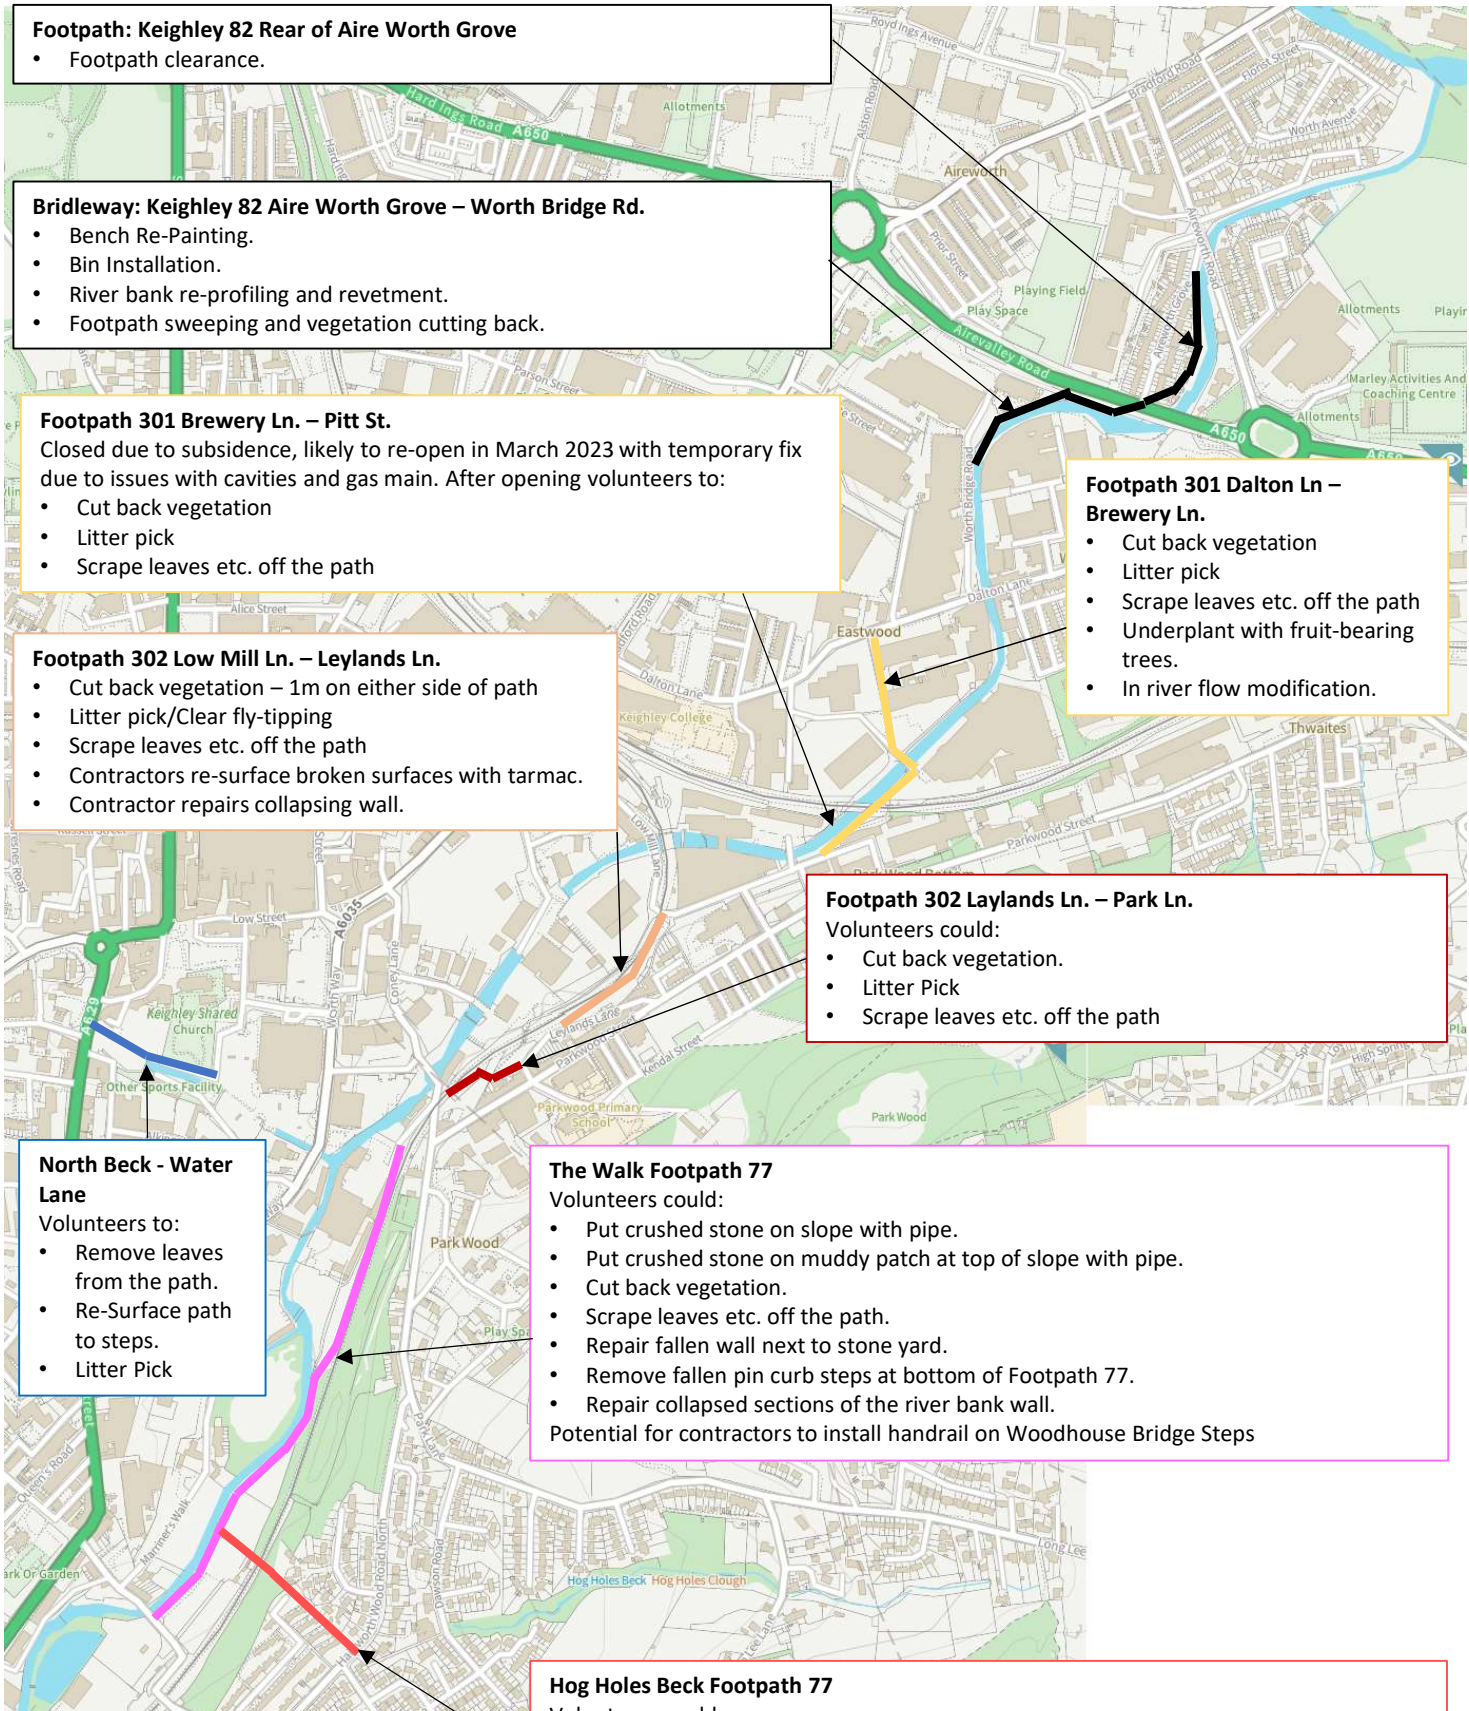
Footpath: Keighley 82 Aire Worth Grove

Bridleway: Keighley 82 Aire Worth Grove – Worth Bridge Rd.

Footpath 301 Brewery Ln. – Pitt St.

Footpath 302 Low Mill Ln. – Leylands Ln.

North Beck - Water Lane

The Walk Footpath 77

Hog Holes Clough

Hog Holes Beck Footpath 77

- Conservation Mowing Regime.
- Autumn Bulb Planting (Native bulbs).
- Planting sparse standard bankside trees.
- Restoration of stone seat planter.
- Community Rubbish Clearance at the Back of houses.

- Removal of Further Stone from Malcolm's Weir.
- Installation of new fence to stop debris falling in river from Hector Moore Ltd.
- Bin Installation
- River bank re-profiling, coir matting, and green revetment to stop bankside erosion under footpath.

- Thin Trees.
- Underplant with fruit-bearing trees.
- Repair collapsed bank top wall on Pitt St. at the junction with Alice St.

- Dense planting of scrub on open space below laylands lane.
- Fence off fly-tipping hot spot below Leylands Ln.
- Litter Pick

- Volunteers to:
- Remove leaves from the path.
 - Re-Surface path to steps.
 - Litter pick.

- Commission feasibility study for Contractors:
- In river tree hinging/flow deflection

- Bradford Council Assets: Woodhouse Way Land Asset Number:54424
- Leaky Dam installation.
 - Litter Pick.

- Remove Bankside Woody Debris with the potential to block the channel.
- Work with Bradford flood team to keep beck in the channel.
- Pollution Hunt misconnections and improve water quality.
