Drawing Title:
Photomontages;
Locations 2 and 4

Client:
**A.D Calvert Architectual Stone
Supplies Ltd.**

Site:
Horn Crag Quarry

Drawing Number:	Rev:
232/5 - 11	1.0

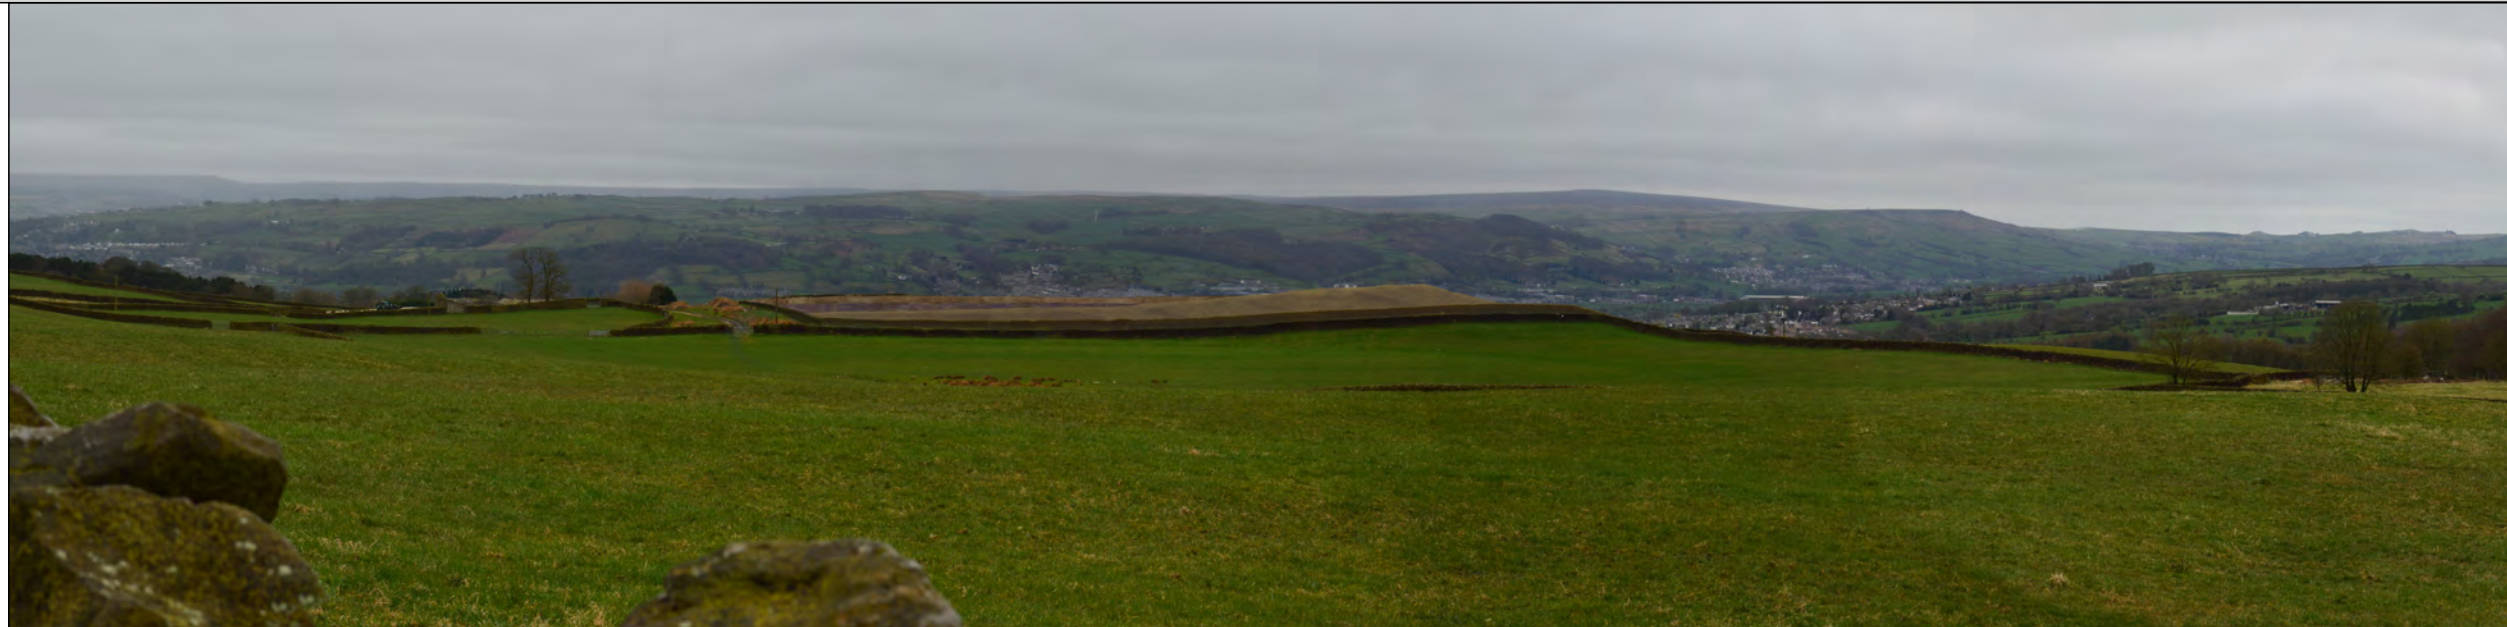
232/5-11a: Photomontage of Viewpoint 2

Looking southwest towards The Site during the initial working of Phase 5, when Phase 5 has been stripped. Phase 6 of working would not have begun yet. Phase A of restoration has begun with planting starting from the south. Phase B of restoration would not be visible from this viewpoint; however, it would not have begun yet. The dry-stone walls above the northern and eastern faces would be visible from this viewpoint. The Working Phasing Plan (ref: 232/5 - 3) and the Restoration Phasing Plan (ref: 232/5 - 10) are included in this application.

It is estimated that this would be the view from this location for approximately 1 to 2 months because extraction would start immediately and so more of the restored Phase A would become visible.

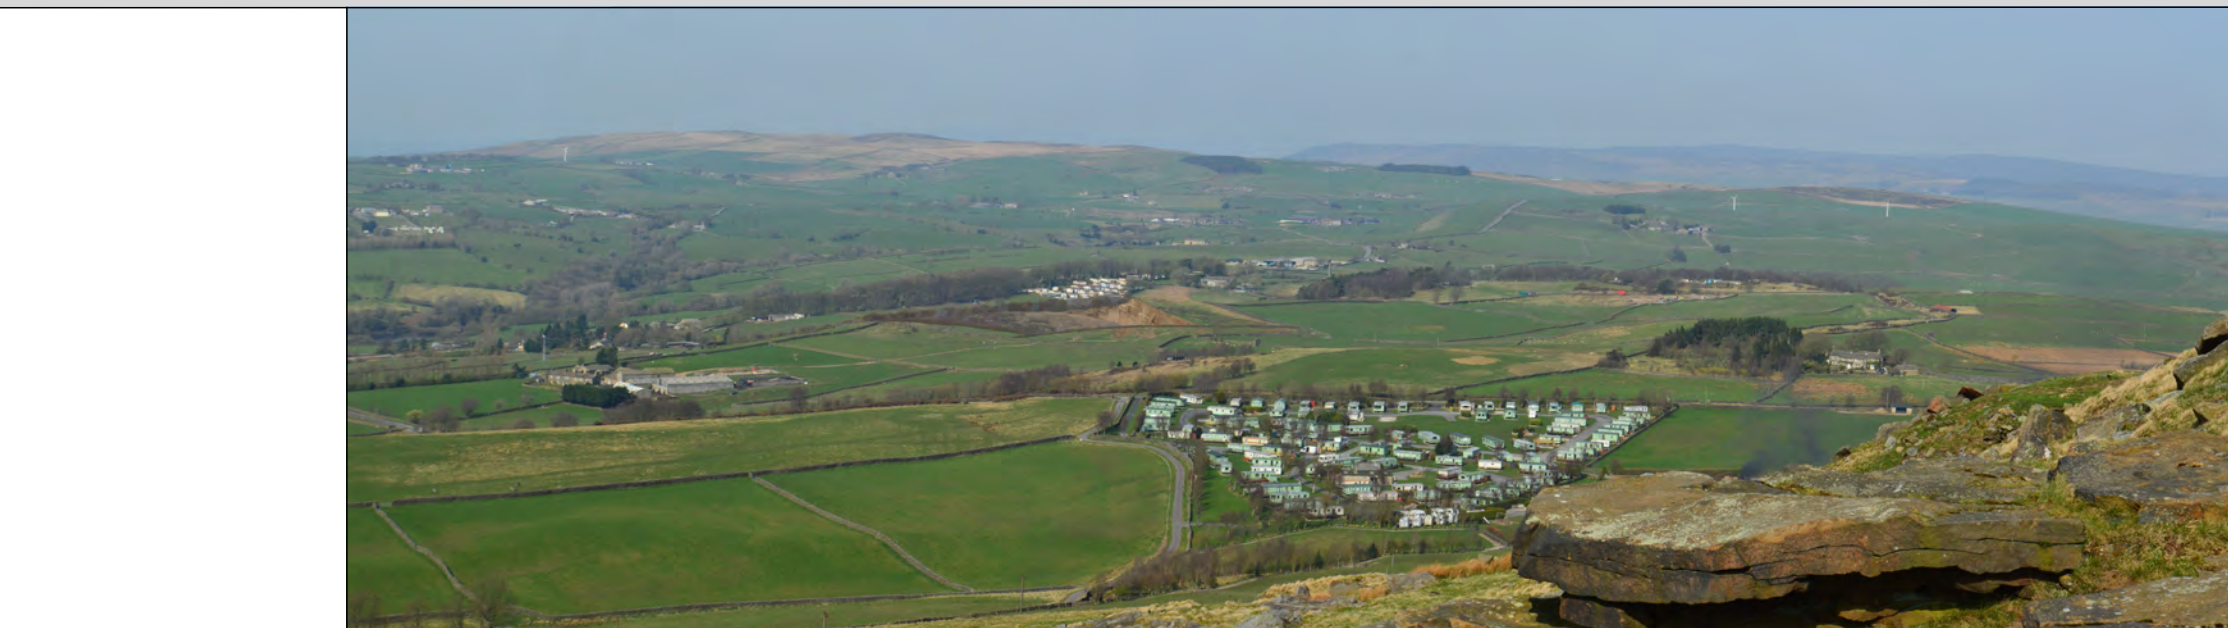
232/5-11b: Photomontage of Viewpoint 4

Looking northwest towards The Site after the completion of Phase 4 but before Phase 5 has commenced. Phase A of restoration has accomplished the proposed restoration contours, and planting has commenced from the south. Phase B of restoration has not been started and the face at the southern edge of working Phase 5 is visible from this viewpoint. The benched floor and the small face on the western edge of the extraction boundary would be potentially discernable from this viewpoint. The vegetation along the western edge of The Site would have grown during the lifetime of The Site and would be visible from this viewpoint. The Working Phasing Plan (ref: 232/5 - 3) and the Restoration Phasing Plan (ref: 232/5 - 10) are included in this application.

It is likely the site would be similar in visual appearance to the view depicted here from 1 to 2 years, whilst the working and restoration scheme evolves.
