Maintenance, Repair and Restoration **Chimneys**

The Conservation Value of Chimneys

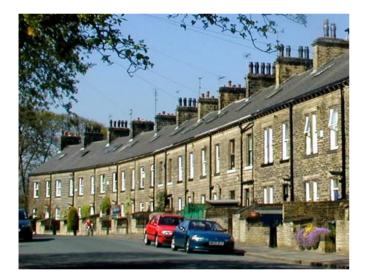
Top: These well maintained chimneys enhance the appearance of this house. Above: The removal of posts and cornice detail and the shortening of the stacks has drastically altered this roofscape.

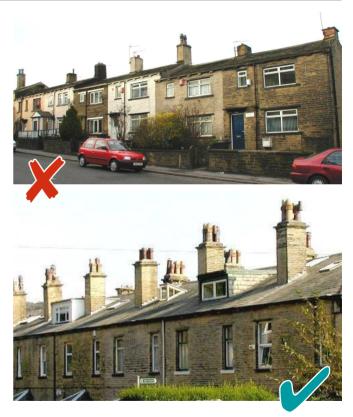
Top: Only two of the nine houses in this terrace retain all their details giving a disjointed skyline. Above: The retention of full height chimneys and pots gives this terrace a uniform appearance.
