## 8.1 Permeability and Streetscape: Apsley Crescent

### ***Summary of Permeability and Streetscape***

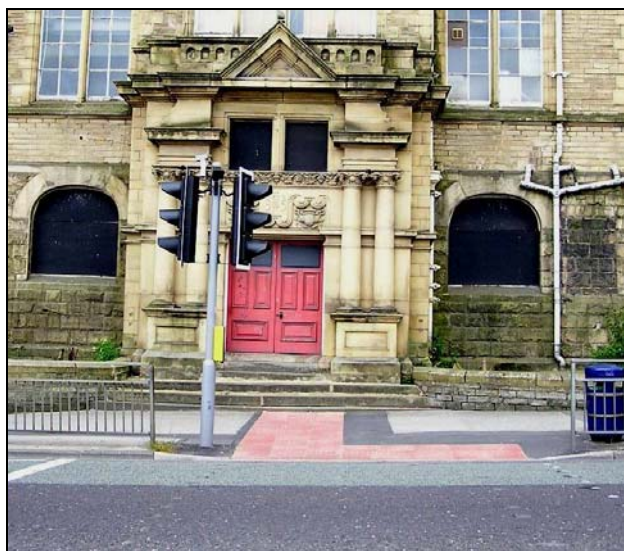
*Inconsistent, modern surfaces and unsympathetically detailed and sited street furniture are common along the main routes through the conservation area.*

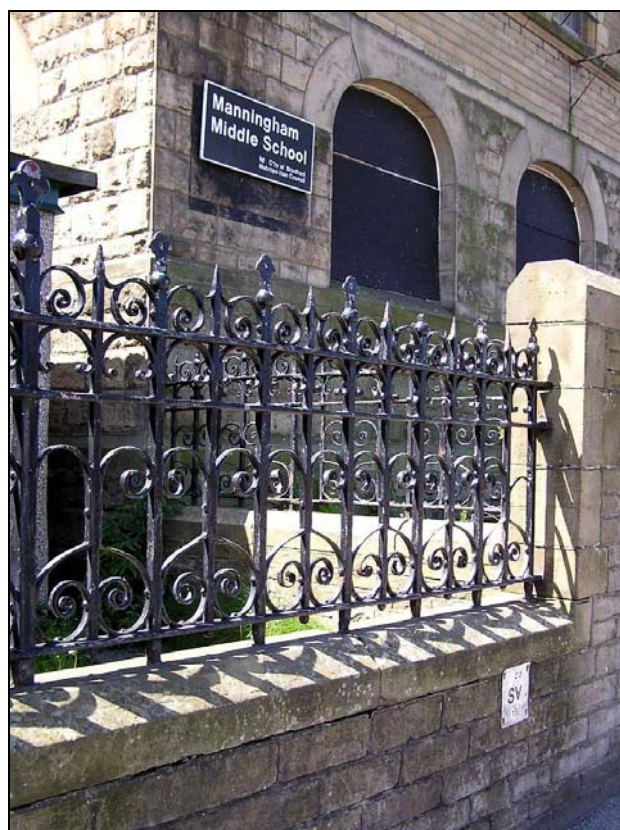
*This is one of the very few surviving sections of the original iron railings at the former Manningham Middle School.*

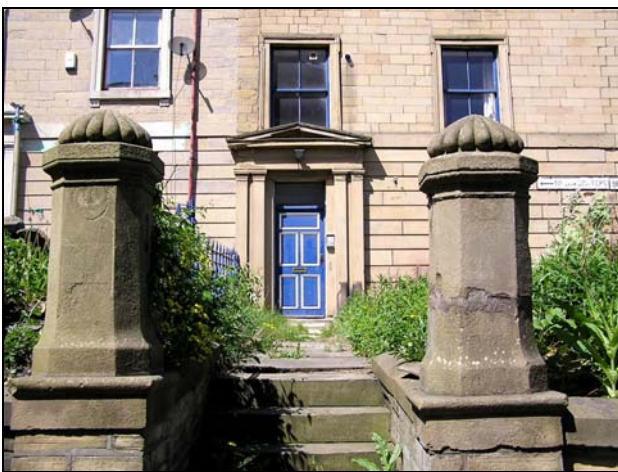
*Most of the distinctive monolithic gatepiers to the houses at Belle Vue remain in place. They are a key feature of the street scene and complement the architecture of the terrace.*

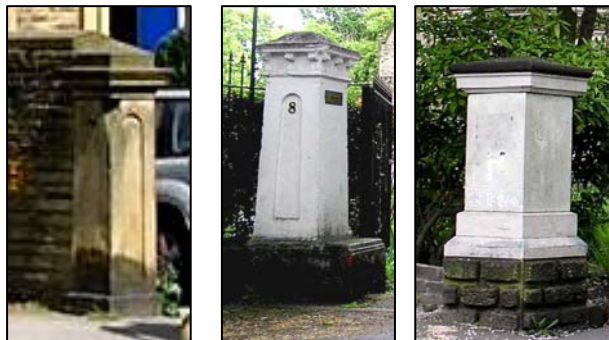
*Traditional monolithic gateposts at Clifton Villas. These important elements of the street scene should not be painted.*

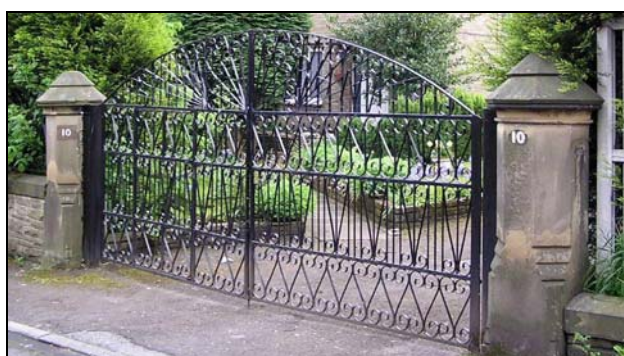
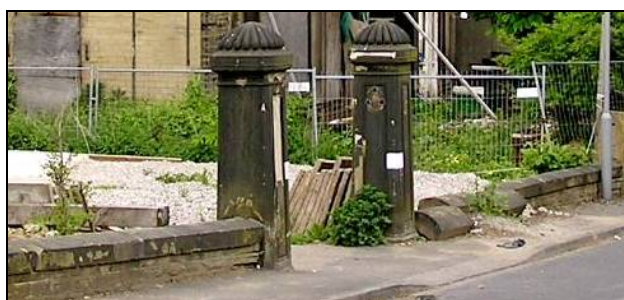
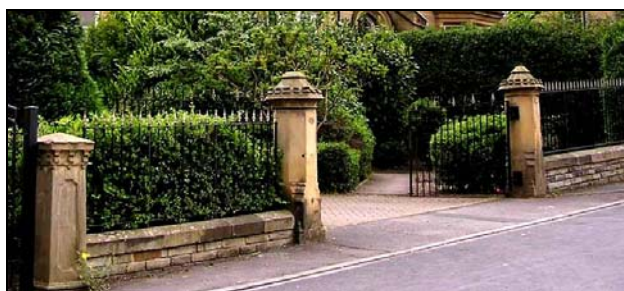
*The traditional boundary features and gateways to the houses along Spring Bank Place add to the street's sense of place. The walls and gatepiers retain their original character (although some are damaged) while in some cases sympathetic new railings and gates have been installed.*

be reinstated. In most cases property owners have installed modern traditional style cast iron railings on top of the walls, with similar gates between the monolithic ashlar gateposts. Unlike at Clifton Villas, the gateposts to each property are of a different design. For example, the Italianate 6 Spring Bank Place has Italian style square gateposts with modillion brackets carrying a pyramidal capping with a quadrant corner panel below, while the gateposts to 10 Spring Bank Place has broached octagonal shafts with almost conical octagonal capitals. The square gateposts at 5 Spring Bank Place have chamfered angles and a moulded panel on the front side of the shaft which is crowned by a circular capital with a distinctive 'jelly mould' capping. The boundary walls and gateposts are all important elements of the street scene.

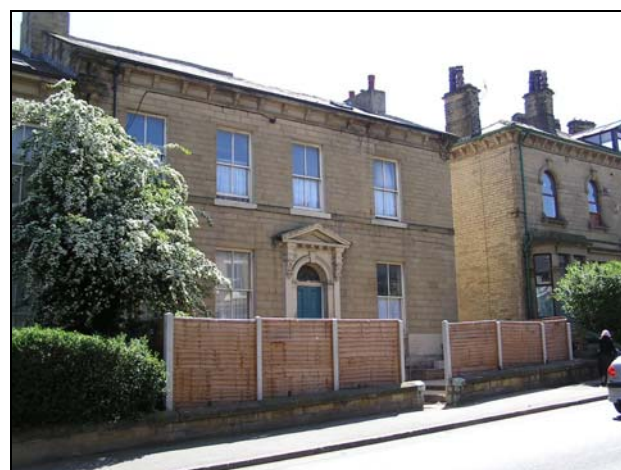
*This fence at 29 Marlborough Road is unsuitable for both the street and the Grade II Listed building behind it.*

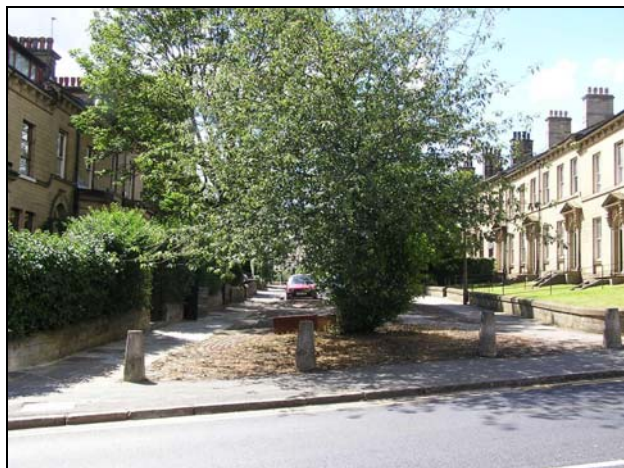
*This highway intervention closes off the junction of Apsley Crescent and Marlborough Road. The concrete tiles and bollards are inappropriate to the area, while the overgrown trees block vistas along the curved crescent.*

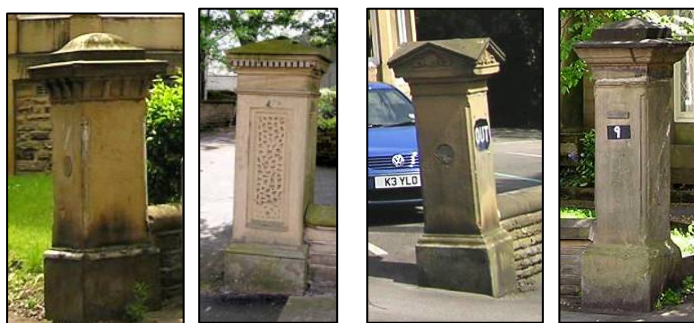
*The various style of gateposts along Walmer Villas reflect the different architecture and architectural styles of the houses.*

Vistas along Walmer Villas have much of the same quality and qualities as views along Mornington villas due to the greenery of the gardens, the refined appearance of the buildings and the consistency of the low coped boundary walls and monolithic gateposts. The concrete slab pedestrian surface of the pavements is of a lower quality than at Mornington Villas. As at Mornington Villas, the retention and appearance of the gateposts at the foot of each drive is important to the street scene and the overall feel of the area. As the houses are all Italianate in style, the gateposts (which are different at each pair of villas) are broadly similar to those at Mornington Villas.

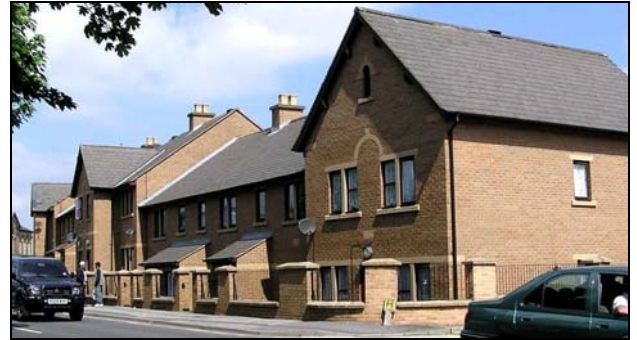
*The modern housing at 218-254 Lumb Lane has a strong boundary feature which is alas made out of materials which are alien to Manningham*

Lumb Lane have what would be a very good boundary wall with railings if it wasn't for the use of the same orangey buff coloured brick that was used to building the houses themselves. The brick walls have overhanging triangular stone copings. Its height alternated between high and low and the higher sections frame plain cast iron railings. The same materials and details are used in the gate posts.

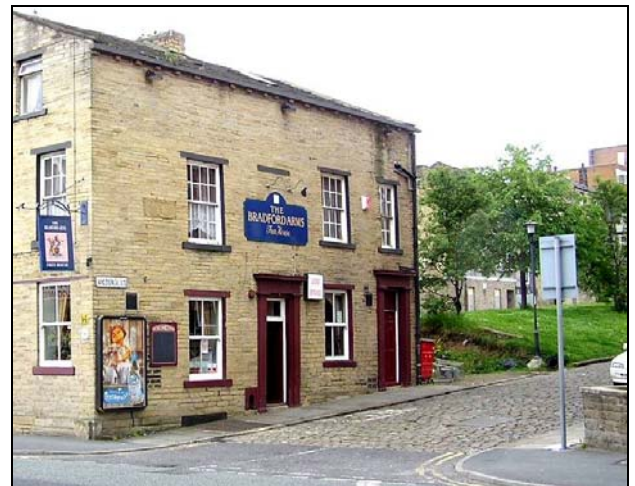
*The setted street at Victoria Street complements the stonework of the Bradford Arms but contrasts with the modern surfaces elsewhere.*

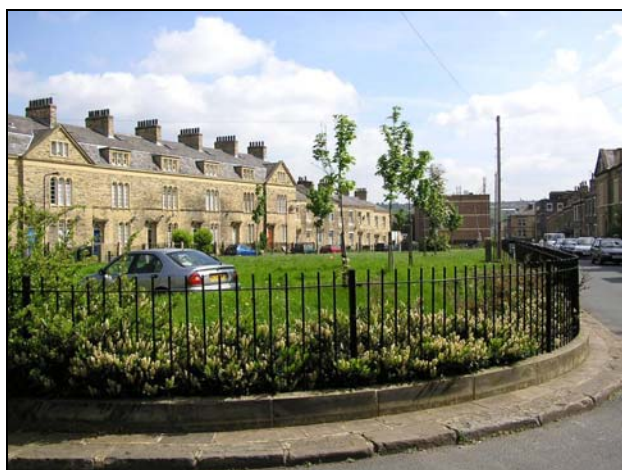
*The stone kerbing, low walls and iron railings around the central garden at Hanover Square help the area uphold its historic character.*

To the north of Sylhet Close, **Hanover Square** is another cul-de-sac of sorts, this time built in the mid-19<sup>th</sup> century with the access road looping back onto itself around the central garden. It is unclear whether the only access to the Square (off Manningham Lane) was ever gated to ensure that the middle class residents had maintained their privacy. The horseshoe shape of the long terrace of houses at Hanover Square closes off vistas and helps give the area a calm, serene atmosphere, despite the area's proximity to Manningham Lane. The street around Hanover Square is tarmaced, with speedhumps regularly spaced along the one-way street. The pavement in front of the houses is surfaced throughout with stone flags edged with stone kerbing. To each house there is a low ashlar slab wall to which plain iron railings are attached (these were introduced when Hanover Square was improved in the late 1980s). At the foot of the pathway leading to each house is a pair of gently tapered monolithic ashlar gateposts with round heads. The consistency of the boundary features, gateways and traditional stone paving means that the uniform appearance of the houses (which retain traditional features and details) is strongly supported by their immediate setting and adds to the character of Hanover Square no end. The

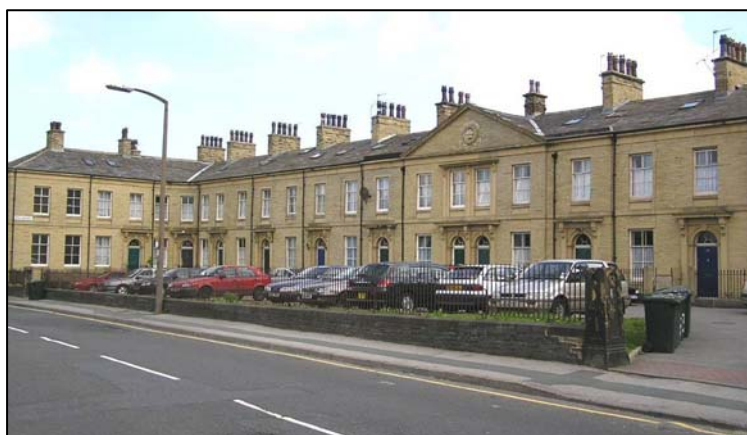
*The railings and traditional walls at Peel Square are key elements of the street scene. Note the inappropriate red paviers to the right.*

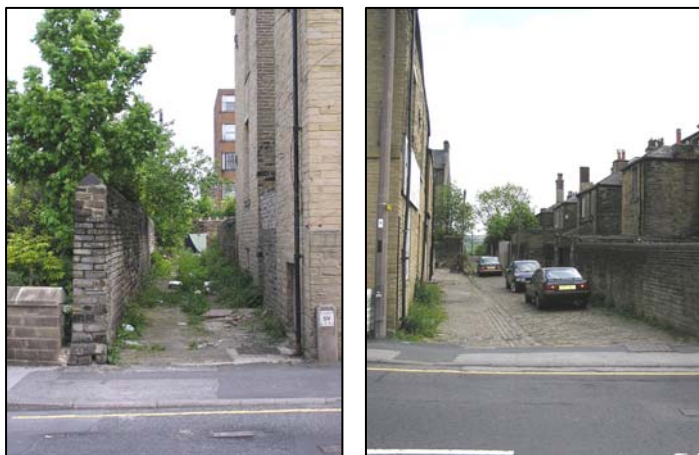
*The back streets to Peel Square retain traditional stone settled surfaces, but suffer to varying degrees from neglect and vandalism.*

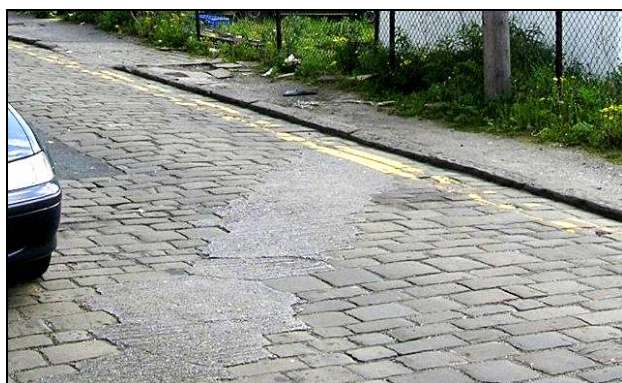
*Darfield Street retains half of its settled surface, some stone kerbing and some stone flags, but much of these surfaces are in a poor state, particularly the pedestrian spaces.*

the rest of its length the stone setts are only covered by tarmac where utility companies have been at work under the surface. The setts are showing signs of neglect, but the main problems concern the kerbing and pedestrian surfaces along this street. The northern side has a consistent stone kerbline, but an inconsistent mixture of stone flag, patchy tarmac and concrete slab surfaces, while on the opposite side the stone kerb has been re-laid on the wrong side and is weathering badly, while the pedestrian surface is a mixture of patchy tarmac, gravel and badly broken and loose flags. The dilapidated chain link fence and the gravel car park beyond do nothing to enhance the street scene. Some buildings face directly onto the street, but where there are boundary walls these are modern in character and are made of cast concrete, imitation stone or use modern railings. Number 30 retains a sandstone slab low wall and segments of the original iron railings. The flags on Darfield Street wrap round the corner onto **Houghton Place**.

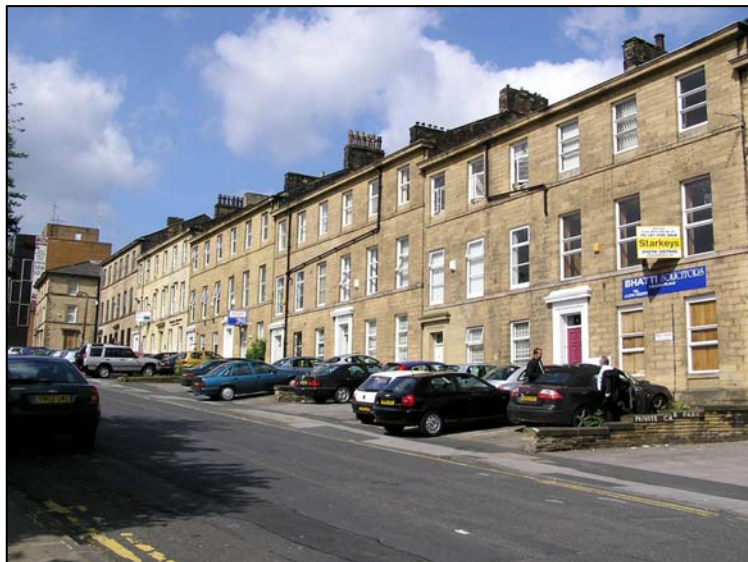
*The lack of boundary features to the terrace along Eldon Place and the use of the gardens for parking gives these houses an undignified immediate setting and provides a poor street scene.*

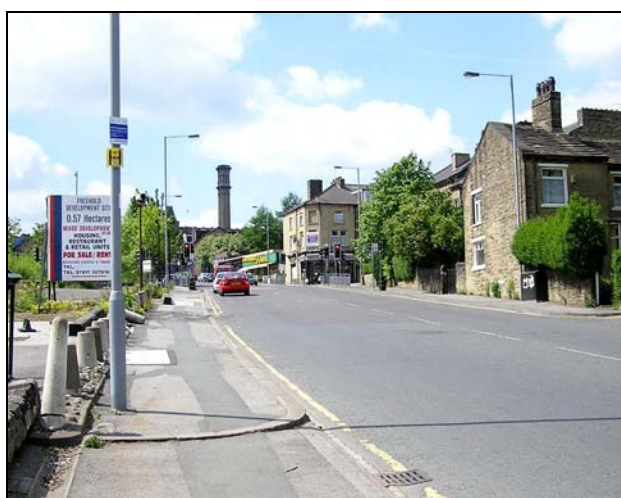
*The streetscape west of St Mary's Road is undermined by poor boundaries on the south side of the road. The chimney of Manningham Mills is visible at the brow of the hill.*

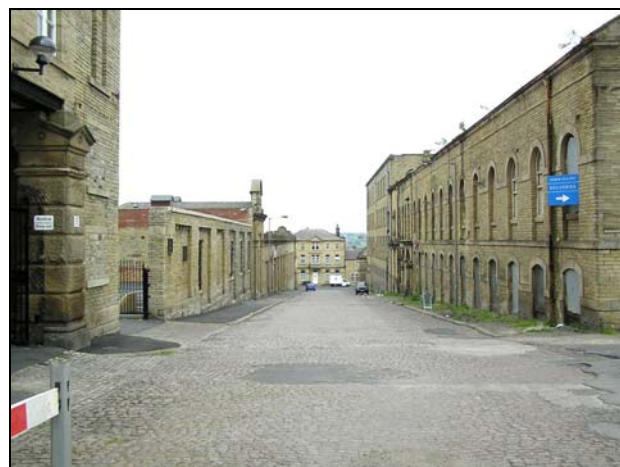
*Beamsley Road is surfaced with mostly stone setts and lined with the former buildings associated with the mill. This characterful street now has a sense of dereliction but the redevelopment of the mill should restore some of its vibrancy.*

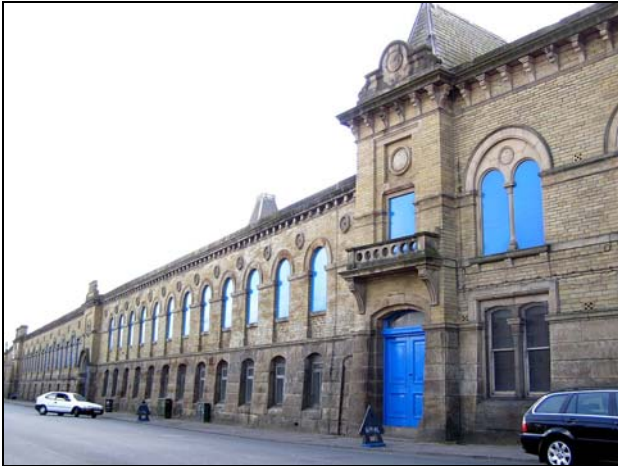
*The impressively stark streetscape along the western side of Heaton Road is countered by the open space and young trees immediately opposite.*

The most impressive street frontage of Manningham Mills is along Heaton Road which there is a consistent tall one/two storey façade to both of the large blocks of the complex. The high defensive-looking wall which its rusticated battered lower storey and a regular rhythm of features and details are an important component of a unique and characterful industrial street scene. Between Oak Lane and Victor Road the elevation faces a corresponding line of semi-mature trees, which despite its obvious differences, forms a complimentary wall-like mass with regularly spaced trunks and a consistent canopy height. The greenspace the trees stand in is edged with stone kerbstones. Between Victor Road and Park View Road are the only residential terraces in the conservation area which face directly onto the street, which, with the elevation of the Mills, gives this section of Heaton Road a very hard, tunnel-like character. Half way along the small yard between 246 and 246a Heaton Road retains an overgrown setted surface.

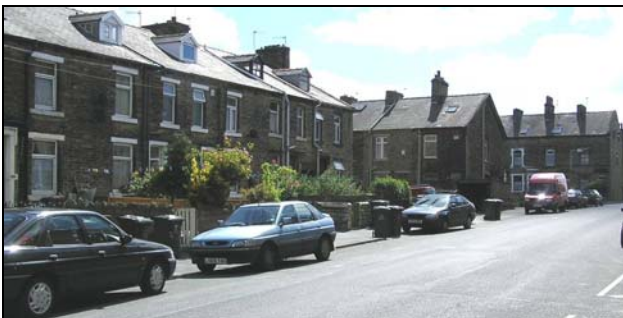
*The streetscape along the northern-most section of Heaton Road is disjointed due to redeveloped boundary walls, replacement gates etc.*

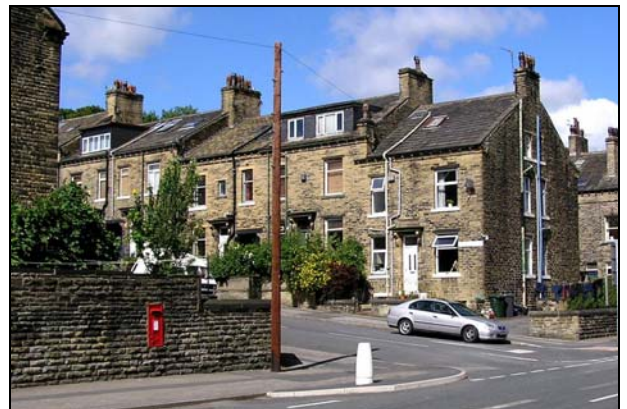
*The steep slope of Milford Place (above) and Milford Place adds interest to the streetscape.*

The back-to-back terraced streets of Firth Road and Milford Place step down the hillside and the stone boundary walls with chamfered copings stones do the same and reinforce the linear character of these streets. All boundary walls remain in situ, although incongruous additions have been made to some. The low iron railings which were originally attached to the copings remain in places, such as at 18

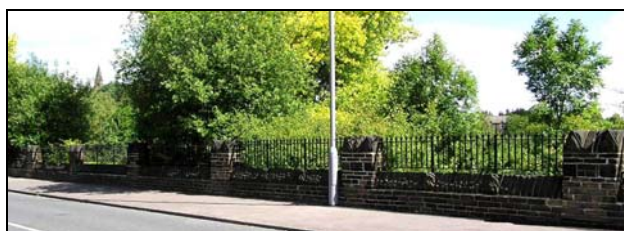
*The stone boundary wall and railings along the edge of the reservoir on Wilmer Road forms a strong edge to the streetscape.*

St Cuthbert's Roman Catholic Church and the former reservoir are both bounded by characterful stone walls. These walls are comprised of low and high sections. The low sections have rock-faced triangular copings with regularly spaced rusticated 'gabled' copingstones to which the pointed iron railings are attached (those at the church have been removed). The high sections are treated as piers to which the railings are attached where they remain in

place. These 'piers' have similar copings with two rusticated triangle-fronted copings flanking a single triangular rock faced copingstone. At St Cuthbert's Church the principal entrance to the churchyard is demarked by a pair of ashlar block gatepiers with gothic style 'gabled' capitals which have central circular panels with a cross relief carving. The gates have long been removed and in its place to prevent vehicles from entering the car park is a basic unpainted railing which is locked to housing which is set in concrete.

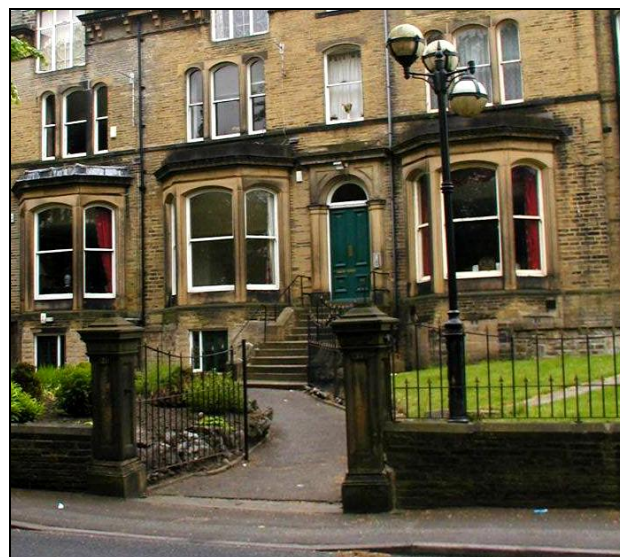
At 19-22 North Park Road, the terrace and its gardens are set behind a low boundary wall with chamfered copings. At number 22 some very good simple but visually pleasing traditional style railings have been attached to the wall, while at 19 there more simple pointed modern traditional style railings. The other sections of wall lack railings. At

either entrance to the central carriage sweep (which is surfaced with tarmac and is used as a pedestrian access rather than a vehicle access) is demarked by a pair of monolithic ashlar gatepiers. These gatepiers are square and stand on moulded plinths. Each face of the shaft is panelled and the entablatured capitals are topped by hipped cappings to which lights are still connected in most cases. At 22 North Park Road is a distinctive iron gate which matches the style of the railings. Within the gardens is an interesting old iron streetlight.

*The stone walls, iron railings and gates to no. 22 North Park Road are all original and add distinction and character to this part of the streetscape.*

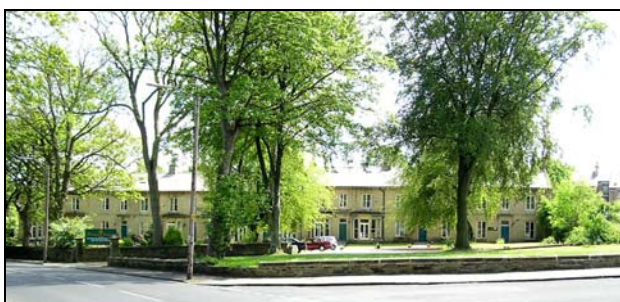
North Park Terrace and its large communal garden stand behind a low triangular coped boundary wall which allows views across its grassed gardens towards Fairmount. The entrance to the shared drive is flanked by square monolithic ashlar gatepiers with tapered shafts that stand on plinths. The pyramidal capitals are stepped. The grounds of Fairmount are separated from North Park

Terrace by a simple round coped boundary wall. Facing onto North Park Road is a drystone wall; a rare remnant of the fields which existed up until the mid-19<sup>th</sup> century. The 'street' in front of Fairmount is more for show now that the entire row is in use as a single care home, but retains many of its traditional characteristics. The entrance retains its original gateposts with a good pair of modern replacement iron gates (Fairmount was one of two streets in the conservation area which are known to have been gated). The square monolithic gatepiers stand on plinths and have shaped pyramidal capitals. The individual gardens to each house stand behind the original low boundary/retaining walls with chamfered copings, with a higher wall facing onto North Park Road.

*The green and leafy garden to the front of North Park Terrace and Fairmount complements the openness of the park opposite.*

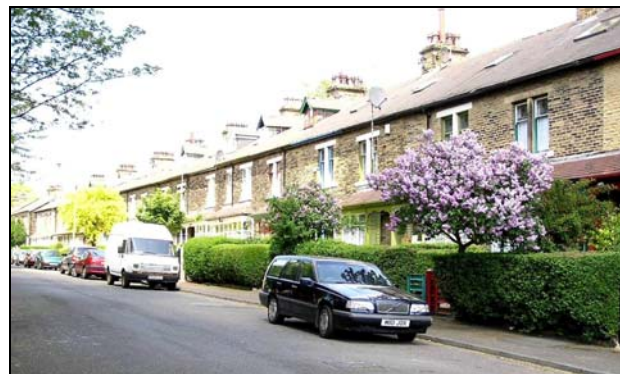
*The streetscape along Oakfield Grove has a disjointed appearance due to the loss of traditional boundary treatments.*

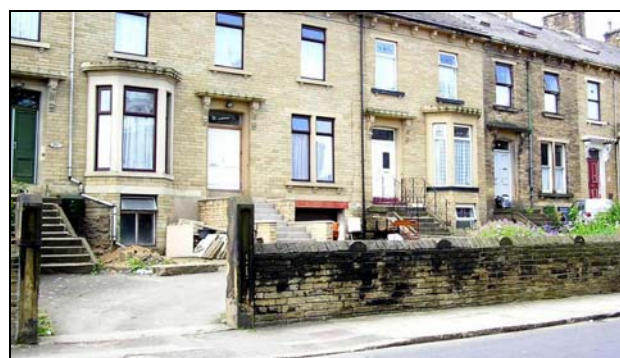
*The gate posts and walls to nos. 51-71 St Mary's Road once contained iron gates and railings that enclosed the private drive and gardens.*

Further uphill, the terraces of houses at St Mary's road have a linear layout which is reinforced by the line of traditional chamfer coped boundary walls with ramped sections adjoining the end houses. 51-71 St Mary's Road has a shared private drive and communal garden which is enclosed by a long wall with a gateway at either end. The gateways have

monolithic panelled square gatepiers with chamfered heads. The wall in between these gates has a hammer dressed triangular copings with regularly spaced chamfered stones to which the iron railings were originally attached. The sections of wall to either side of the gates join the end houses of this terrace and are very high ramped walls with triangular copings.

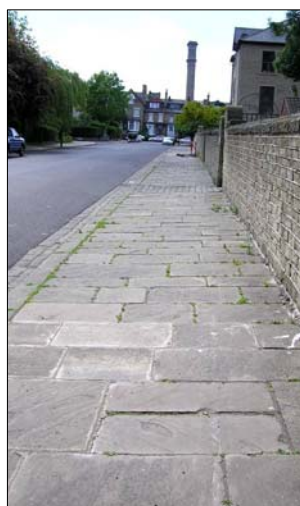
Selborne Terrace is near the end of St Mary's Road and retains flagged pavements, stone kerbs and setted gutters which enhance the street scene.

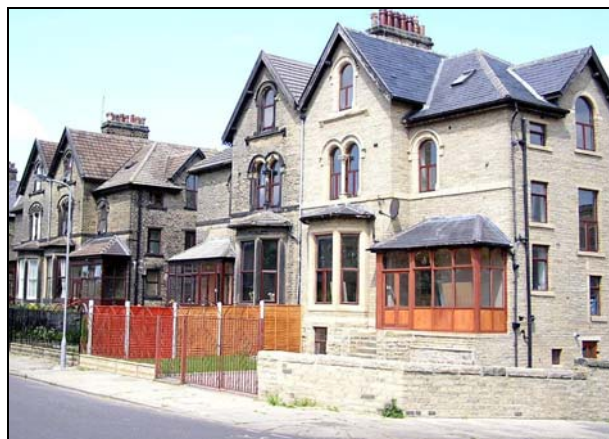
*The loss of original boundary walls and railings along Selborne Grove has undermined the integrity of the streetscape.*

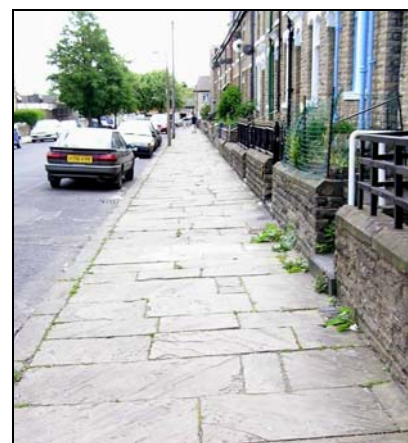
*The stone setted streetscape along Sunderland Street enhances the setting of the buildings along its edges and makes an important contribution to the character and feel of the place.*

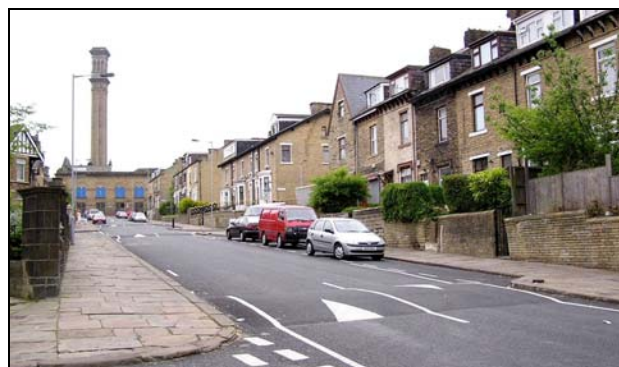
Victor Road is a long street which is lined by a number of different terraces which step down the hillside. The tarmac road is crossed by speed humps at various points and parking spaces are set into the pavements. Apart from the area around Selborne Grove, which is surfaced with concrete tiles and tarmac, the full length of the pavements along Victor Road are surfaced with natural stone flags with stone kerbing, which helps the street to retain some of its historic character. The flags are complemented by the stepped stone boundary walls to all residential and ecclesiastical properties which are topped by chamfered copingstones. This general uniformity of the boundary features makes inappropriate boundary features all the more

prominent and makes their negative effect on the street scene apparent. Examples of inappropriate boundary details include the missing boundary to 37 Victor Road, the high breezeblock wall at 64 Victor Road, the painted stone and concrete block walls at 15-27 Victor Road and the high boundary wall at 6 Victor Road, which is only inappropriate due to its scale which contrasts with the neighbouring walls.

*The diverse streetscape along Victor Road is visually dominated by the monumental Manningham Mills at its western end.*

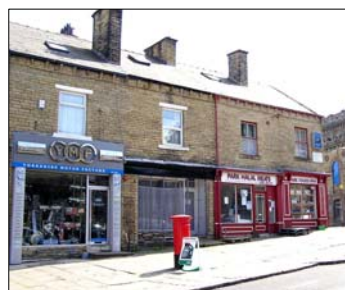
At the top of Victor Road, the shops at 45-53 Victor Road/182 Heaton Road open directly onto the street and are fronted by a wide stone flagged pavement.

Traditionally goods would have been displayed in this space, but now it is empty, save for the pillar box stranded in the middle of this space. At the other end of the row the shop at 39 Victor Road is fronted by a similar space, but here the surface is concrete slabs. At the foot of the road the large

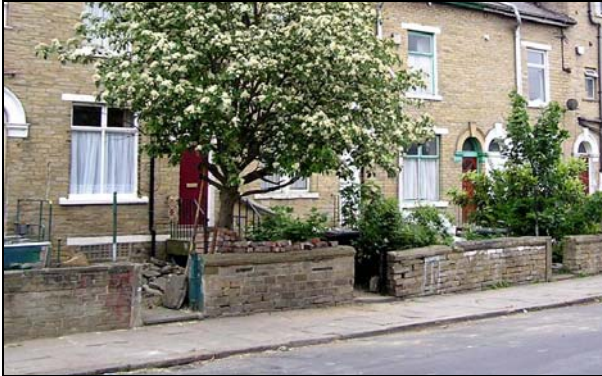
*The remaining stone walls and stone flagged pavements along Temple Street and Buxton Street visually complement the character of the streetscape.*

The back-to-back terraces at Buxton Street and Temple Street are fronted by boundary walls with unusual carved rounded copingstones. Unfortunately some of these walls have been unsympathetically altered and in some cases crude walls built out of modern materials have been erected between neighbouring properties, harming the street scene. Both streets have natural stone flagged pavements in front of the dwellings.

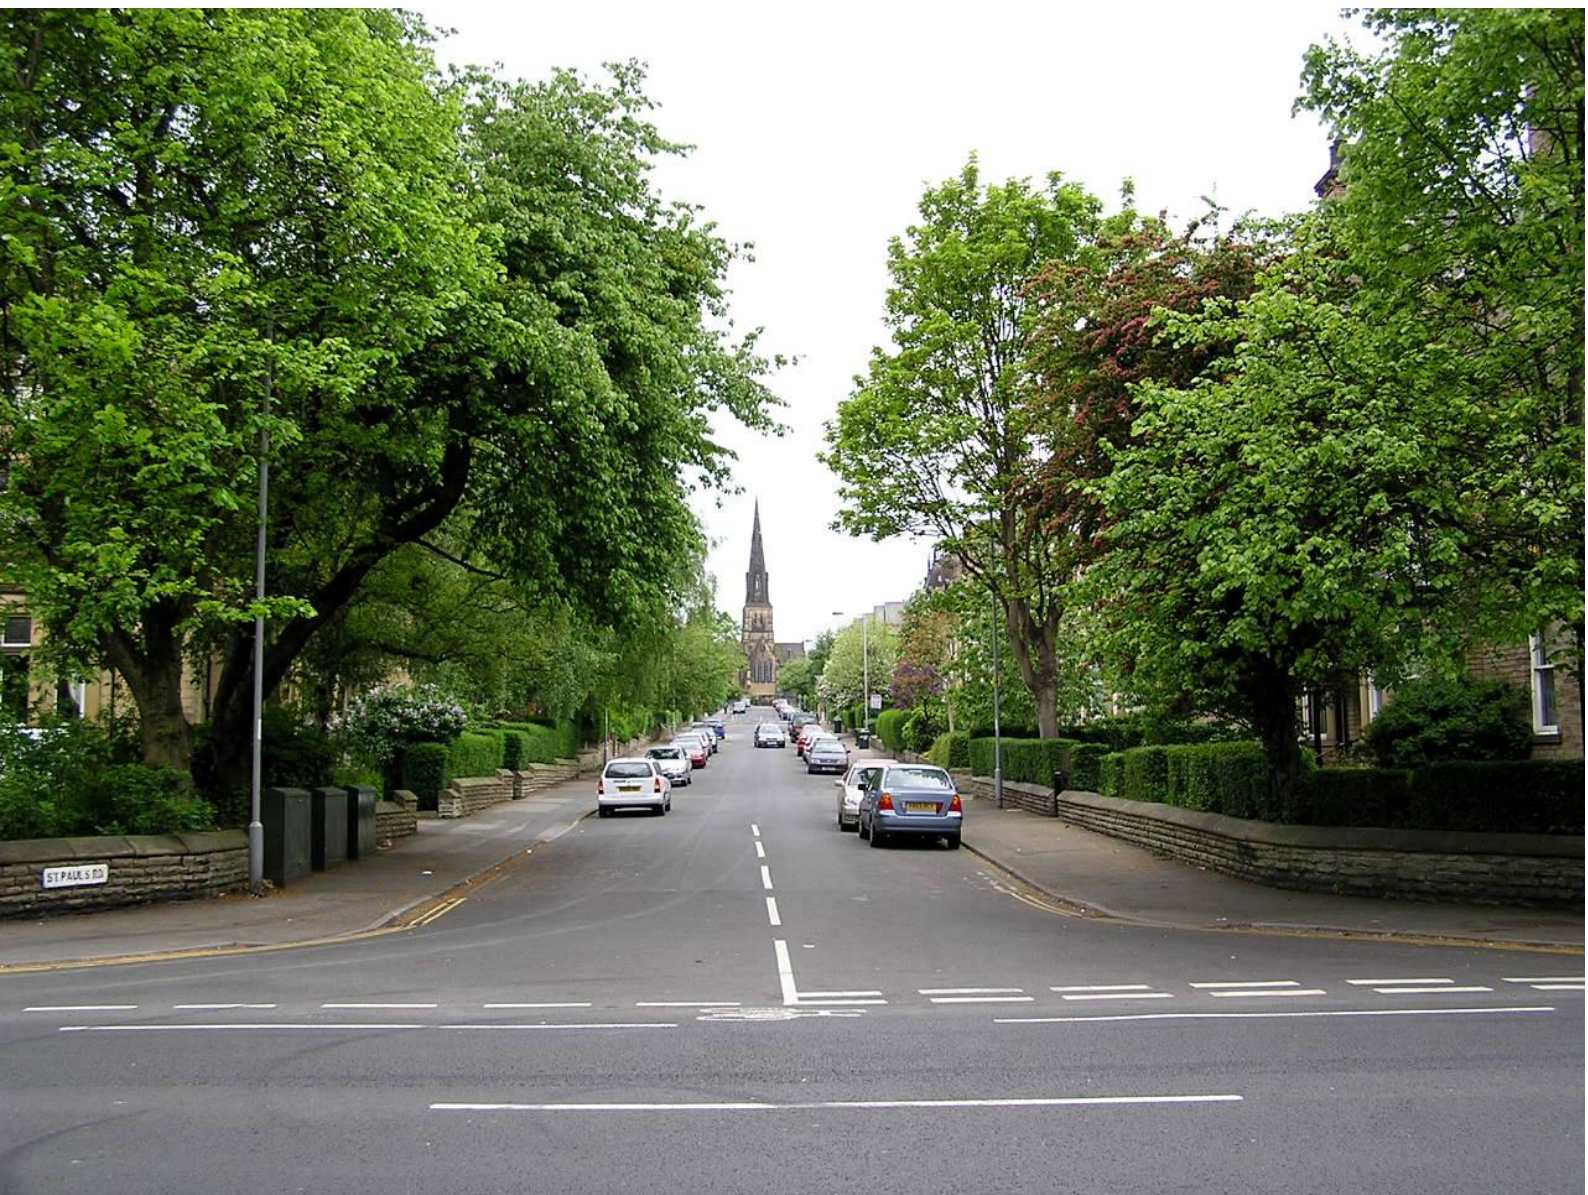
*This characterful vista up St Paul's Road is delineated by stepped boundary walls and hedges.*

Halfway along the stretch of Manningham Lane that runs through the conservation area is the vista up St Paul's Road which terminates in the tower and spire of St Paul's Church. The trees and hedges, the straight building line and the straight line of the road and the boundary walls and pavements which flank it are all important factors that make this vista so distinctive. The street and pavement surfaces are all modern, but most of the front boundary wall, which either step or slope downhill remain in place and retain their original character. There is a slight variation in the height of wall and the type of coping between each terrace which lines St Paul's Road. Some houses, like 17-27 St Paul's Road, have coped boundary walls which extend up to the doorways as solid balustrades, while the terrace at 30-54 St Paul's Road has a wall with higher sections of coped wall which originally flanked iron railings which were attached to the copings of the lower sections of wall. Because of the uniformity of the boundary features, those instances where walls have been altered (such as be rendering them or creating larger entrances) stand out more than they would otherwise. Halfway up St Paul's Road is a modern highway intervention which was inserted to prevent the street from becoming a through road by motorists wanting to avoid the junction of Oak Lane and Manningham Lane. This intervention runs diagonally across the junction with Bertram Road and its materials, such as concrete kerbs, steel posts, concrete bollards and cast concrete tiles are unsuitable for a historic area such as this and the scheme could have been done using more sensitive materials. A similar modern intervention seals the junction between St Paul's Road and St Mary's Road.

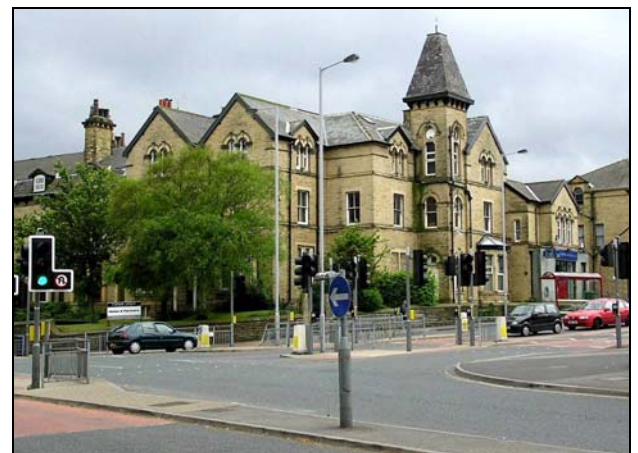
*Along the main thoroughfares of St Paul's conservation area, traditional buildings and boundary features and pleasant greenery are juxtaposed with out of keeping modern highway interventions.*

traffic islands which pay little regard to the historic character of the area. The pavements are surfaced with concrete slabs, those at the corner with Marlborough Road (*left*) are particularly broken up and in poor condition. These modern surfaces are juxtaposed with the traditional hammer dressed stone

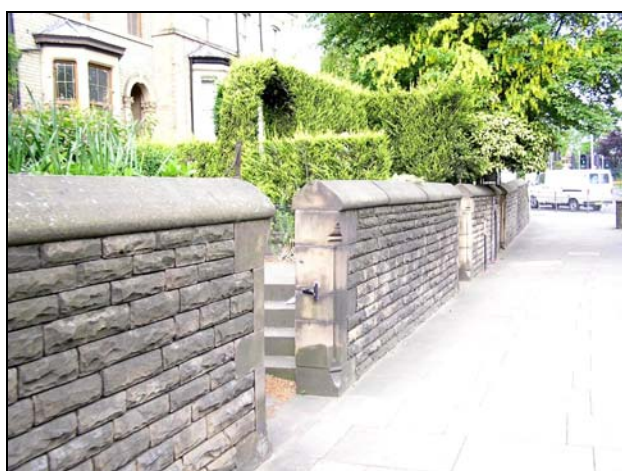
along the lane. The walls are all quite low and were originally topped by iron railings. The copings change with each group of houses from flat coping to chamfered copings. The walls at 287-311 Manningham Lane incorporate ramped sections and some of the houses have gateways made up of ashlar quoins with chamfered angles. The wall in front of Blenheim Mount is interrupted by two gateways which lead to the sweeping private drive which is shared by the properties. The gateways are announced by square gatepiers on plinths which are topped by pedimented capitals. Unfortunately one of the gateposts at the southern entrance is missing while those to the northern entrance have painted shafts. The drive itself is tarmaced and the gardens to either side have traditionally lacked boundary features, which makes the high close-boarded fence to 1 Blenheim Mount look particularly out of place.

*The traditional boundary walls along Manningham Lane provide the street scene with an element of consistency*

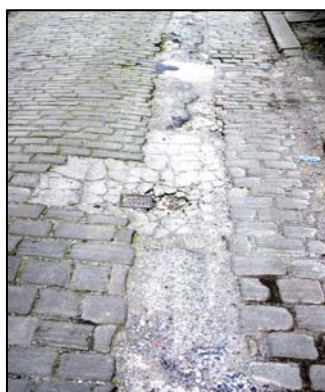
The back streets to the houses lining Manningham Lane, namely Back Lindum Street and Back Blenheim Mount, retain stone setted carriageways, stone kerbing and stone flagged pavements, which harmonise with the high coursed stone boundary walls which line them. Unfortunately these surfaces are in varying condition and would benefit from re-laying in places, particularly as vegetation is pushing up between the stones in places. Worse still is the fact that elements of the stone surfaces have been removed and the resultant space resurfaced with gravel or tarmac with concrete kerbstones, which gives the streets an inconsistent appearance visually standing out. Some of these new surfaces are a result of the theft of the stone surfaces, but the

most damage (*right*) has been done by utility companies who have replaced setts with tarmac, while the new development behind Bundria Court has resulted in a new tarmac pavement with concrete kerbing being laid. Further damage to the street scene has been done by the whole or partial demolition of the rear walls of the Blenheim Mount/Manningham Lane properties. This disrupts the regular rhythm of walls and monolithic round-headed gateposts with large voids in the wall or modern gates.

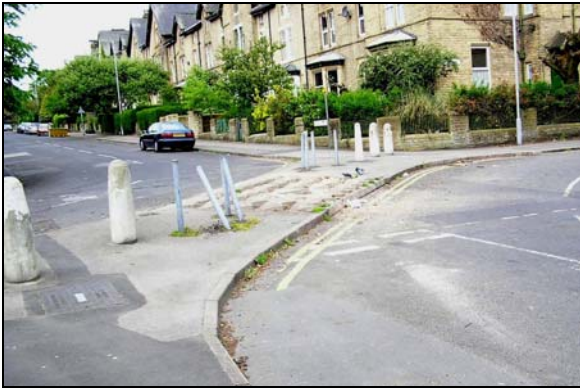
*Traffic management installations should be made of traditional materials and should make an effort to complement the character of the surrounding area.*

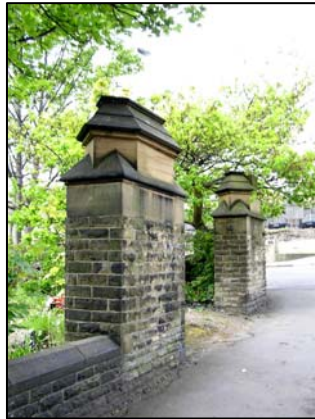
lane, the vacant site to the north of Bertram Road is fronted by a line of concrete bollards set in an overgrown concrete conglomerate verge. Boundary features such as this one are wholly unsuitable for strongly coherent areas of traditional townscape such as Manningham. At the corner with Rosebery Road (*right*), the site of Salem Chapel retains a good stone boundary wall with chamfered ashlar copings and tall gatepiers with complex ashlar copings, which are the only remnants of the building which once occupied this overgrown, rubbish strewn site. This same boundary continues in front of the former Sunday school to the Church, 21 St Mary's Road, and makes a positive contribution to the street scene. Neglect and a lack of purpose for the site of the chapel mean that parts of the walls are collapsed or missing. On the edge of the conservation area, the rear garden of Manningham Old Hall lacks a boundary and is full of broken red bricks, although to the Rosebery Road side is a good tall boundary/retaining wall with rounded hammer dressed copings.

*Top of next column: At Bertram Road one of the few remaining traditional boundary walls (*right*) stands next a collection of unsympathetically altered boundaries or new ones which undermine the row's unified appearance.*

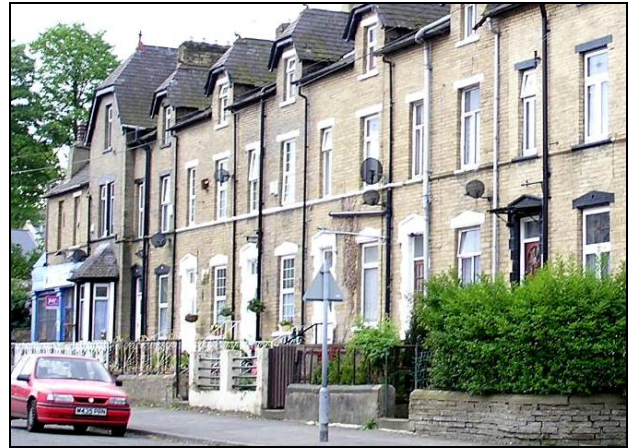
The long, straight course of Bertram Road is delineated by the positions of the terraces of houses and the straight line of the boundary features and pavements. The street is tarmaced, the kerbstones are concrete (with overgrown gutters) and the pavements are a visually poor mixture of concrete slabs. The last terrace to be built along the road, 52-68 Bertram Road has low sandstone slab walls to which iron railings were originally attached. In some cases this is the only boundary feature, while in others the walls are surmounted by box hedges or unsuitable timber fences. The other terraces originally had low coursed wall with chamfered copings to which railings were once attached. While 8-20 retains traditional walls with hedges rather than railings above, the opposite terrace (3-19 Bertram Road) is fronted by a range of unsuitable or unsympathetically altered boundary features which lack the unity provided by the traditional features. The corner shop at 3 Bertram Road is cordoned off from Church Street by ugly utilitarian pedestrian barriers. The back streets to Bertram Road are all setted, kerbed and paved in stone and retain much of their traditional character, particularly as a lower proportion of the back walls to properties have been altered. But as elsewhere in this conservation area, the stone surfaces have been neglected, with elements missing and replaced with unsuitable materials or vegetation sprouting between the stones.

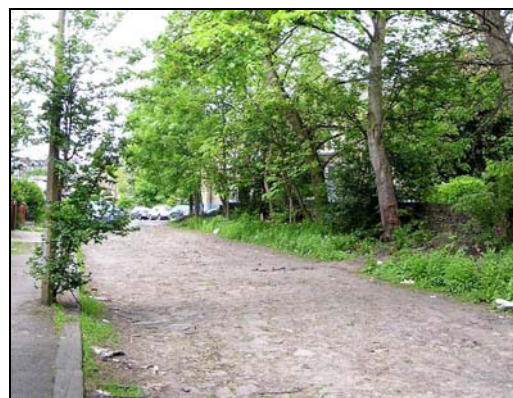
*The unsurfaced roadway with overgrown edges at Welbury Drive.*

Welbury Drive branches off Bertram Road. This dead-end private road has a tarmac pavement with stone kerbing along it one side and a road surface that is a bumpy, uneven mixture of bare earth, gravel and stones. The gutters to the road are overgrown and full of debris while most of the stone boundary walls have been removed and either not replaced or modern suburban style picket fences have been built.

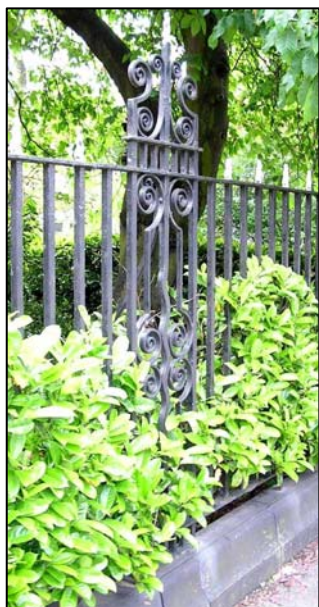
This street lacks much of its coherent, traditional character. The adjacent nursing home retains a distinctive boundary to St Mary's Road which is made up of shaped stone slab wall or copings topped by ornate iron railings (*left*). These railings match those which top the flat roof of the rotunda wing of the nursing home and incorporate the same sections of scrolled ironwork either side of a wavy baluster with a pointed scrolled finial decoration above. The sections of railing between these flourishes have regularly spaced pointed heads. The boundary between the nursing home and Welbury Drive is an irregularly coursed mortared

former drystone wall, which is an unusual detail for an urban location such as this. The site behind the nursing home is the same vacant site without a boundary feature which faces onto Bertram Road and Oak Lane.

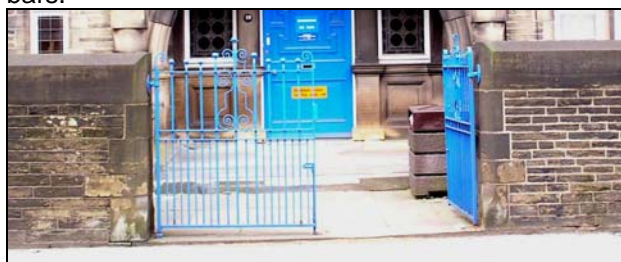
Across St Mary's Road from the former Bradford Children's Hospital and complimenting its ornate architecture and boundary feature is St Catherine's Home. The boundary wall to the Home is topped by railings and sweeps around the corner at Fern Terrace. The ashlar copings are chamfered and the railings have regularly spaced flourishes of scrolled ironwork topped by pointed and scrolled finials. The railings in between these flourishes are topped by ball finials. At the entrance to the building, the copings ramp upwards and terminate at the main gateway with chamfered composite ashlar block jambs. The original iron gates remain in place and complement the railings as they have a central scrolled flourish flanked by straight, vertical iron bars.

*The traditional boundary walls and iron gates of St Catherine's Home complement the materials and architecture of the building.*

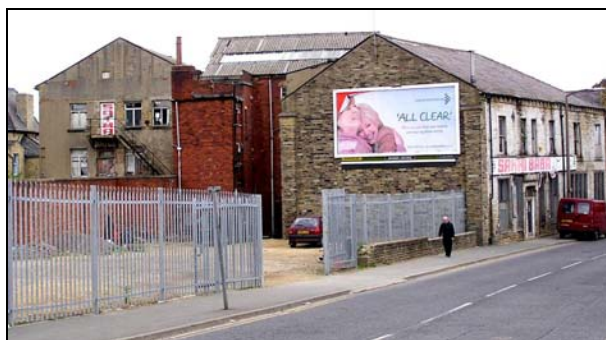
It is a shame, therefore that the street scene to the south of St Paul's Church along Church Street is marred by unsuitable modern boundary features such as the reconstituted stone wall with flat concrete copings to the new industrial unit and the tall unpainted palisade fencing to the north of Smith's Buildings. The latter is made more prominent by the fact that it stands on the outside of bend of the gently S-shaped course of Church Street, another ancient lane associated with Manningham village. The inside of the bend contains a number of good traditional stone boundaries. These include the low coursed walls to 5-7 Church Street with alternating chamfered and square ashlar copingstones, and the tall segmental-coped wall to the shared gardens at Rose Bank. The latter has ramped sections, but has collapsed at one end, while at its centre is the shared main gate with square monolithic gatepiers with chamfered edges and pyramidal capitals. To the south of Qureshi View is a new traditional style hammer dressed stone wall which lacks a coping detail and is instead topped by a thin layer of cement topped by plain railings. This modern wall adjoins the traditional flat coped retaining wall which separates Highfield Place from Church Street.

*Bare modern boundary features such as this palisade fencing on Church Street are out of place in conservation areas.*

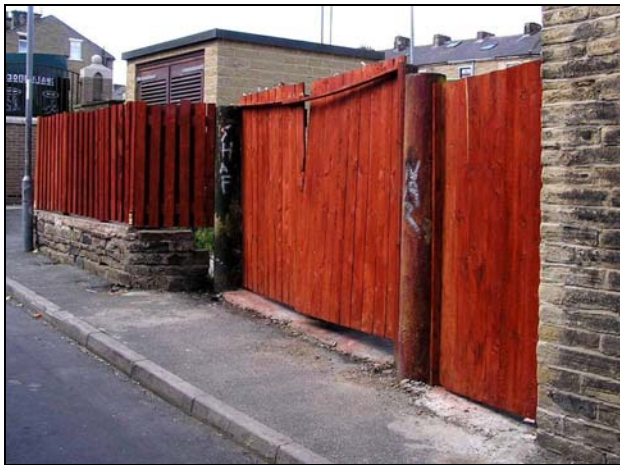
To the west of Qureshi View, East Squire Lane and Ashdown Place are two streets which predate the suburbanisation of Manningham and are the only old roads to retain their original narrow widths and as a result feel quite pent up compared to the broad Victorian avenues which typify the rest of the conservation area. The streets are closely bounded by buildings and boundary walls but much of their character has been lost through the laying of modern surfaces and the loss of traditional boundary features. At 6 East Squire Lane the cylindrical monolithic gateposts are Grade II Listed for they were originally columns which were removed from the Bradford Buttermarket when it was demolished in 1812. The Buttermarket was one of Bradford's ancient markets, but the piers (or rather columns) date from the 18<sup>th</sup> century. Unfortunately these listed gateposts have been painted and now support modern timber gates and are flanked by tall timber fences all of which have been stained a bright red colour and look completely out of place alongside the Grade II Listed 6-8 East Squire Lane.

*The Grade II Listed gatepiers which are made from the columns of Bradford's ancient Buttermarket stand among modern style brightly stained timber fences and gates.*

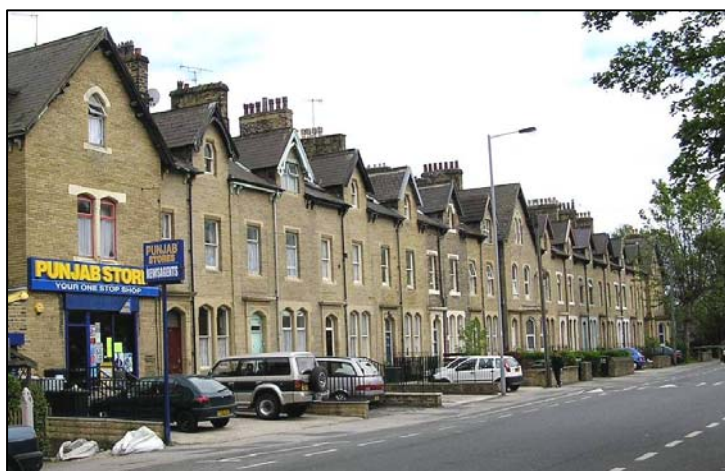
*The demolition of the front boundaries to most of the properties along Oakroyd Terrace has changed the character of the street for the worse.*

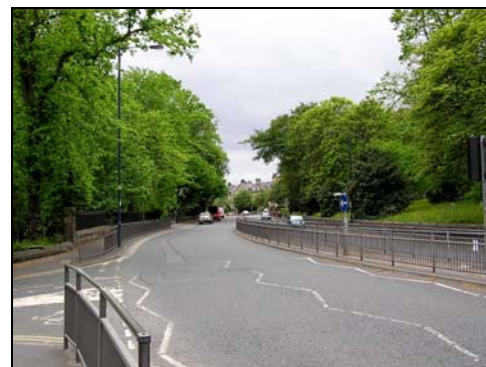
*Keighley is a leafy main artery of Manningham, but is unfortunately marred by standard modern highway interventions such as the long pedestrian barriers.*

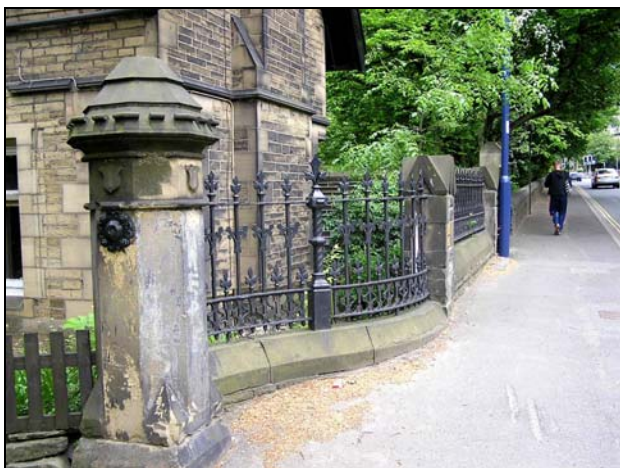
*This crenellated gatepost and ornate iron railings to 2 Keighley Road are key features of the street scene. The house was formerly the lodge to a much larger detached villa called Oak House.*

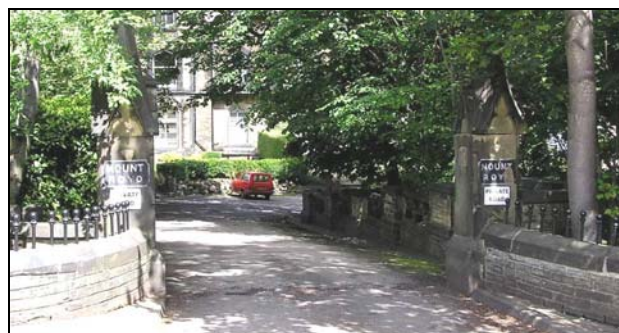
*The gothic style gatepiers to Mount Royd are Grade II Listed along with the unique stone wall in front of the houses with gothic style openings.*

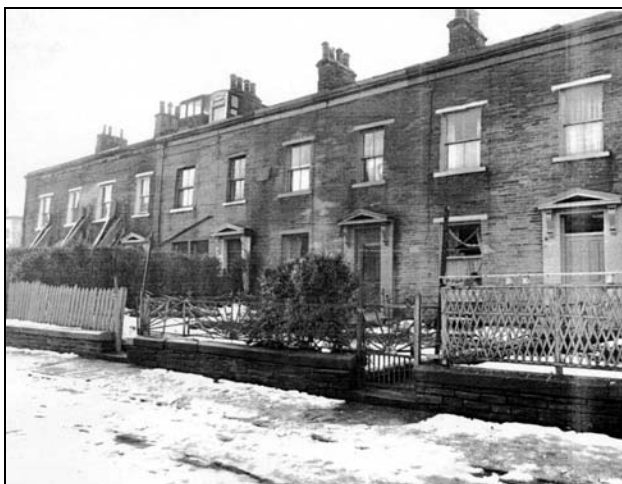
*The houses and road running around Southfield Square (photograph c.1977) fell into a severe state of disrepair and were threatened with demolition during the 1970's.*
