## 8.1 Permeability and Streetscape: Apsley Crescent

### ***Summary of Permeability and Streetscape***

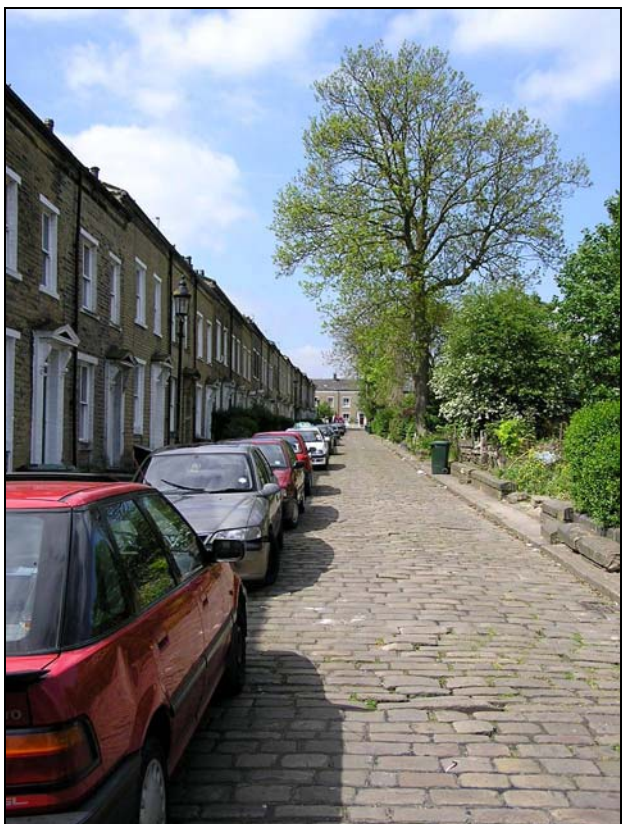
*The stone setts around the Square were re-laid at a cost of £80,000 as part of a regeneration and restoration programme undertaken in the 70's.*

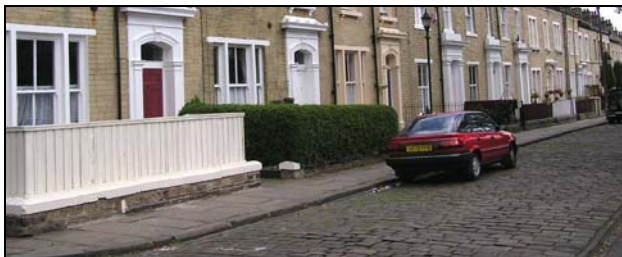
*The disjointed appearance of the modern boundary treatments outside nos. 51-56 Southfield Square undermines the historic character of the buildings.*
