## Conservation Area Appraisal

# Apsley Crescent

**December 2007**

**City of Bradford MDC**

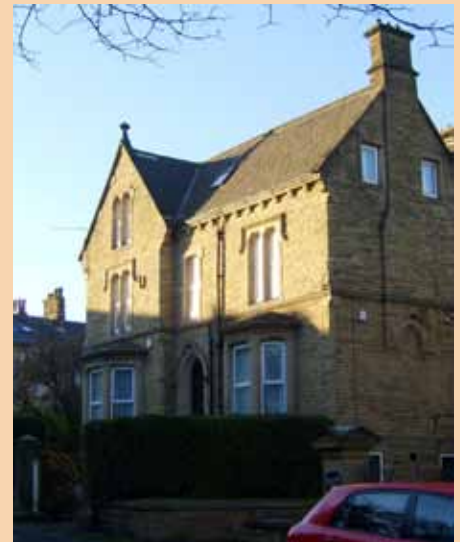
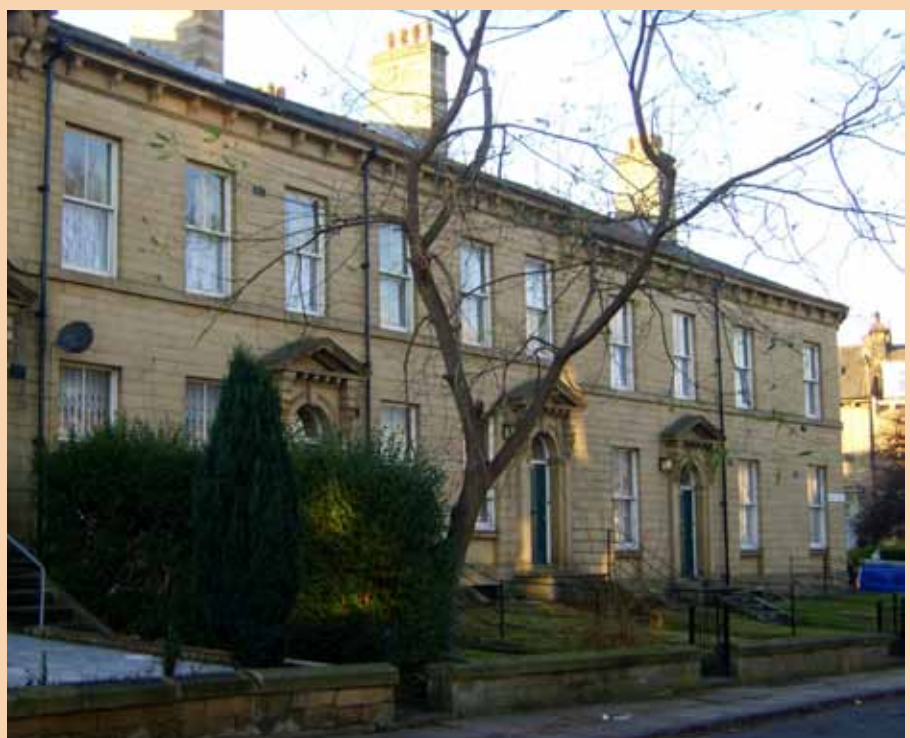
*Top: Large well proportioned Victorian house on Mornington Villas.  
Right: Well maintained Victorian terraced houses on Apsley Crescent.*

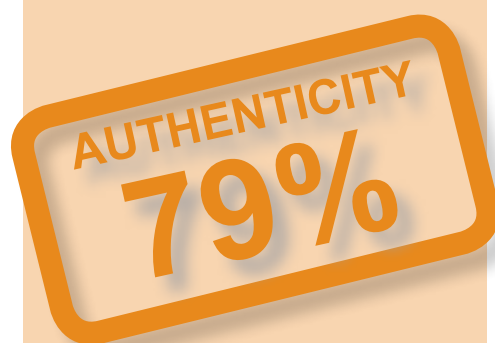
- The level of authenticity is based on an assessment of each property to ascertain the level of retention of original features.
- Features assessed are: chimneys, roofs, rainwater goods, walls, windows and doors, boundary walls, porches, bargeboards, bay windows and shopfronts. Not all buildings have all of the above features and the scoring is adjusted to take this into account.
- Only residential properties and retail properties built prior to 1956 are scored.
- 177 properties were assessed for the purpose of the study; this is 69% of all properties within the conservation area.
- The listed buildings scored an average authenticity rating of 79%.
- Buildings with shopfronts scored an average of 59%

A breakdown of the authenticity assessment shows which features and details in particular are being retained and/or maintained and where there are the greatest threats.

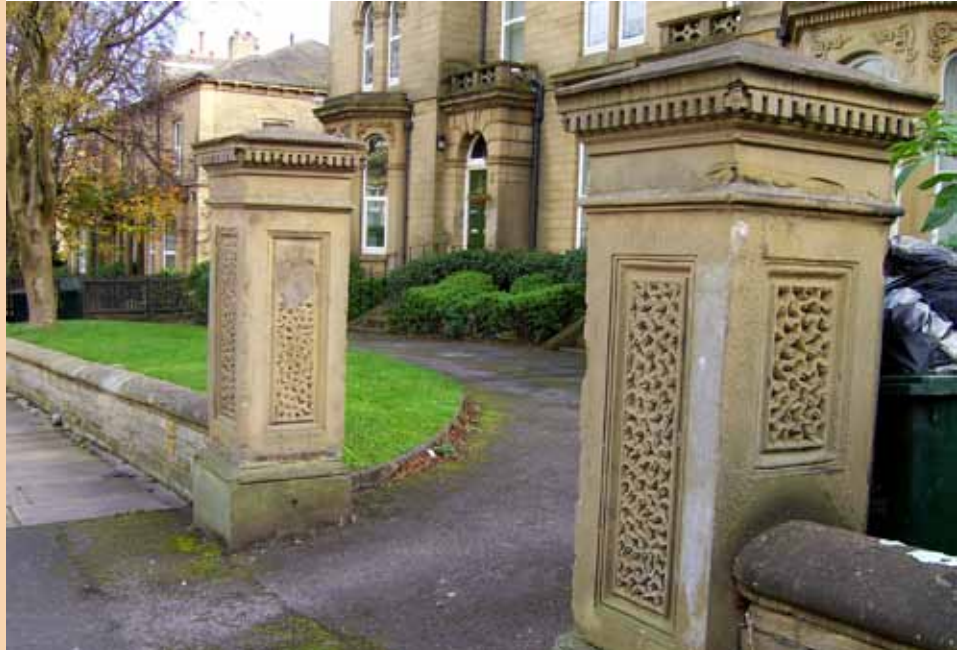
*Traditional, well maintained gate posts and boundary wall.*

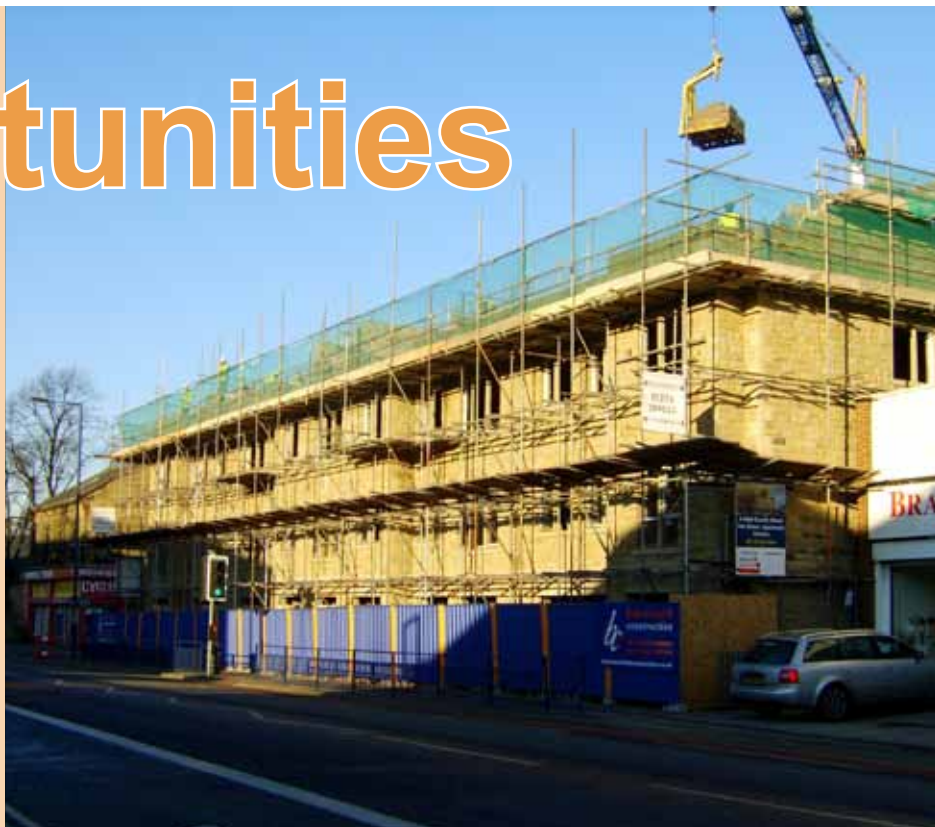
*Development in progress along Clifton Street.*

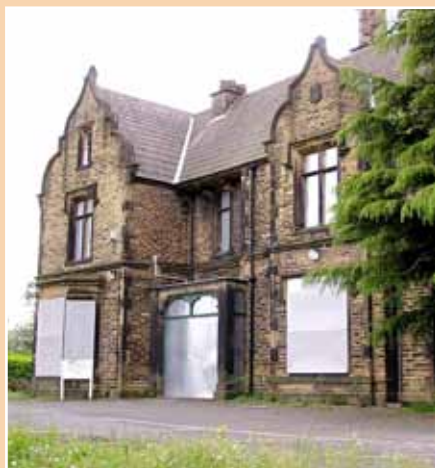
### ● Rosemont, Clifton Villas

Permission has been granted in 2003 and 2005 for a total of 29 houses within the site, including 9 apartments within the existing Victorian house itself. Rosemont has been vacant for some years and it is a positive step to see the building being brought back into use. The development of the grounds is currently underway however it is too early to assess the impact that this will have on the openness of the gardens and this part of the conservation area.

**POSITIVE IMPACT**

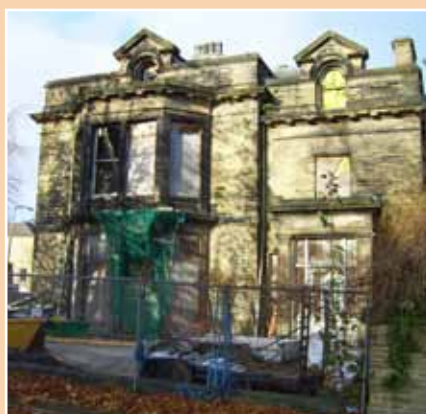
● **7 Spring Bank Place.** The building is in an advanced state of dereliction and as a key unlisted building in the conservation area, is a grave cause for concern. Little appears to be happening on site and the building is in a further advanced state of dereliction with signs of fire damage since the last assessment.

**NEGATIVE IMPACT**

**Lesson:** The owners of the building, with encouragement from the Design and Conservation Team should make a positive effort to bring the building back into use.

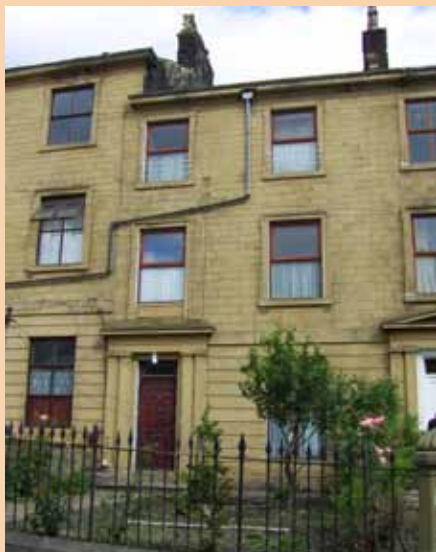
- **9, 10 and 11 Belle Vue (Grade II listed buildings).** The original sash windows in these buildings have been replaced, without LBC, with stained hardwood top opening casements.

#### NEGATIVE IMPACT

**Lesson:** Listed building consent is required to alter windows in a listed building. Enforcement action should be pursued in order to reinstate a traditional window detail.

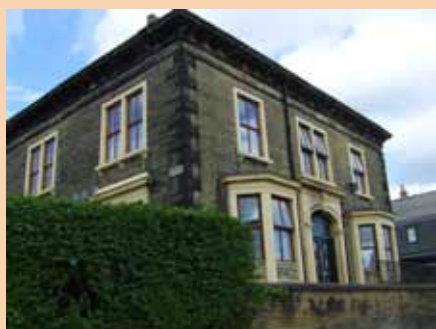
- **1 Camden Terrace (Grade II listed building).** The traditional sash and casement windows in this building have been replaced, without LBC, with stained hardwood top opening casements.

#### NEGATIVE IMPACT

**Lesson:** Listed building consent is required to alter windows in a listed building. Enforcement action should be pursued in order to reinstate a traditional window detail.

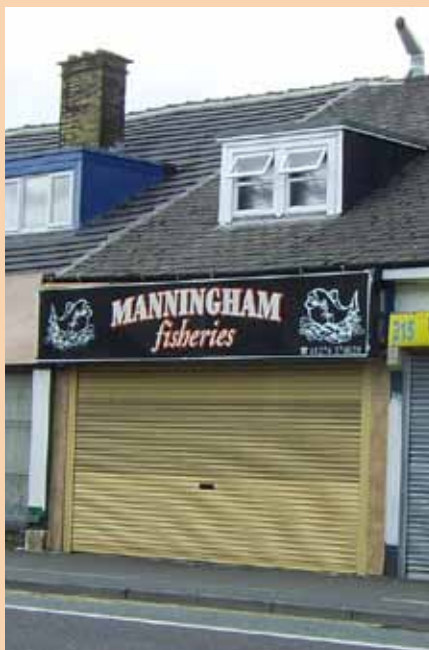
- **209 Manningham Lane.** The fascia sign on this building has been replaced and metal roller shutters installed over the shopfront. No planning permission has been granted for this alteration.

#### NEGATIVE IMPACT

**Lesson:** Planning permission is required for this alteration. Enforcement action should be pursued in order to instate a more appropriate detail.

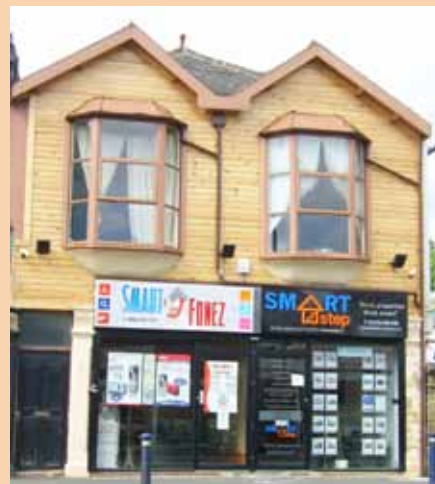
- **227 Manningham Lane.** The double fronted traditional shopfront on this building has been replaced, without planning permission with two modern shopfronts. The front elevation of the building has been clad with stained timber.

#### NEGATIVE IMPACT

**Lesson:** Planning permission is required for this alteration. Enforcement action should be pursued in order to instate a more appropriate detail.

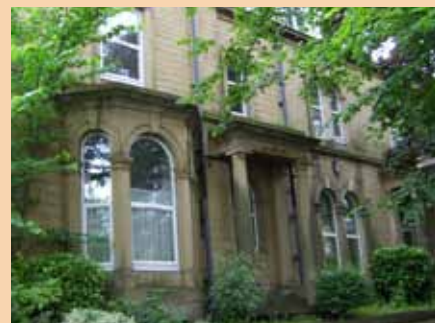
- **9 Mornington Villas.** The original sash windows in this large Victorian villa have been replaced with uPVC casements. The building is not listed but is a key unlisted building in the conservation area. Currently in commercial use, planning permission has not been sought for this alteration.

#### NEGATIVE IMPACT

**Lesson:** Planning permission is required for this alteration. Enforcement action should be pursued in order to instate a more appropriate detail.

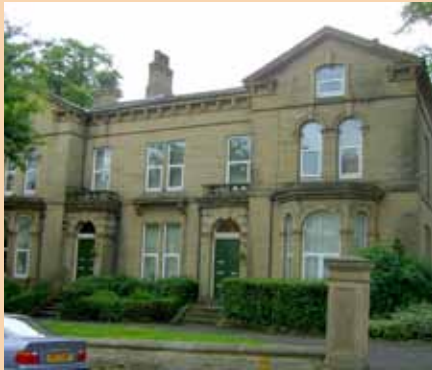
● **11-13 Mornington Villas.** The original sash windows in this large Victorian villa have been replaced with uPVC casements. The building is not listed but is a key unlisted building in the conservation area. Currently in commercial use, planning permission has been not sought for this alteration.

## NEGATIVE IMPACT

**Lesson:** Planning permission is required for this alteration. Enforcement action should be pursued in order to instate a more appropriate detail.

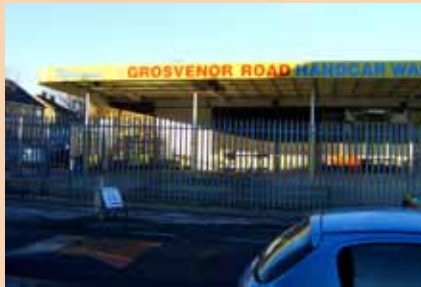
● **Grosvenor Road Hand Carwash.** This former petrol station was granted permission for use as a hand car wash. The building itself is typical of its type however the new galvanised fencing that surrounds the site is incongruous and unsuitable for this sensitive location. Planning permission was given for the change of use but not specifically for the fencing.

## NEGATIVE IMPACT

**Lesson:** Planning permission is required for this alteration. Enforcement action should be pursued in order to instate a more appropriate detail.

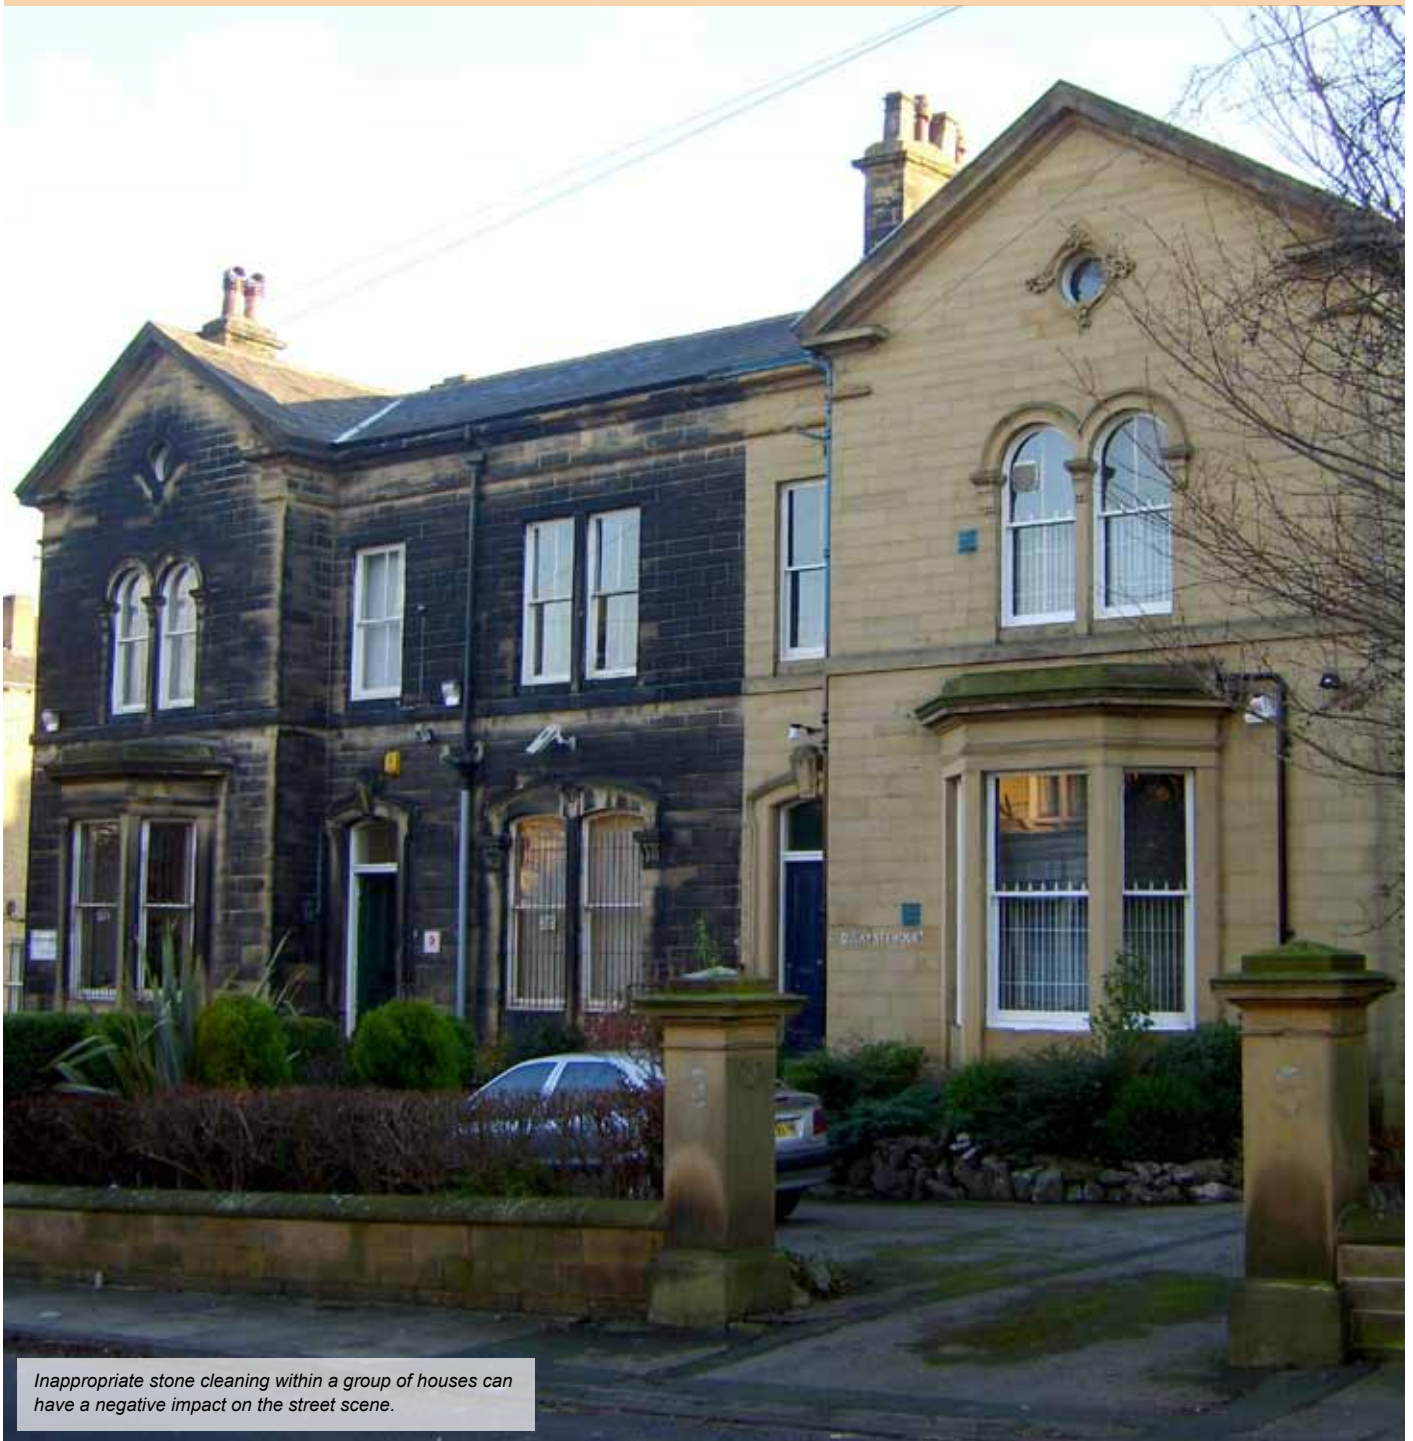
*Inappropriate stone cleaning within a group of houses can have a negative impact on the street scene.*
