Conservation Area Appraisal

Baildon

December 2009

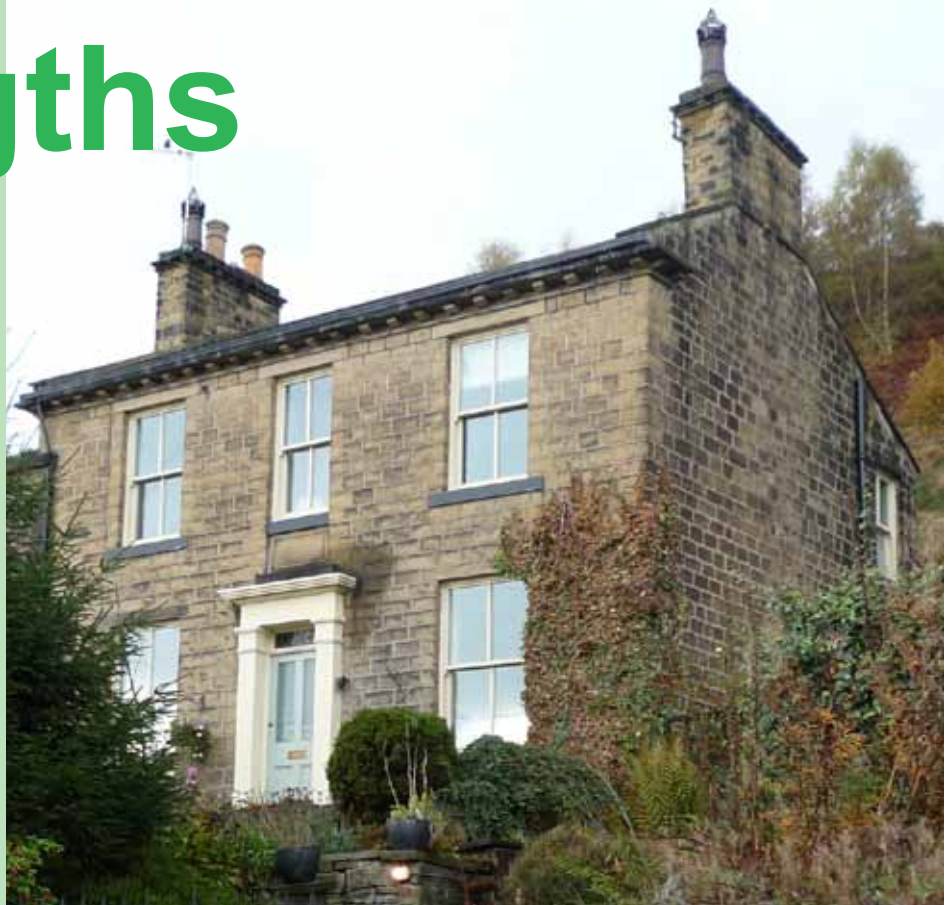
19 Green Road displays many traditional features and details, including sash windows

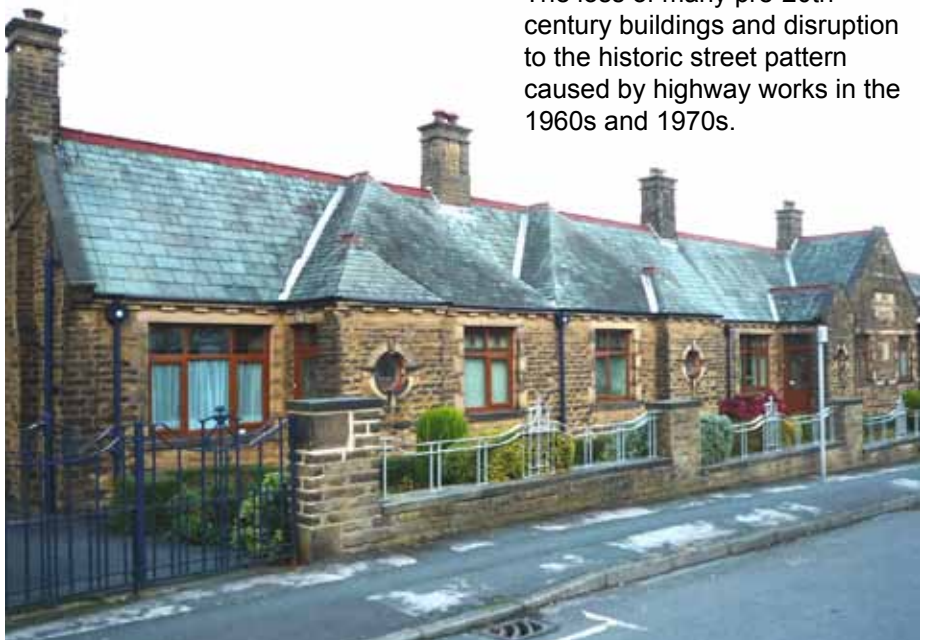
The brown PVCu windows and doors installed at Butterfield Almshouses have harmed the character and appearance of these attractive properties

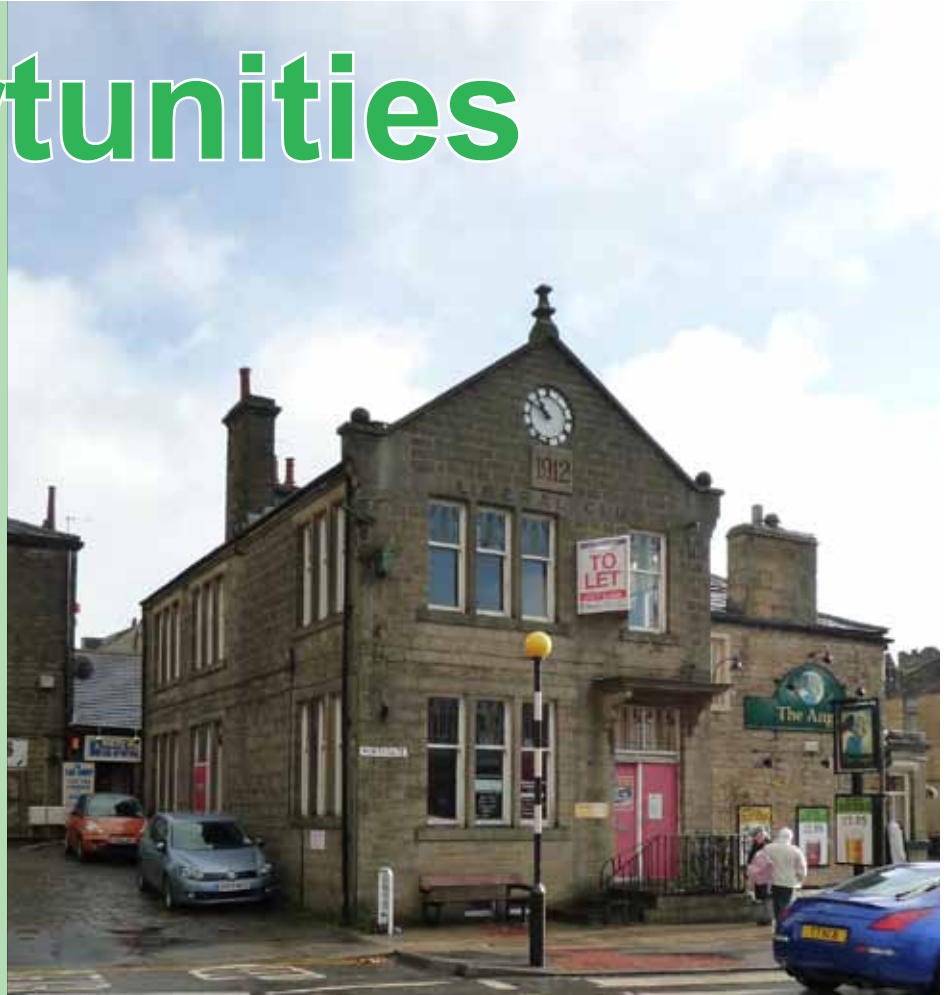
There is an opportunity to bring this attractive building, which is set in the heart of the village, back into use

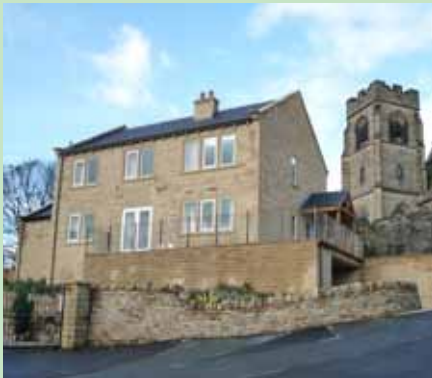
A new Vicarage at Church Bank has been constructed on the site of a former Scout hut. The design of the new dwelling and the materials used are sympathetic to the character of the conservation area and has enhanced the appearance of the previously developed site.

POSITIVE

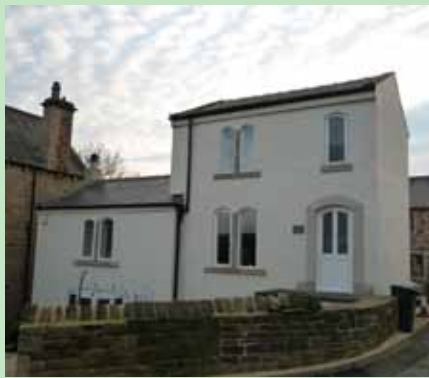
At Beech Cottage, Moorgate, a two storey side extension has been constructed. The design of the proposal is well related to the original dwelling and maintains the character of the conservation area.

NEUTRAL

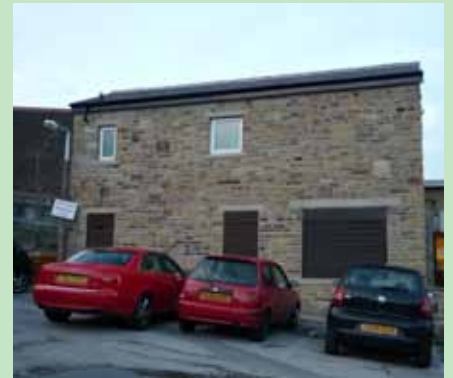
6a Northgate has been largely rebuilt and now incorporates a pitched roof. The new building is an improvement upon the previously existing building.

POSITIVE

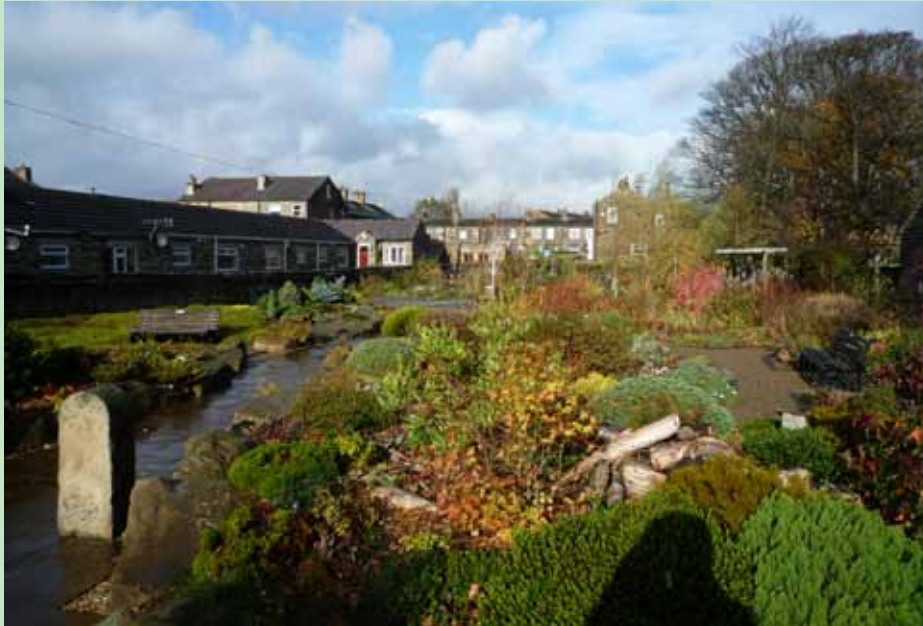
A community garden has been created on land adjacent to Batley House. The work done by the community has greatly improved the appearance of the area.

POSITIVE

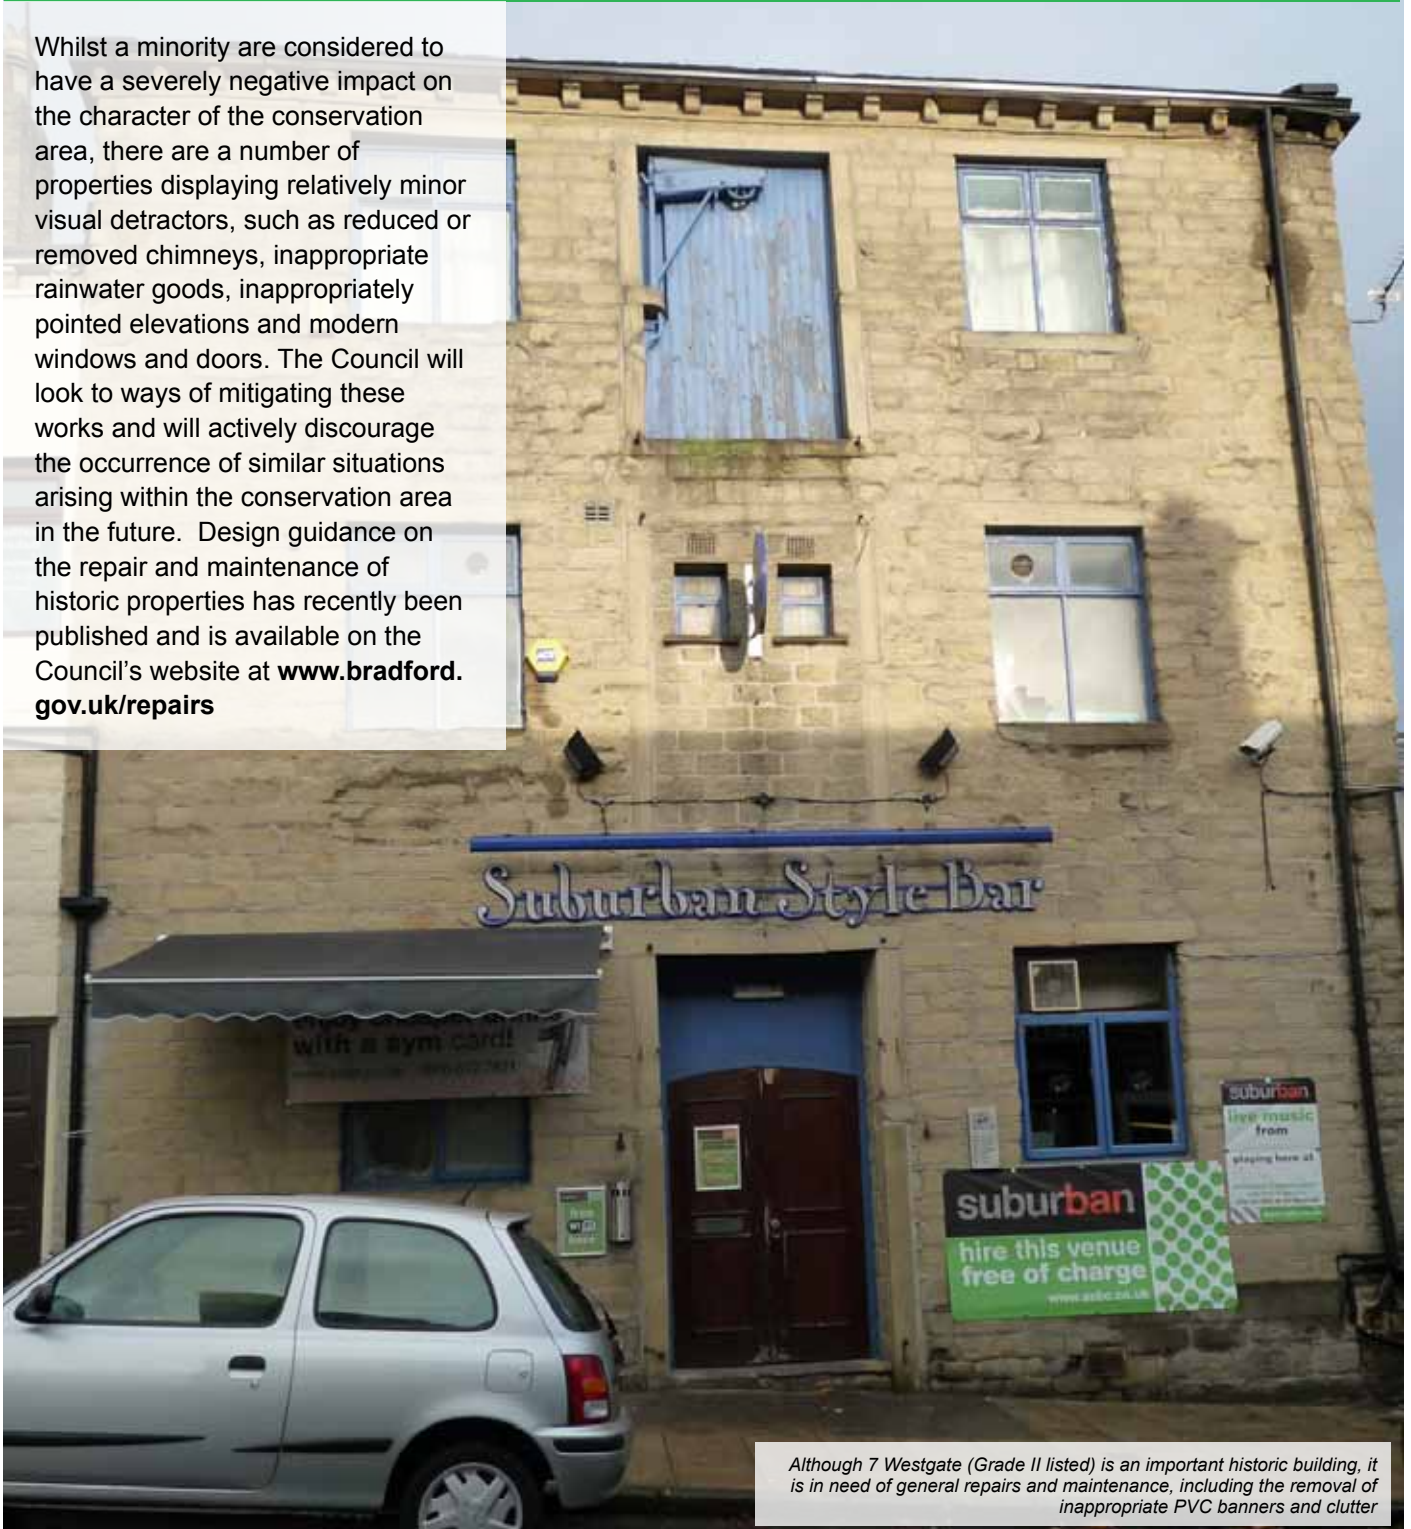
Although 7 Westgate (Grade II listed) is an important historic building, it is in need of general repairs and maintenance, including the removal of inappropriate PVC banners and clutter
