Conservation Area Appraisal

Brunthwaite

June 2008

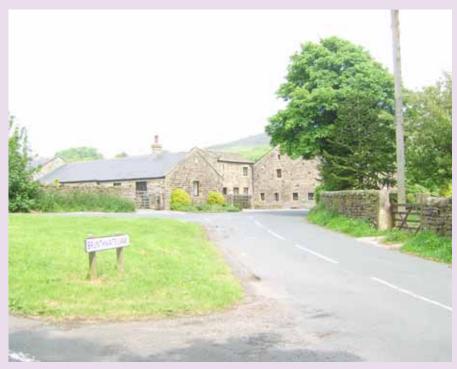
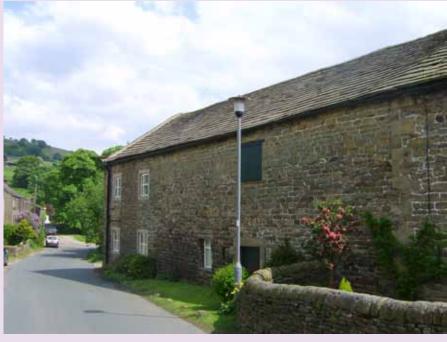
Above: Open space at entrance to the hamlet. Right: Former agricultural buildings have a strong presence in the hamlet.

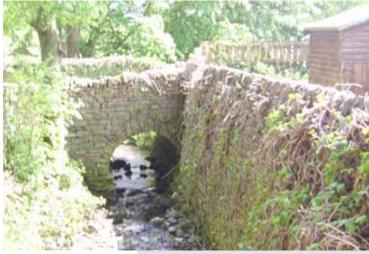
Top right: Brunthwaite Beck makes a key contribution to character. Top: House retaining original features. Above: Typical informal surfacing to access track

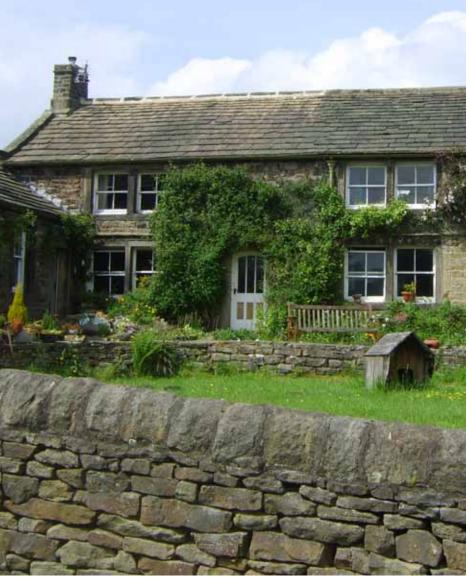
Farmhouse retaining traditional details

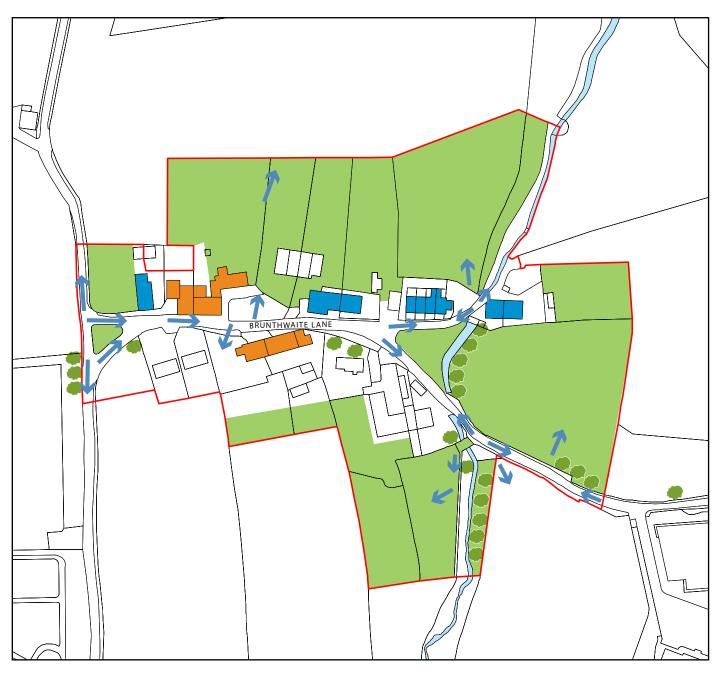
Open Spaces, Trees, Views, Listed and Key Unlisted Buildings

NB This map does not identify key trees individually, but merely indicates where there is at least one important tree.

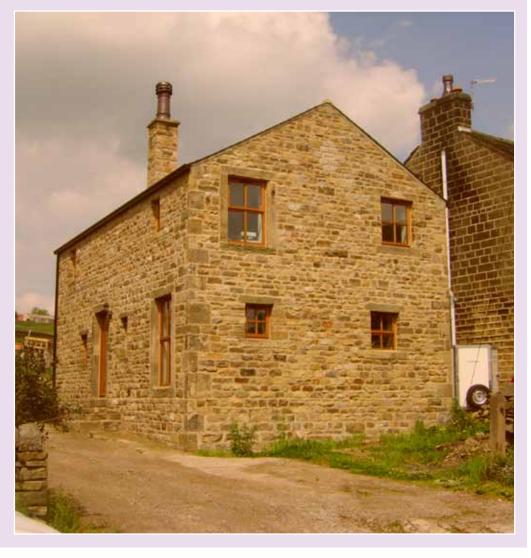
Planning permission was granted in 2003 for demolition and rebuilding to form a new dwelling at **Bullcroft House.** Brunthwaite Lane. The property is a well designed detached dwelling which is made from reclaimed stone with good quality artificial roof slates and incorporates traditional features and details. However, the windows are inappropriate to the conservation area due to them being a stained rather than painted finish, trickle vents and the windows being top openers.

Bullcroft House has re-placed a previous derelict vacant cottage and there are no longer any vacant buildings:

LESSON: Positive change because it has re-placed a derelict vacant building. Neutral change because in conservation areas external detailing is very important. Developers and decision makers should be aware of this.
