## Conservation Area Appraisal

# East Morton

**April 2008**

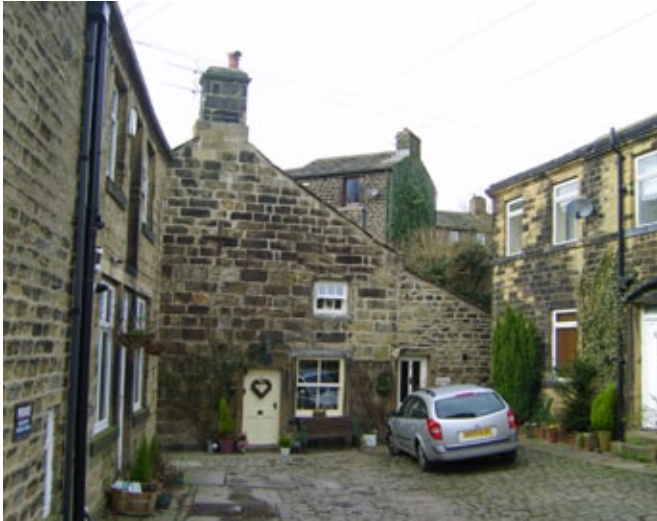
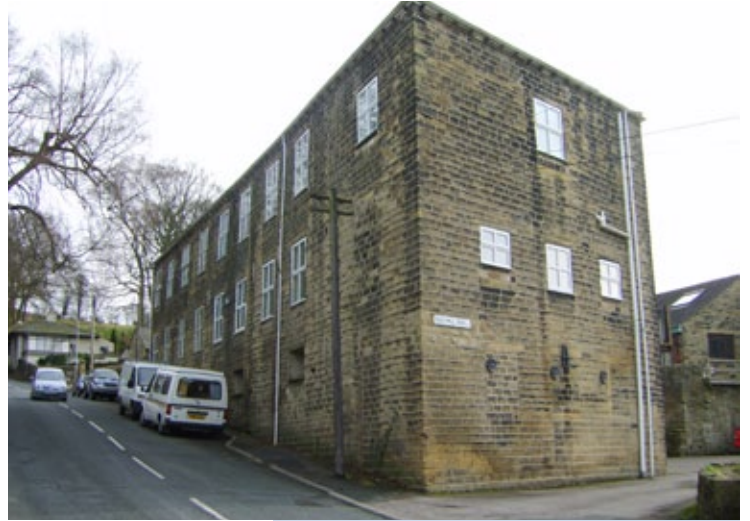
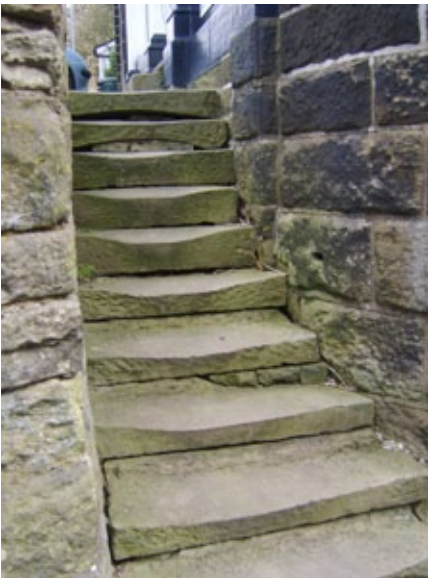
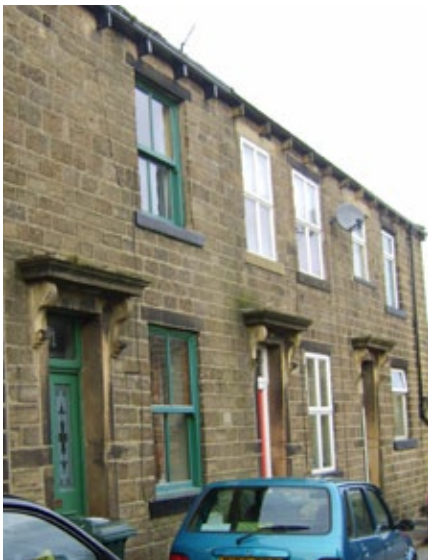
*From top right: Silk Mill - converted to flats with minimal impact on the character of the property. The Square contains traditional highway materials.*

*Traditional stone steps still in situ in East Morton. Green End Road - high amounts of traditional sash windows.*

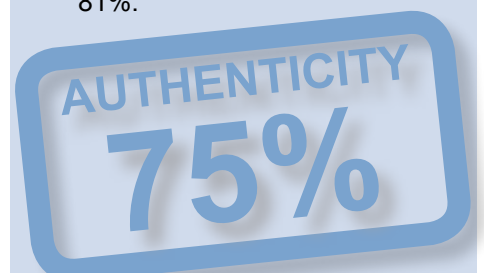
A breakdown of the authenticity assessment shows which features and details in particular are being retained and/or maintained and where there are the greatest threats.

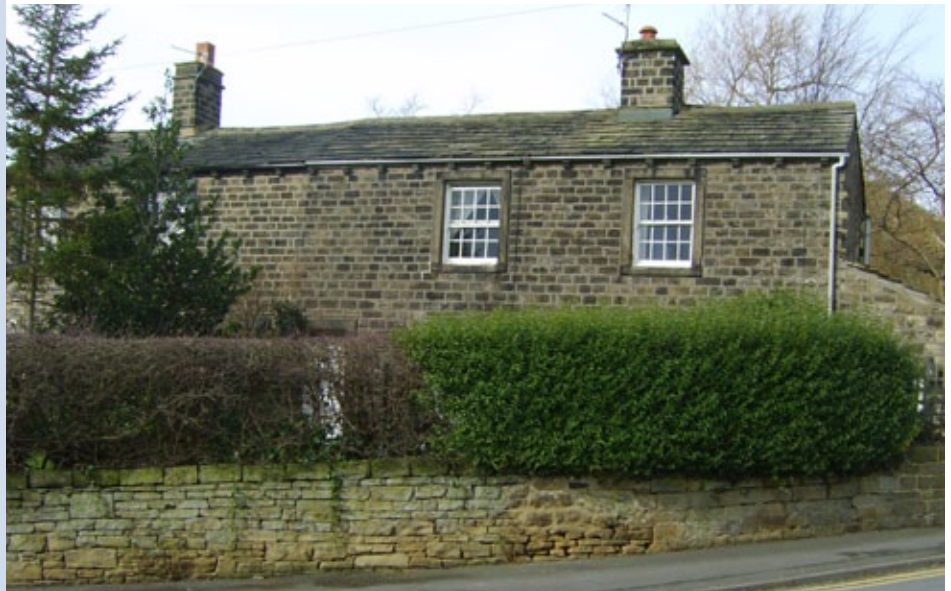
*Main Street - traditional features retained such as stone slate roof and timber sash windows.*

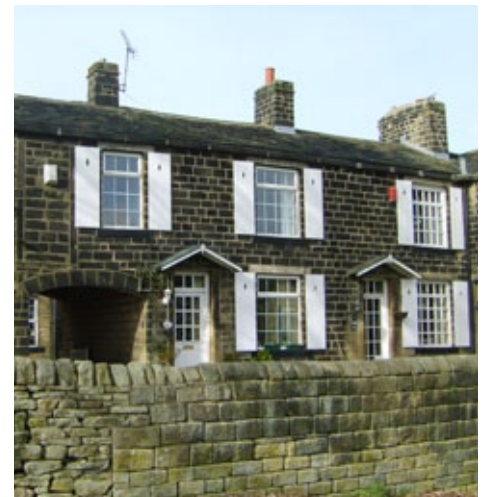
*Amblers Mews contains large amounts of clutter on their principle elevations*

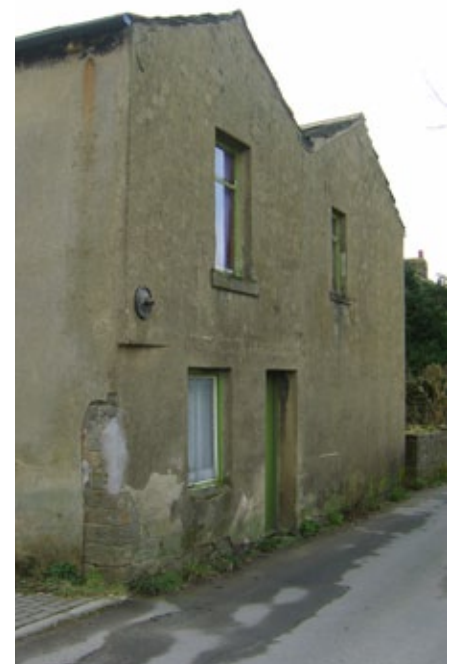
Inappropriate rendered building in need of repair

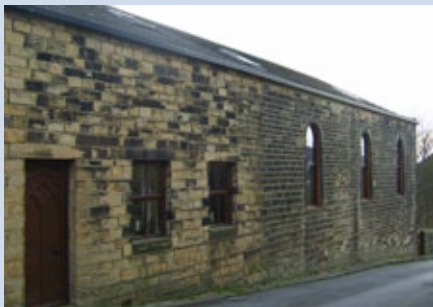
**10, Green End Road** in 2007 had planning permission approved to change the chapel into a single dwelling. Alterations respect the buildings character.

**POSITIVE IMPACT**

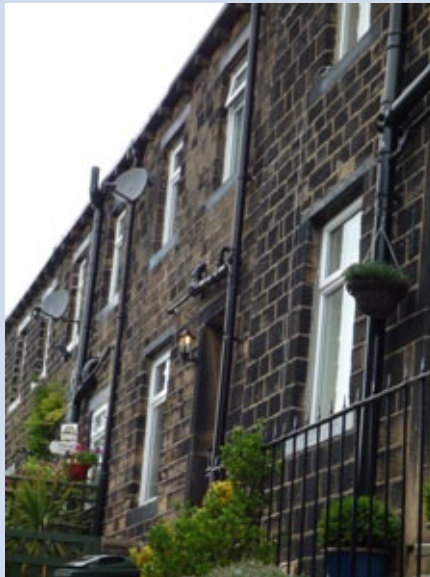
**3, Sun Street** has received planning permission in 2007 to create a 2 storey extension to the rear of the property. Even though this is not in character with the street it has little impact on the street scene as it is not visible.

**NEUTRAL CHANGE**

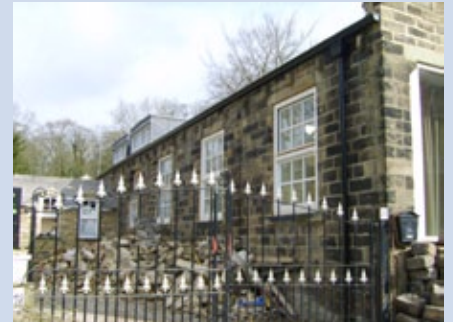
The **former joiner's at Otley Road** received planning permission in 2006 for the conversion to a dwelling. The conversion brings a vacant building back into use without giving it an overly domestic character.

**NEUTRAL IMPACT**

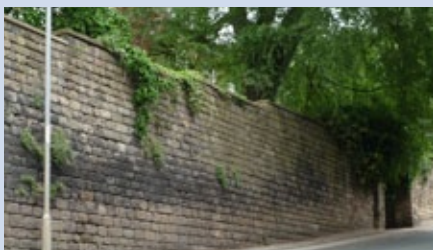
**Oldside, Otley Road** has received planning permission in 2007 to increase the boundary wall. The wall materials chosen are in keeping with the boundary wall already there which has meant the raising of the boundary wall is not discernable.

**NEUTRAL CHANGE**

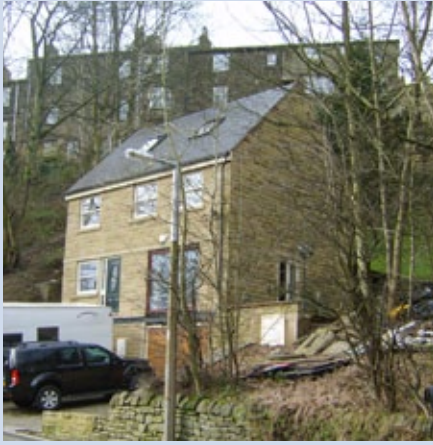
**6 Otley Road** is nearing completion whilst it is built of appropriate stone, blue slate and incorporates sash windows; its design is neither traditional nor modern and lacks a front boundary feature.

#### NEGATIVE IMPACT

**LESSON:** New dwellings should respond to their setting and be designed with conviction. Applicants and planners should refer to conservation area appraisal

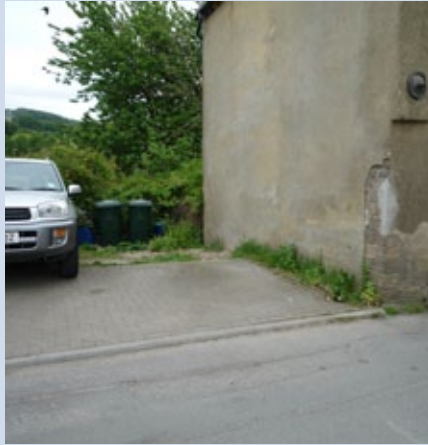
Land at **44 Green End Road**, planning permission was received in 2007 to create a car parking area. The area has been created with sets which aren't in keeping with the street scene.

#### NEGATIVE IMPACT

**LESSON:** Samples of material should have been checked before planning permission was approved. This would have meant that the parking area could have been built to complement the street scene and incorporated some landscaping.

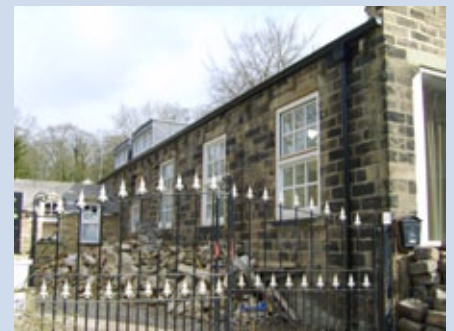
- Drummond Neate & Co (*above*)
- 4 Croft Road.

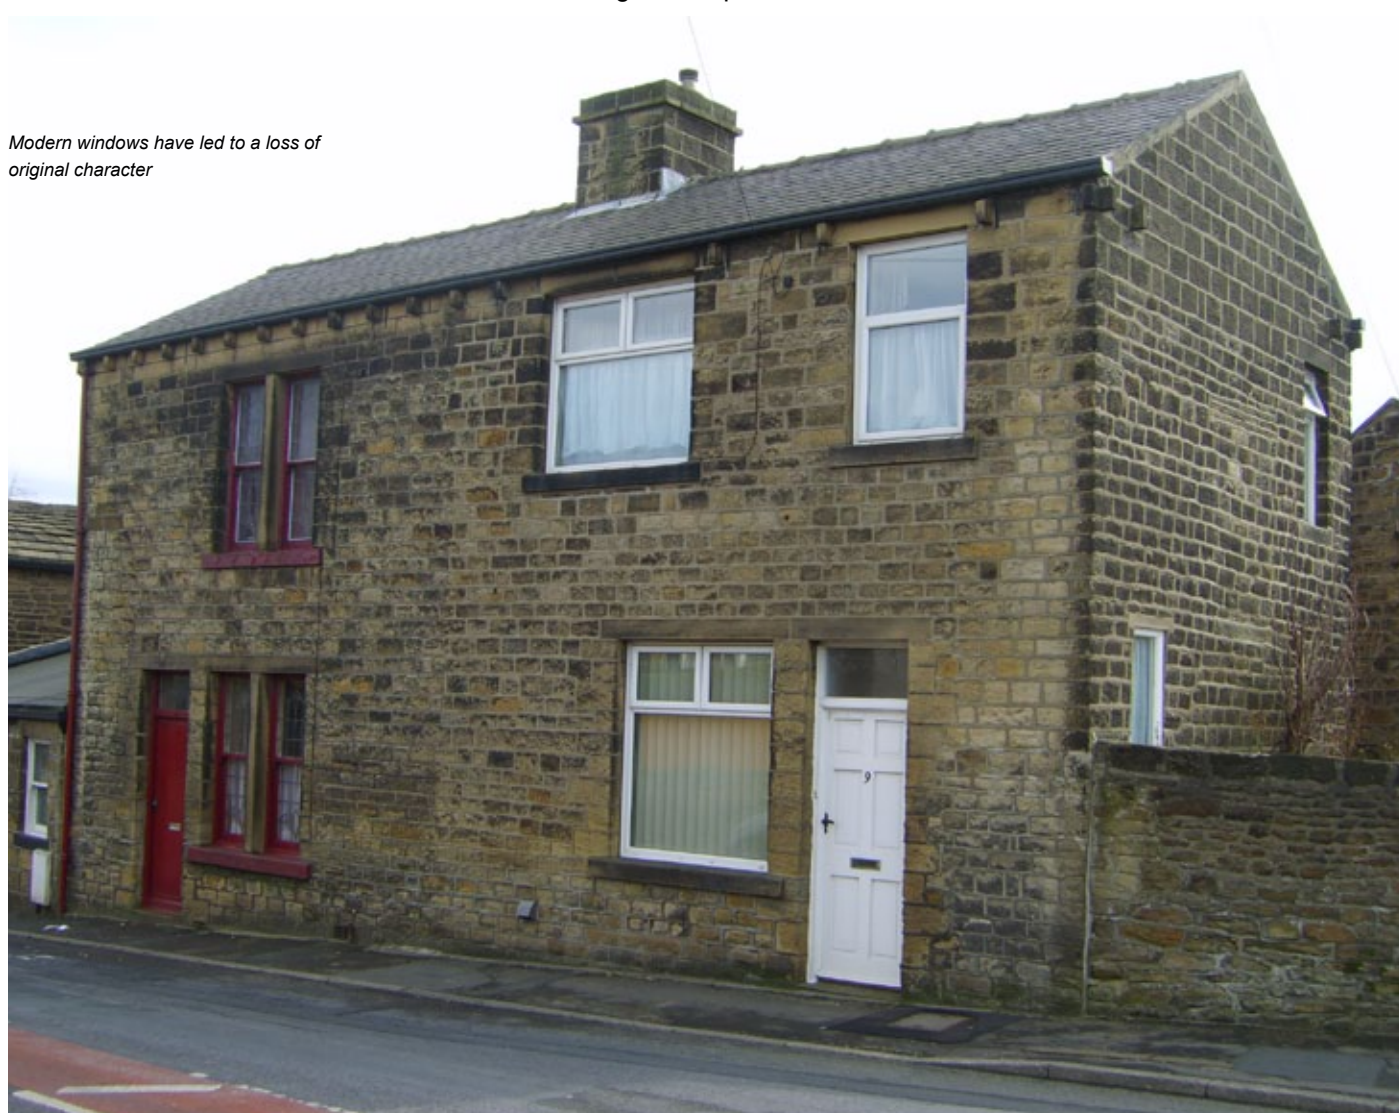
*Modern windows have led to a loss of original character*
