## Conservation Area Appraisal

# Esholt

January 2006

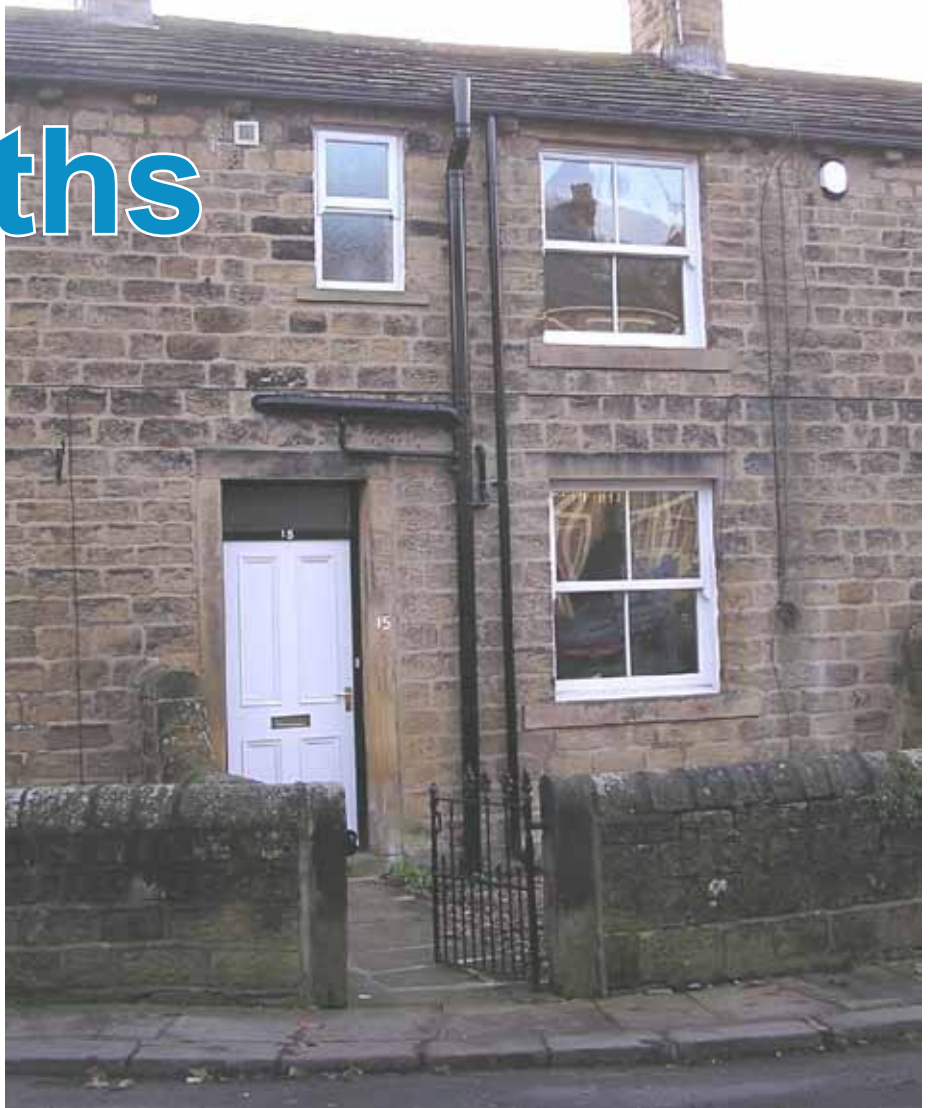
*Top right: Traditionally detailed cottage.*

*Lower right: Inappropriate doors and windows.*

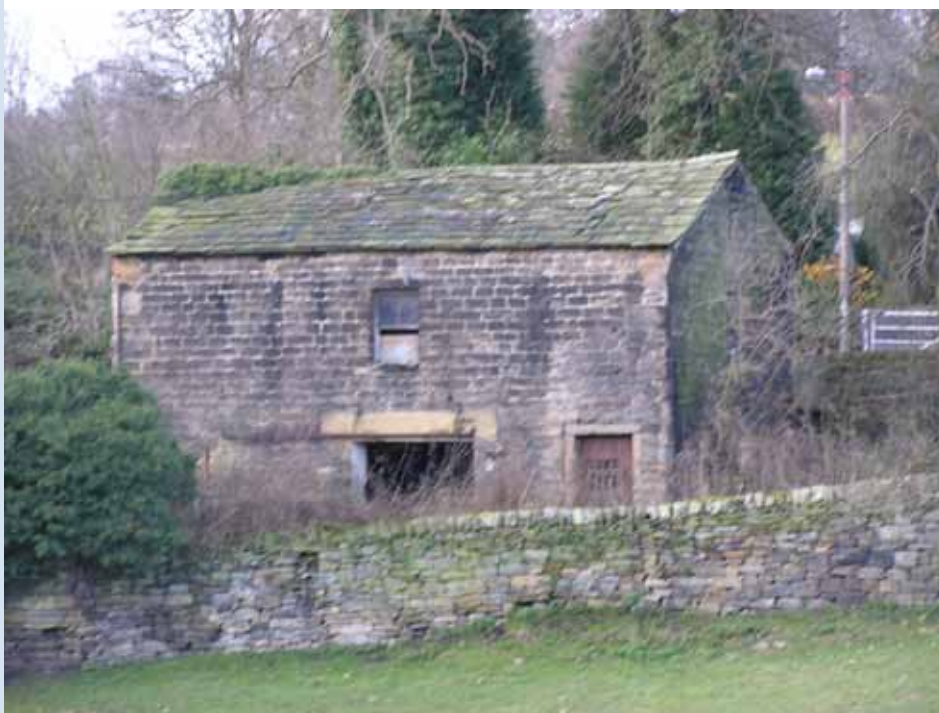
*The continued loss of traditional features and details impacts the character and appearance of the conservation area.*

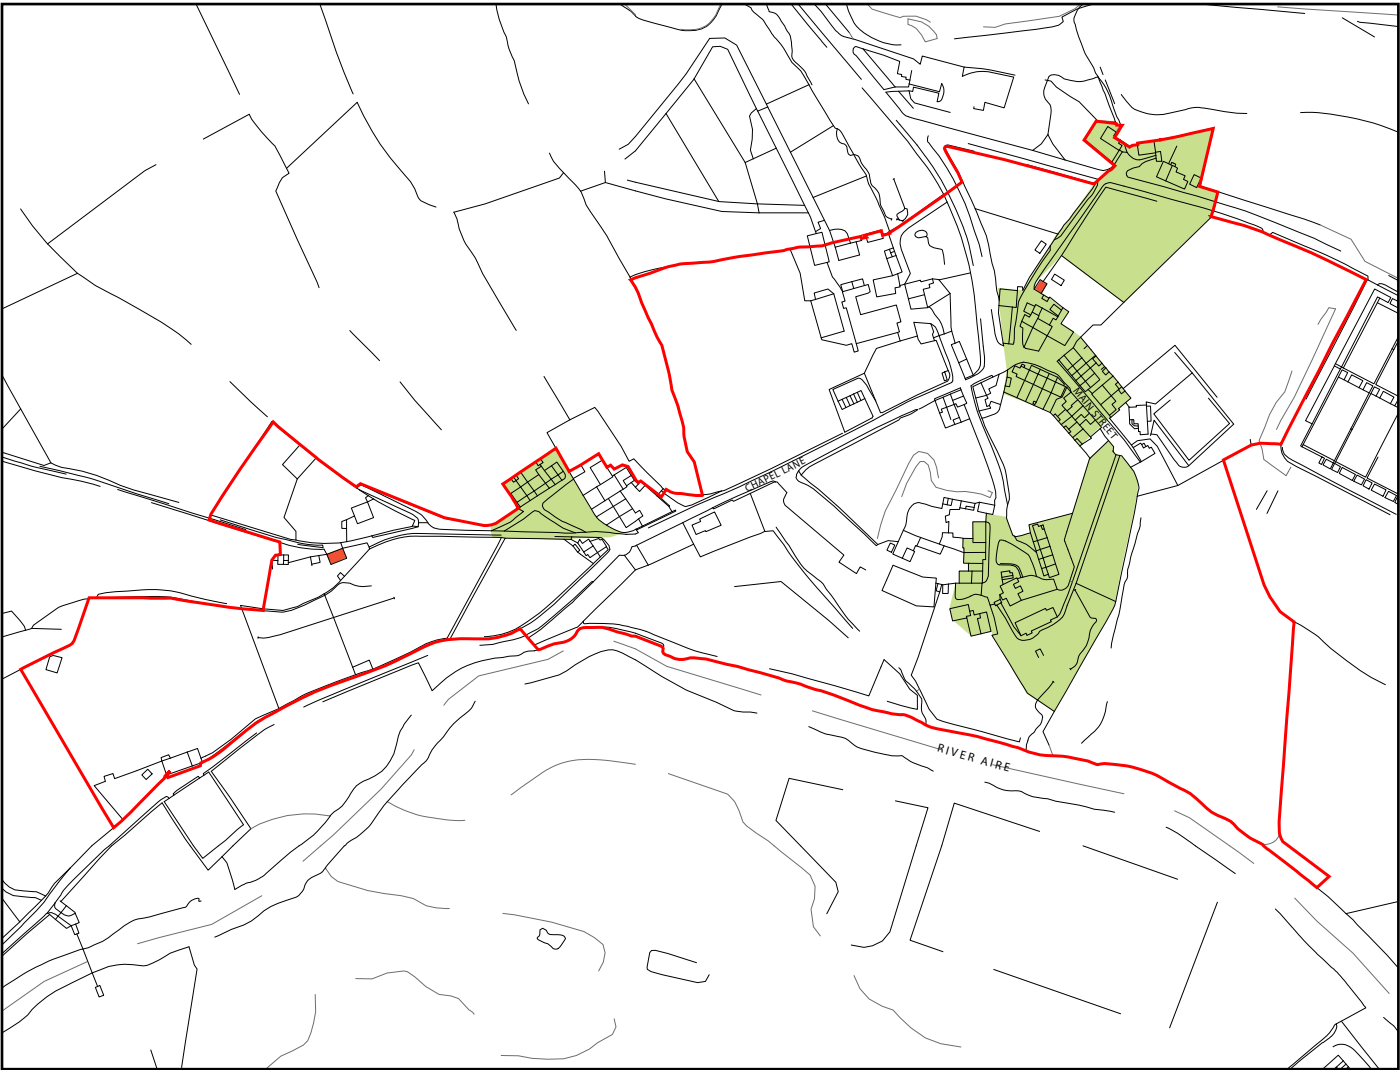
## Character Contributions

Areas providing a **positive** contribution to character
-

Areas providing a **negative** contribution to character

NB The 'positive', 'negative' and 'neutral' areas relate to the contribution the site/building currently makes to the character of the Conservation Area. The classification in no way means that the site/building has no special architectural, historic or archaeological interest.

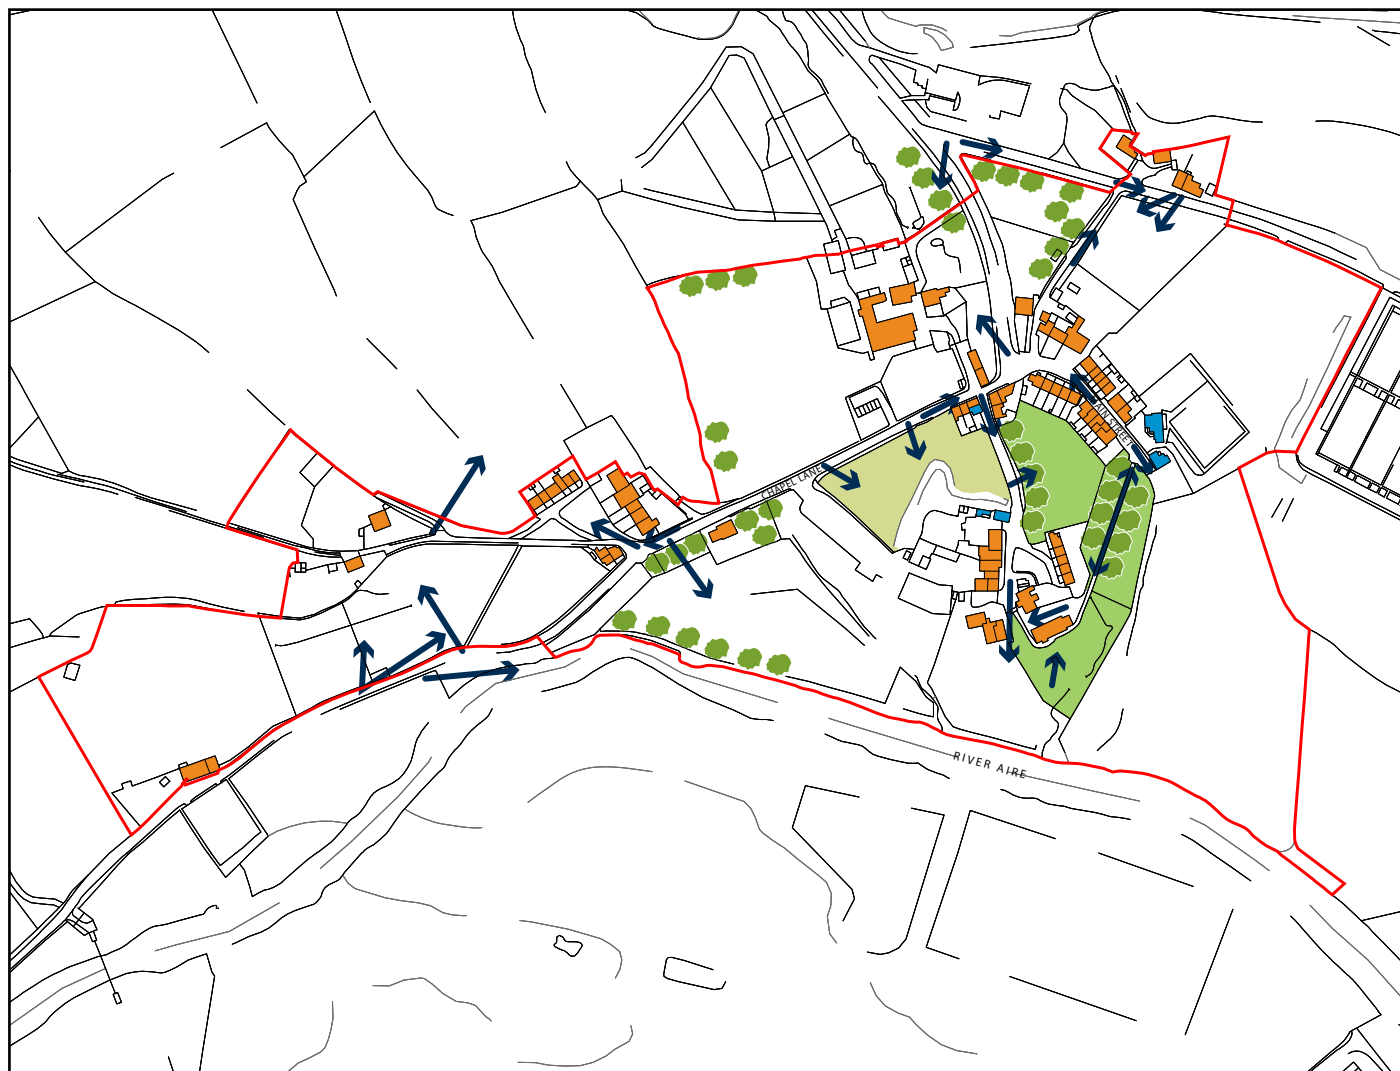
## Open Spaces, Trees, Views, Listed and Key Unlisted Buildings

-   Conservation Area Boundary
-   Listed building
-   Key unlisted building
-   Key open space
-   Class 2 Archaeological Site
-   Important tree(s)
-   Key view or vista

**NB** This map does not identify key trees individually, but merely indicates where there is at least one important tree.

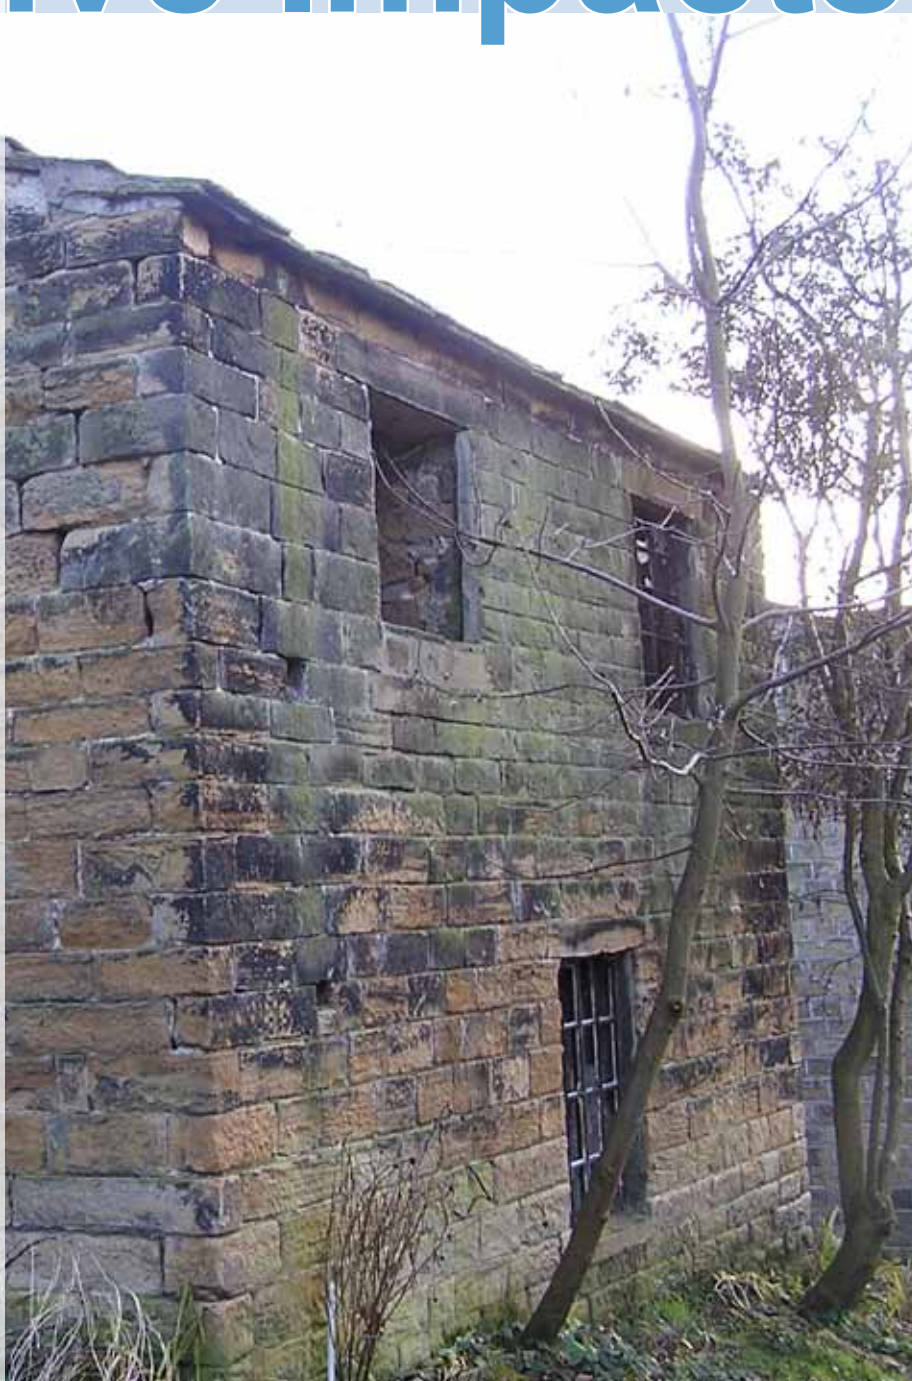
As part of the review of the conservation area a number of properties displaying inappropriate alterations and additions have been noted.

Whilst none are considered to be major detractors or have had a severely negative impact on the character of the conservation area, there are a number of properties displaying relatively minor visual detractors, such as unauthorised windows and doors on listed buildings. The Council will look to ways of mitigating these works and will actively discourage the occurrence of similar situations arising within the conservation area in the future.
