## Conservation Area Appraisal

# Great Horton

**August 2008**

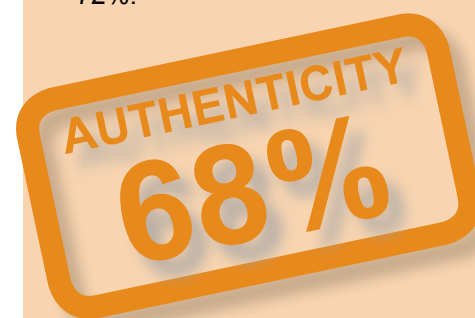
A breakdown of the assessment shows which features and details in particular are being retained and/or maintained and where there are the greatest threats.

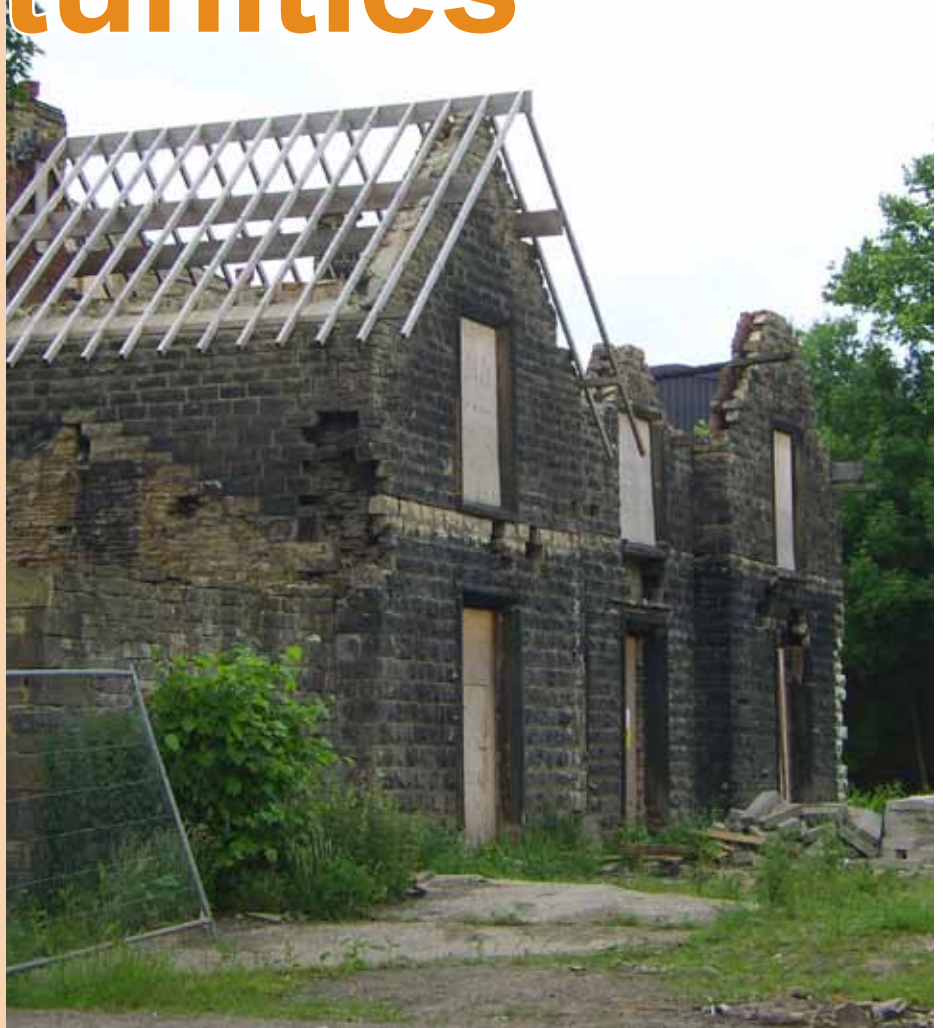
*Investment and vision will be required to bring the Liberal Club back to use*

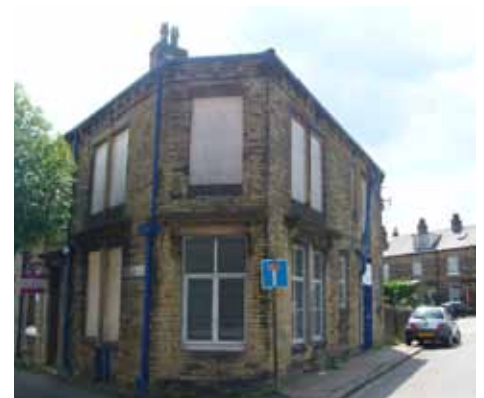
*Vacant buildings are vulnerable and can blight an area*

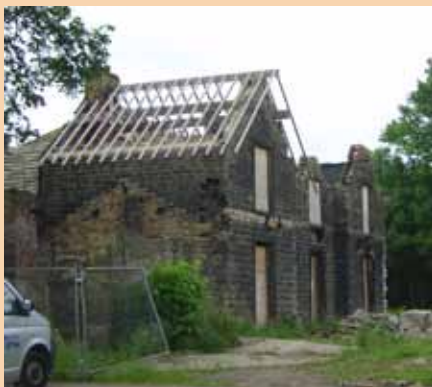
**Cross Lane Liberal Club** is currently vacant and in disrepair. The roof and windows are missing. The inappropriate modern extension to the building has been demolished. It is unsure whether work as come to a halt or not.

**POSITIVE CHANGE / CONCERN**

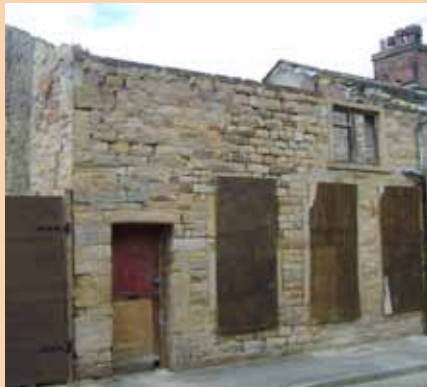
**78 Cross Lane** is currently vacant and in disrepair. The roof is missing and windows boarded up. There is currently a pending planning application which if approved and implemented would bring the property back into use.

**NEGATIVE CHANGE**

**LESSON:** Owners should consider the impact of their alterations on the character and appearance conservation area. Consent should be sought and granted before works begin.

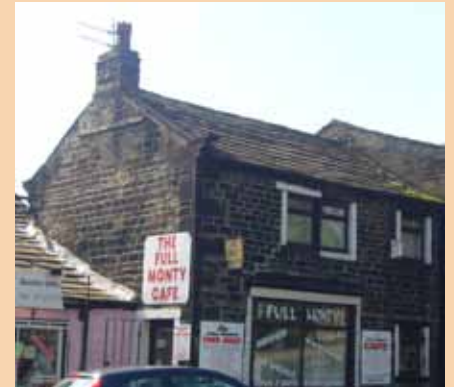
**513 Great Horton Road**, a grade II listed building, appears to have various unauthorised and inappropriate signage on the property.

**NEGATIVE CHANGE**

**LESSON:** Owners should consider the impact of their alterations on the character and appearance conservation area and the Grade II listed building. Permission should be granted before work begins. The Shopfront Design Guide contains helpful advice. Enforcement action could be taken to remove the unauthorised works.

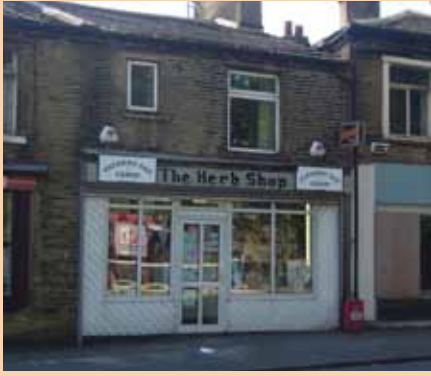
**517 Great Horton Road** appears to have an inappropriate and unauthorised shop front.

#### NEGATIVE CHANGE

**LESSON:** Owners should consider the impact of their alterations on the character and appearance of the conservation area. Permission should be granted before work begins. The Shopfront Design Guide contains helpful advice. Enforcement action could be taken to remove the unauthorised works.

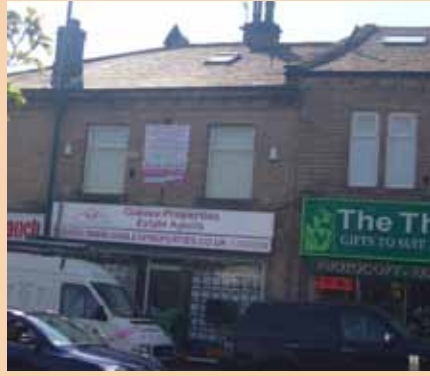
**557 Great Horton Road** has various inappropriate and unauthorised signage placed on the property.

#### NEGATIVE CHANGE

**LESSON:** Owners should consider the impact of their alterations on the character and appearance of the conservation area. Permission should be granted before work begins. The Shopfront Design Guide contains helpful advice. Enforcement action could be taken to remove the unauthorised works.

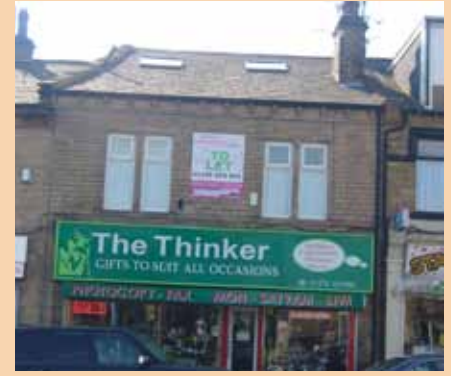
**561 Great Horton Road** has a large inappropriate and unauthorised fascia sign on the property.

#### NEGATIVE CHANGE

**LESSON:** Owners should consider the impact of their alterations on the character and appearance of the conservation area. Permission should be granted before work begins. The Shopfront Design Guide contains helpful advice. Enforcement action could be taken to remove the unauthorised works.

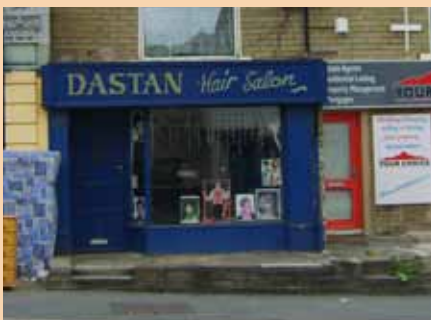
**566 Great Horton Road** is no longer vacant and has been brought back into use, which is a positive change. However, the signage appears to be unauthorised and does not preserve the character of the property.

#### POSITIVE/ NEGATIVE CHANGE

**LESSON:** Owners should consider the impact of their alterations on the character and appearance of the conservation area. Permission should be granted before work begins. The Shopfront Design Guide contains helpful advice. Enforcement action could be taken to remove the unauthorised works.

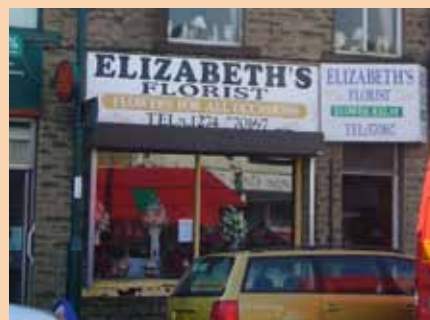
**567 Great Horton Road** has a large inappropriate fascia sign and roller shutters which appear to be unauthorised.

#### NEGATIVE CHANGE

**LESSON:** Owners should consider the impact of their alterations on the character and appearance of the conservation area. Permission should be granted before work begins. The Shopfront Design Guide contains helpful advice. Enforcement action could be taken to remove the unauthorised works.

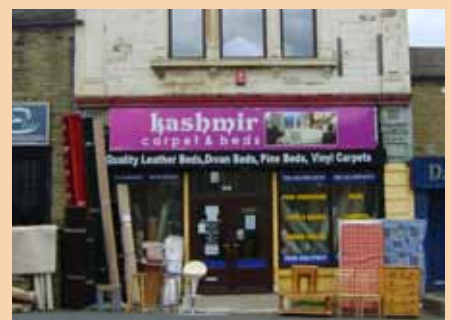
**568 Great Horton Road** has an inappropriate fascia sign. Sliding sash windows have been replaced with inappropriate UPVC windows. All the works appear to be unauthorised.

#### NEGATIVE CHANGE

**LESSON:** Owners should consider the impact of their alterations on the character and appearance of the conservation area. Permission should be granted before work begins. The Shopfront Design Guide contains helpful advice. Enforcement action could be taken to remove the unauthorised works.

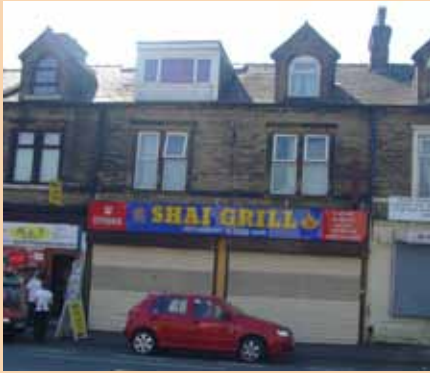
**571-573 Great Horton Road** has a large inappropriate fascia sign, roller shutters and shop front, all of which appear to be unauthorised.

## NEGATIVE CHANGE

**LESSON:** Owners should consider the impact of their alterations on the character and appearance of the conservation area. Permission should be granted before work begins. The Shopfront Design Guide contains helpful advice. Enforcement action could be taken to remove the unauthorised works.

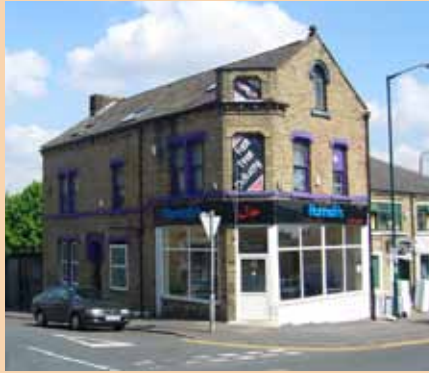
**586 Great Horton Road** has inappropriate signage and a new shop front with white UPVC panelling. All the works appear to be unauthorised.

## NEGATIVE CHANGE

**LESSON:** Owners should consider the impact of their alterations on the character and appearance of the conservation area. Permission should be granted before work begins. The Shopfront Design Guide contains helpful advice. Enforcement action could be taken to remove the unauthorised works.

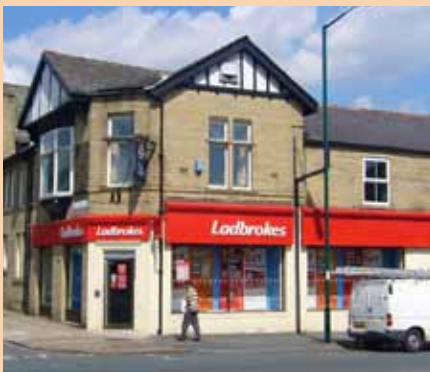
**628-632 Great Horton Road** has inappropriate signage and a new shop front window which was granted planning permission and advertisement consent in 2005.

## NEGATIVE CHANGE

**LESSON:** Decision makers need to make more appropriate decisions for example taking in consideration the character and appearance of conservation area and the Shopfront Design Guide SPD.

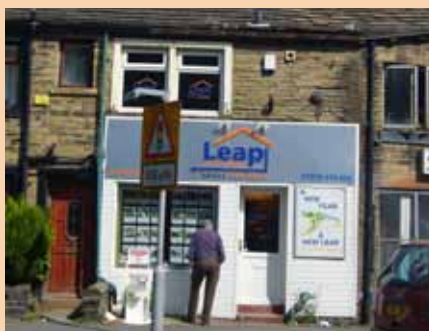
**682 Great Horton Road**, a grade II listed building, has inappropriate signage and a new shop front with white UPVC panelling, which covers the ground floor elevation. All the work appears to be unauthorised.

## NEGATIVE CHANGE

**LESSON:** Owners should consider the impact of their alterations on the character and appearance conservation area. Permission should be granted before work begins. The Shopfront Design Guide contains helpful advice. Enforcement action could be taken to remove the unauthorised works.
