Map 03: Silsden - East of Clog Bridge

Character of the Area

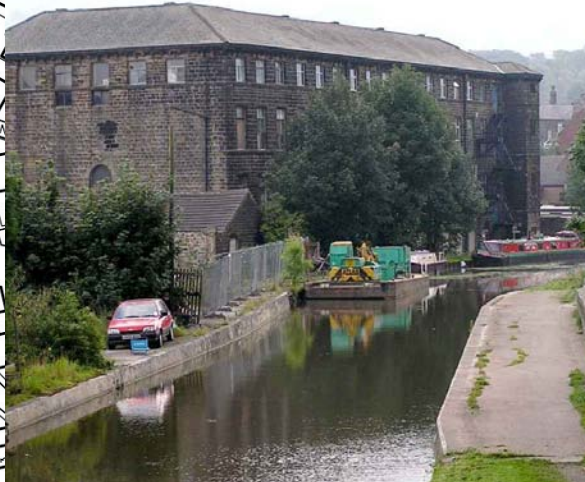
Waterloo Mills is located in Silsden conservation area and dominates views along this stretch of canal.

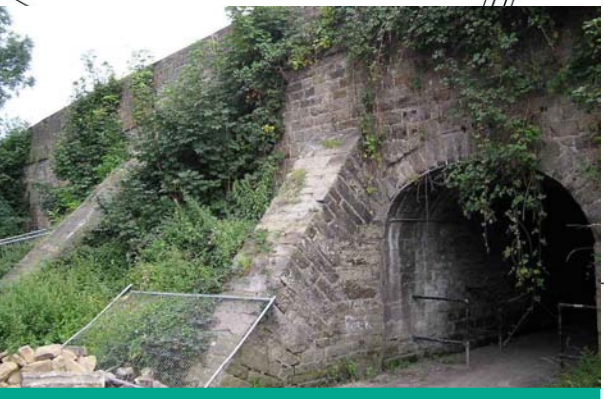
Silsden aqueduct (Grade II Listed) stands within Silsden conservation area.

To the east of the bridge is Silsden aqueduct; a Grade II listed structure that was built contemporarily with the canal (c.1773). Stone built, the aqueduct has a semi-circular arch over the stream and a large basket-arched opening with

dressed voussoirs over Hainsworth Road. On the south side of the canal are three substantial buttresses. To the top of the aqueduct is a simple parapet with stone copings and band.

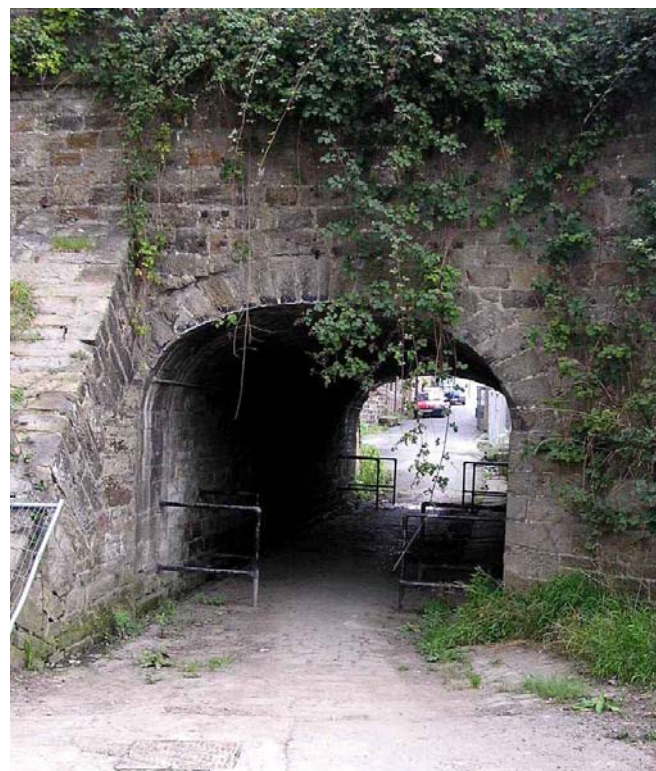
The canal is carried over Hainsworth Road by Silsden aqueduct (Grade 1 Listed). Expensive pieces of engineering such as this are typical 'Brindley features' of canals where John Brindley was employed as engineer. The aqueduct is in need of better maintenance.
