Map 06: Lodge Hill and Low Wood Nature Reserve

Character of the Area

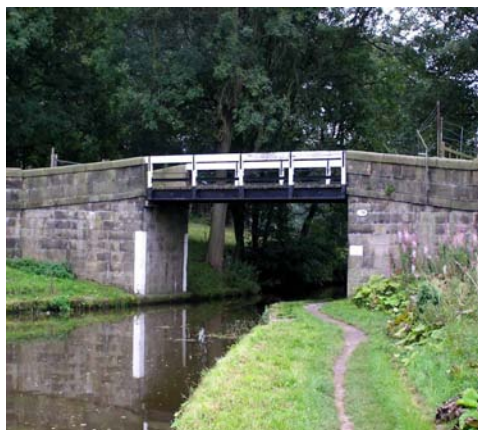
Above: Lodge Hill Bridge, one of the few canal structures along this stretch of the conservation area

1. Lodge Hill Bridge (194): Lodge Hill Bridge is a tall stone structure with high, deeply coursed abutments rising to a flat-topped timber deck. Atop the abutments is a deep stone parapet with stone corning and copings. The timber decking is supported by a metal base that has white painted timber handrails to either side. In fair condition, the bridge appears sparsely used but is an interesting contrast to the more modern metal swing bridges that are common on this stretch of the

canal. The date of construction of the bridge is difficult to estimate. It is shown on the 1852 Ordnance Survey map as a swing bridge and on the 1892 map as an unspecified crossing point serving the woods and Lodge Hill Quarry. The bridge may well date to the end of the 19th century though its flat topped deck is at odds with the more common vernacular style of the earlier arched stone bridges that were built along this section of the canal.

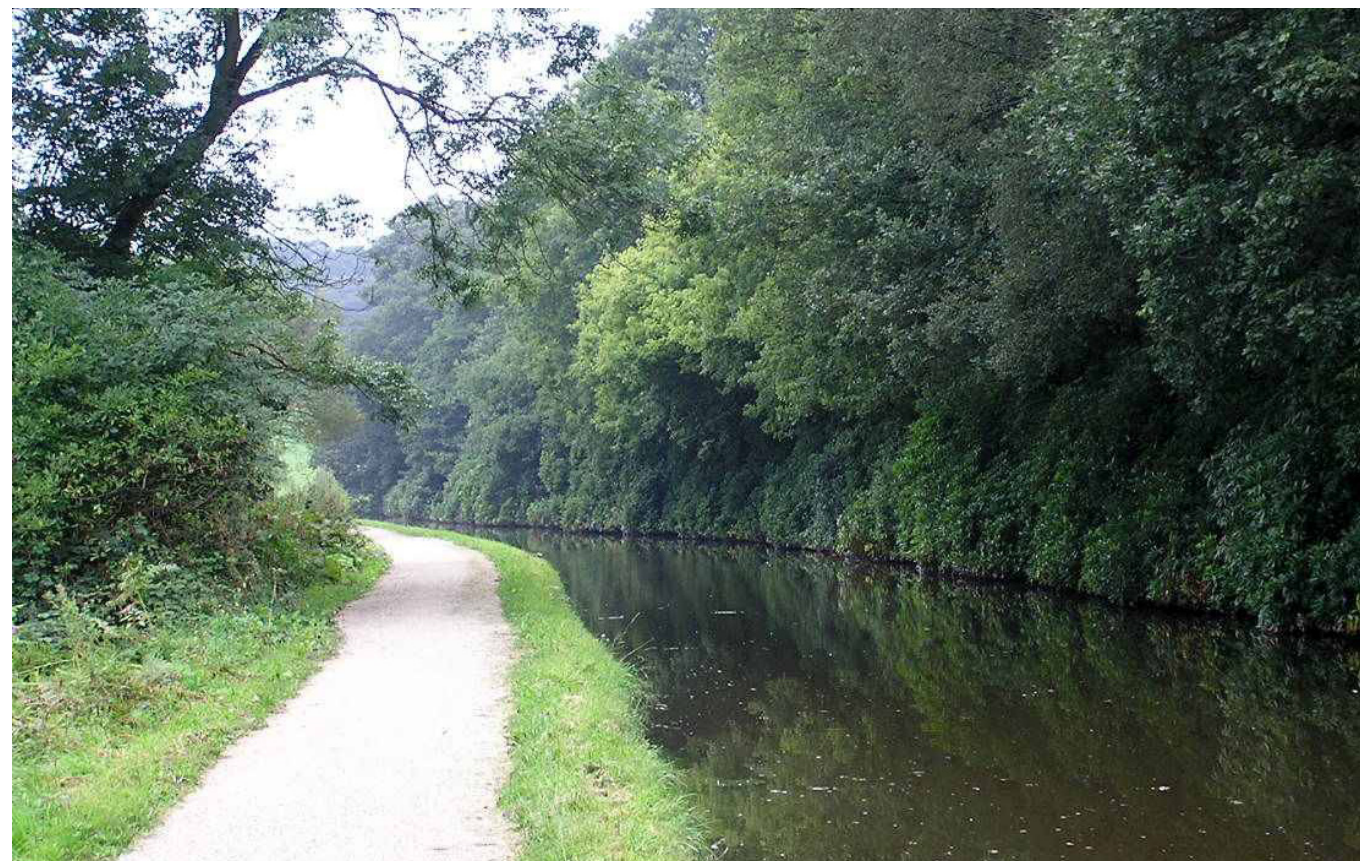
Below: Lodge Hill Wood (across the canal) is an attractive, leafy 'wall' which enhances the tranquil character of this stretch of water.

3. Lodge Hill Wood: Lodge Hill Wood consists of a rocky outcrop that is densely wooded with deciduous trees and contains a former stone quarry. The remaining outcrops of stone are still easily visible through the trees and the concrete moorings alongside this section of the canal indicate that stone was loaded directly onto the barges to be transported to its destination.
