Map 09: Stockbridge Wharf and Banks Bridge

Character of the Area

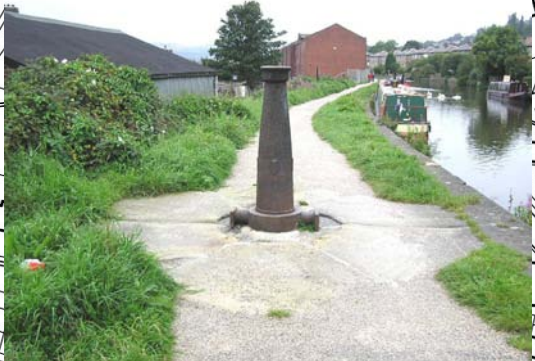
This iron upright is a remnant of a crane which stood on the former Wharf near Bank's Bridge.

By Banks Bridge the setting of the conservation area becomes more green and leafy. Alongside the overflow area immediately adjacent to the bridge is an small area of green open space that appears to be a favourite nesting place for geese and swans. The combination of the old coal yard and the vernacular public house on the north side of the canal gives this area a very traditional and characterful feel. A steel upright standing in the middle of the towpath, the remnants of an old winching machine adds to the visual and historic interest of the area.

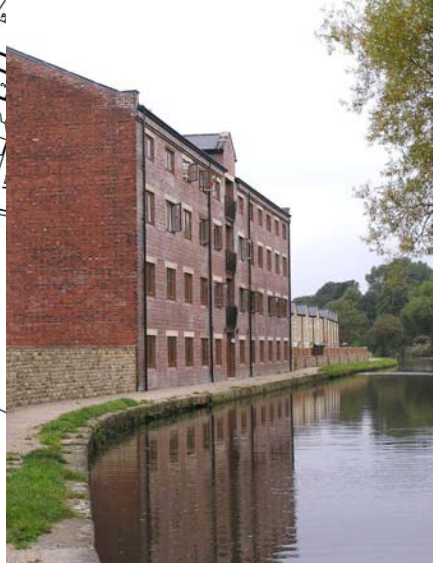
This warehouse (1) at Stockbridge Wharf has recently been converted into apartments.

1. Warehouse on west side of Warehouse Bridge: Immediately abutting the towpath on the south side of the canal is a four-storey, red brick warehouse that is currently undergoing residential conversion. The elevation overlooking the canal has six bays of ashlar-headed windows to either side of a central gabled bay that has a doorway at its base and larger openings recessed into the building. These openings would have once been used as

loading bays through which goods would have been winched directly off and onto boats. Unfortunately the lifting mechanisms and timber hoods have been removed and the plank doors have been replaced with french windows and Juliet balconies.

The warehouse, which was probably built around the start of the 20th century stands slightly away from the main group of industrial buildings on the opposite side of the bridge but makes an important contribution to the feel and character of this part of the canal conservation area.

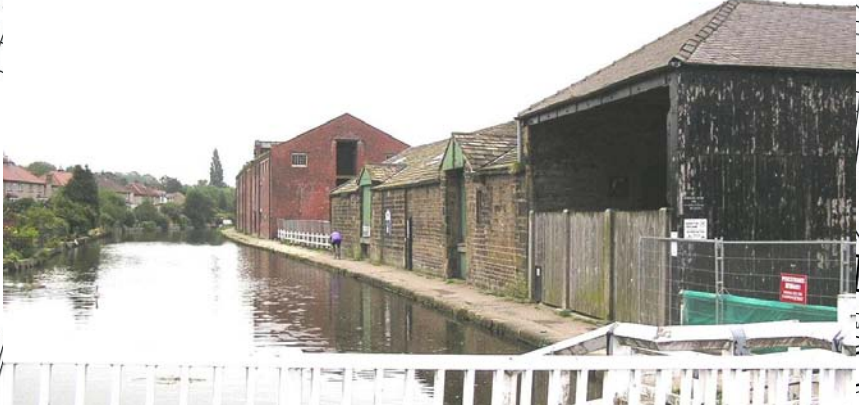
The old warehouse by Warehouse Bridge, with the much later red brick warehouse (4) in the background.

2. Old warehouse, Stockbridge Wharf: Standing on the eastern side of the canal bridge is a long, stone warehouse that was probably built in the first half of the 19th century. The building displays typical vernacular features and appears to have been constructed in more than one phase, with the eastern most section being the oldest. This long range is built of hammer-dressed stone and is a single storey in height beneath a stone slate roof. The elevation onto the canal is sparsely fenestrated, having two gabled bays containing a planked loading door and a ventilator to one side. The south elevation faces onto a yard and unmade track and displays similar gabled bays inset with loading doors. Adjoining the western end of the building is a later extension comprising of stone built offices and a timber storage/garaging area. This section may have been added around the end of the 19th/start of the 20th century. Sadly the building is currently empty and the windows boarded and appears to have been so for some time. Skipton Properties have acquired the property, which was formerly owned by British Waterways with the intention of developing the site for residential use.

Though the later extension to the west of the building is of limited architectural or historic interest, the main body of the warehouse is a fine example of a surviving early 19th century industrial building associated with the commercial use of the canal.

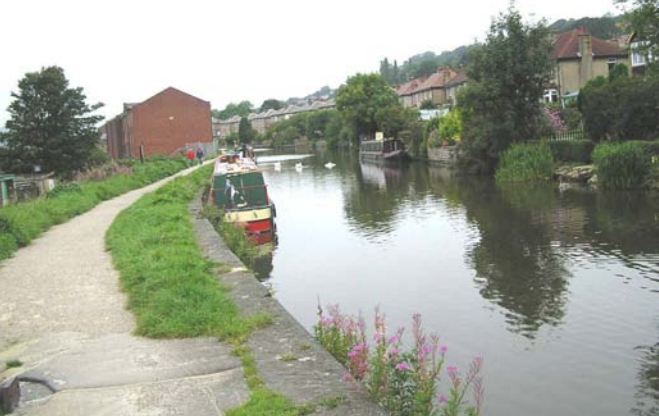
Vista towards the early 20th century warehouse (4) from the east.

4. Red brick warehouse, east side of Warehouse Bridge: Standing a short distance to the east of Warehouse Bridge is an early 20th century red brick warehouse that is probably contemporary with the similarly detailed brick building on the opposite

side of the bridge. The warehouse is currently empty and in poor condition but is still an impressively substantial structure. The elevation facing onto the canal abuts the rear of the towpath and rises up to three storeys in height. Towards the western end of the building is a gabled bay inset with loading doors. Attached to the building over the loading bay was a projecting timber-planked hood with a pitched roof from which goods were winched into and out of the cargo boats. Sadly this structure, which is shown in a photograph of Stockbridge taken as recently as 1996, has since been removed and by doing so has much of the visual and historic interest of the building has been lost. At ground and first floor are a series of simple window openings with ashlar stone heads. High up beneath the eaves is a series of small square windows inset with multiple panes of glass. The south facing elevation is sparsely fenestrated and has a tall, mostly blank elevation. Set into the wide western gable end of the warehouse is an almost continuous opening from ground to apex that probably provided a link through to the now demolished adjoining building.

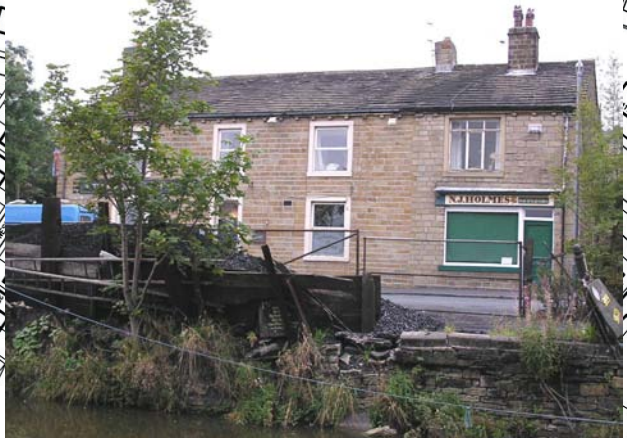
Marquis of Granby and No 1 Hospital Road (key unlisted building) with Oldfield's Coal Yard in the foreground.

7. Marquis of Granby public house and 1 Hospital Road: The Marquis of Granby public house is a building of considerable age and may have been built contemporarily with the canal. Built of dressed, deep coursed stone with a stone slate roof, the inn has been constructed in a typical local vernacular building style incorporating many traditional features. The three-bay front elevation has a centrally located doorway recessed in a simple stone surround. To either side of the door and at first floor are windows set in projecting stone surrounds. The timber guttering is supported on stone dentils and the building retains good corniced chimney-stacks. The building has, sadly lost some of its original character through the replacement of its original multi-pane sash windows with uPVC and the painting of the door and window surrounds.

Attached to the eastern end of the public house is no. 1 Hospital Road, a small single bay shop unit that was built post 1880 (photographic evidence). The shop is constructed of similarly coursed and dressed stone and has a traditional stone slate roof. At ground floor level is the shop front, a traditional timber frontage comprising a large window with doorway to one side and narrow fascia signage constructed from painted timber. Currently used by a green grocer, the shop retains much of its traditional appearance that complements the age and character of the property. At first floor level is a large window opening set in ashlar stone surrounds that may have once been divided by a stone mullion.

8. Oldfield's Coal Yard, Hospital Road: The coal yard occupies a canal-side location on the northern side of the waterway and is thought to have operated from this site since the early 19th century in the same family ownership. Originally the coal would have been transported to the yard by canal boat and though one modern pleasure boat still remains moored alongside the yard, coal is now carried to and from the yard by road. The presence of the still-operational coal yard is a rare survival of a traditional canal-side business and makes an interesting contribution to the character and heritage value of this part of the waterway.

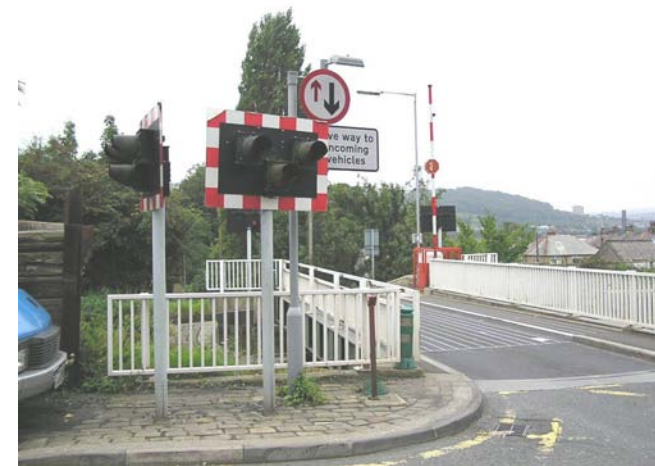
6. Banks Bridge, Riddlesden (Granby Swing 197A): Banks Bridge is a modern, mostly metal structure that carries Granby Lane over the waterway. The bridge operates on an electric swing system that pivots on the north side of the canal. The abutments to either side of the bridge and the overflow on the north side of the canal are stone built, indicating that the crossing has been in situ for many years, probably in the form of a timber bridge until the middle of the 20th century. Today the bridge experiences high volumes of traffic, which is controlled by lights and barriers on both approaches to the canal.
