Map 10: Sandbeds and Swine Lane Bridge

Character of the Area

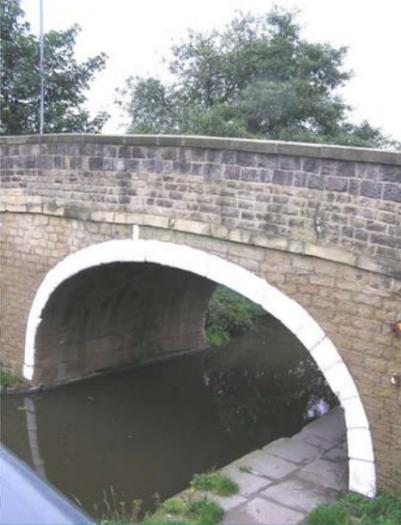
Swine Lane Bridge (Grade II Listed) was built at the same time as the canal.

1. Swine Lane Bridge, Sandbeds (198): The original Swine Lane Bridge is a stone bridge of traditional construction that provides a vehicular crossing over the canal. The bridge, which is a Grade II listed structure is constructed of dressed, coursed local stone and has a high, wide arch to allow passage of boats beneath. The arch has a vaguely horseshoe shape with dressed voussoirs painted white as is traditional on this part of the waterway. The abutments are constructed of dressed stone and the parapet sits atop a projecting stringcourse and is mounted by flat copingstones. Originally stone bridges were much narrower with a steep camber to the arched crossing, however this bridge

may well have been rebuilt and made wider to allow cars to cross.

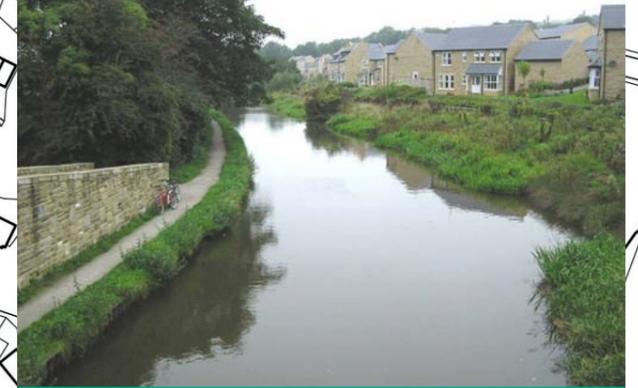
Vista west from Swine Lane Bridge with the suburban housing at Thurlestone Court.

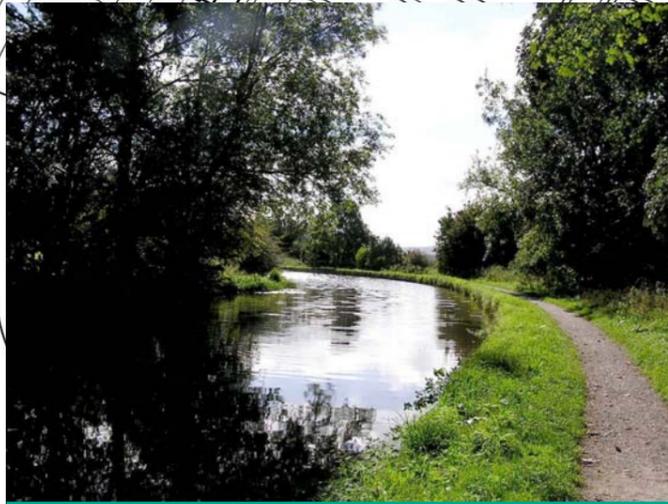
Despite the proximity of the built up area of Sandbeds, the canal retains a leafy, rural character in places.

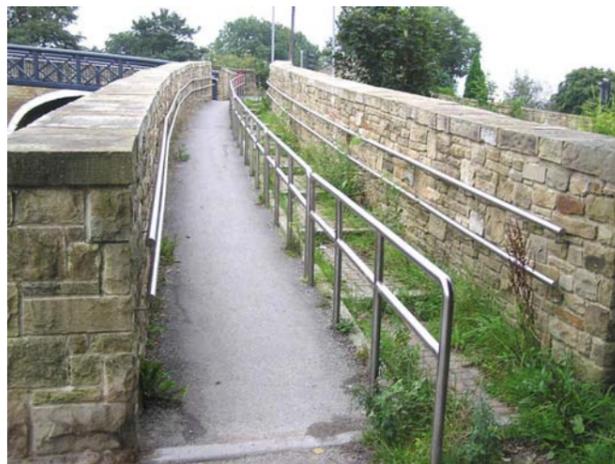
Top: Although recently built, this footbridge adjoining Swine Lane has quickly fallen into a neglected state.

2. Footbridge, Swine Lane, Sandbeds: The arched footbridge immediately to the northwest was added recently to allow pedestrians safe crossing over the canal. Built of metal with decorative black-painted handrails and a slightly arched footway, the bridge has been constructed to a modern design and is complimentary to the stone structure it sits alongside. Access from the towpath to both bridges is taken from a sloping footway that is wide enough to allow passage by prams, wheelchairs etc. The pathway is currently quite overgrown and more frequent maintenance is required in order to preserve access.

- ▶ Loss of original details to the vernacular buildings at Aire View
- ▶ Overgrown access ramp to the footbridge
- ▶ Uneven surface of towpath to the east of Swine Lane Bridge
- ▶ Overhanging and overgrown vegetation along the edge of the towpath
- ▶ Encroachment of water plants, reeds etc into the waterway alongside Swine Lane Bridge

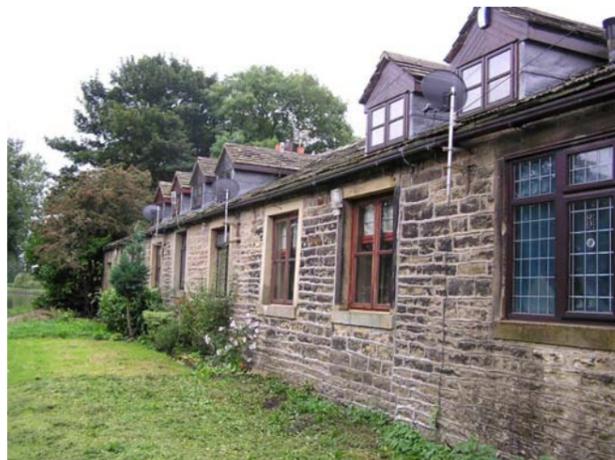
Above: One of the few canal-related historic buildings in the Sandbeds area, the cottages at Aireview are an important, if much altered, feature.

3. Nos. 1-5 (odd) Aire View, Sandbeds: Nos. 1-5 Aire View consist of a terrace of three dwellings located in a converted stone building that may have once been a farmhouse and/or barn. The group faces southwards across the valley bottom with their rear elevations, which are just a single storey in height due to the slope of the land, onto the canal. The building itself

displays typical vernacular detailing, being constructed of rubble stonework with a long stone slate roof, corniced chimneystacks and door and window openings set in flat-faced stone surrounds. Though the building has been much altered over the years, its traditional form and building materials make an interesting and historic contribution to the setting of the canal and conservation area.

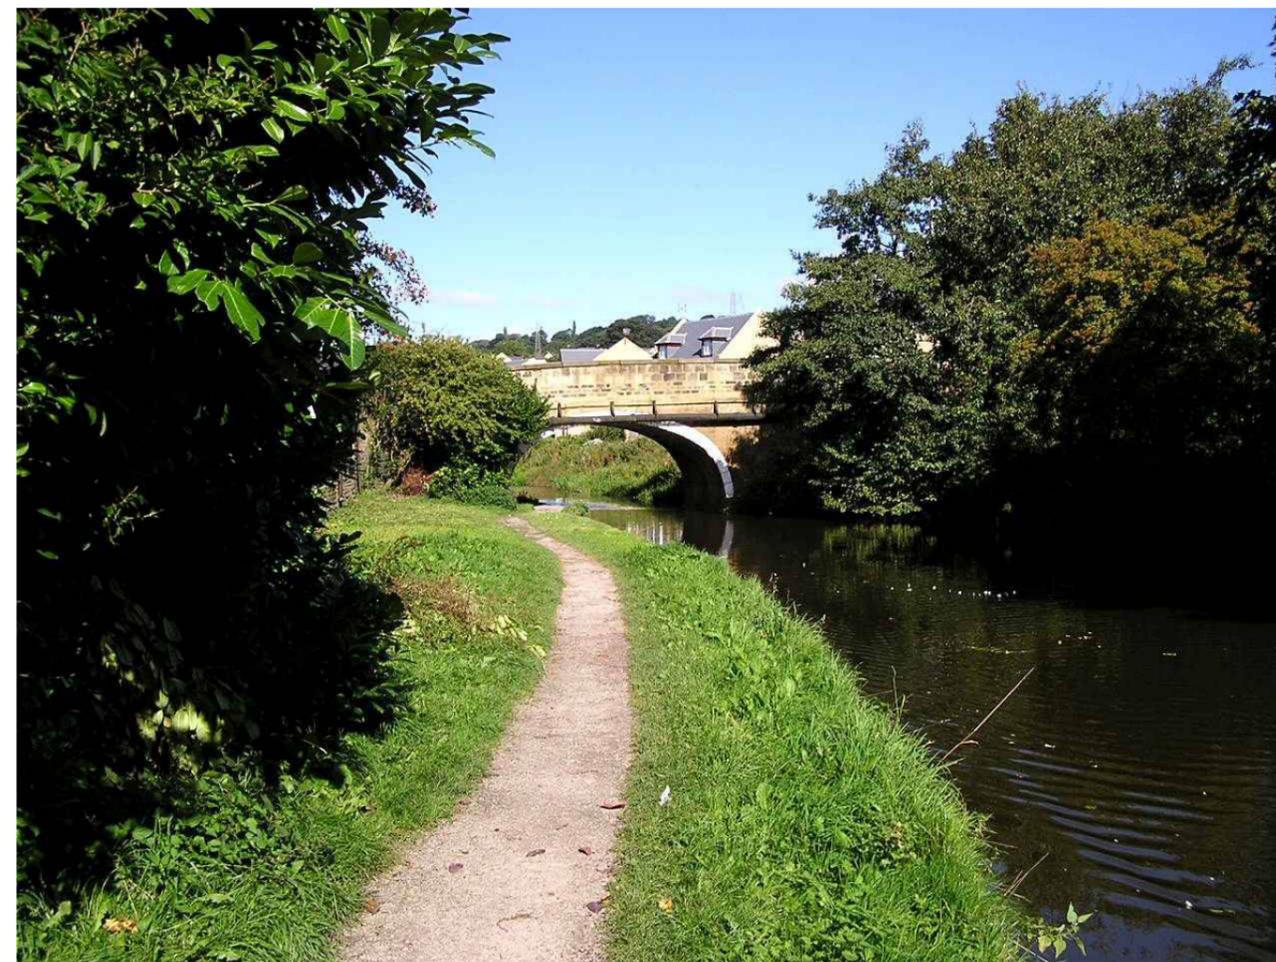
Far Right: Swine Lane Bridge (Grade II Listed) was built contemporarily with the canal.
