Map 13: Airedale Mills and Micklethwaite Bridge

MICKLETHWAITE CONSERVATION AREA

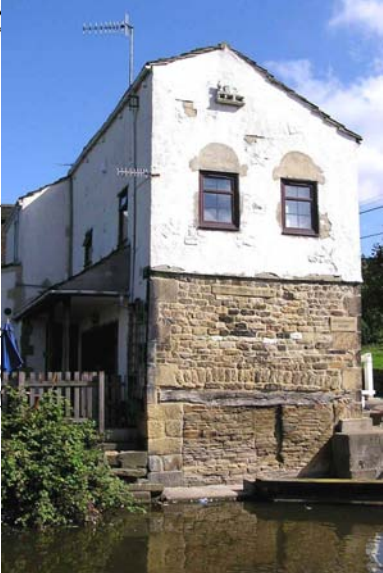
Airedale House, Micklethwaite Lane, a key unlisted building in the conservation area.

1. Airedale House, Micklethwaite Lane: Airedale House is a substantial late 19th century villa, built in coursed, dressed stone with a hipped slate mansard roof and corniced chimneystacks. The principal frontage to the house faces east onto Micklethwaite Lane and has a three bay elevation with a central doorway mounted by a hooded cornice on carved brackets. The windows to ground and first floor have ashlar stone heads and sills and retain their original, part leaded sash window frames. The west elevation faces onto the canal and due to the sloping land is three stories in height, having windows to the basement level and large bay windows to the ground floor. Sadly this elevation has been much altered, the original window pattern having been altered with the replacement of the traditional timber frames with white uPVC. The house was originally built for the owner of Airedale Mills and so has a strong historical and visual link with the canal and its industry.

- ▶ Loss of traditional roofing materials to some buildings in the Airedale Mills group.
- ▶ Loss of traditional window details to Airedale House, Micklethwaite.

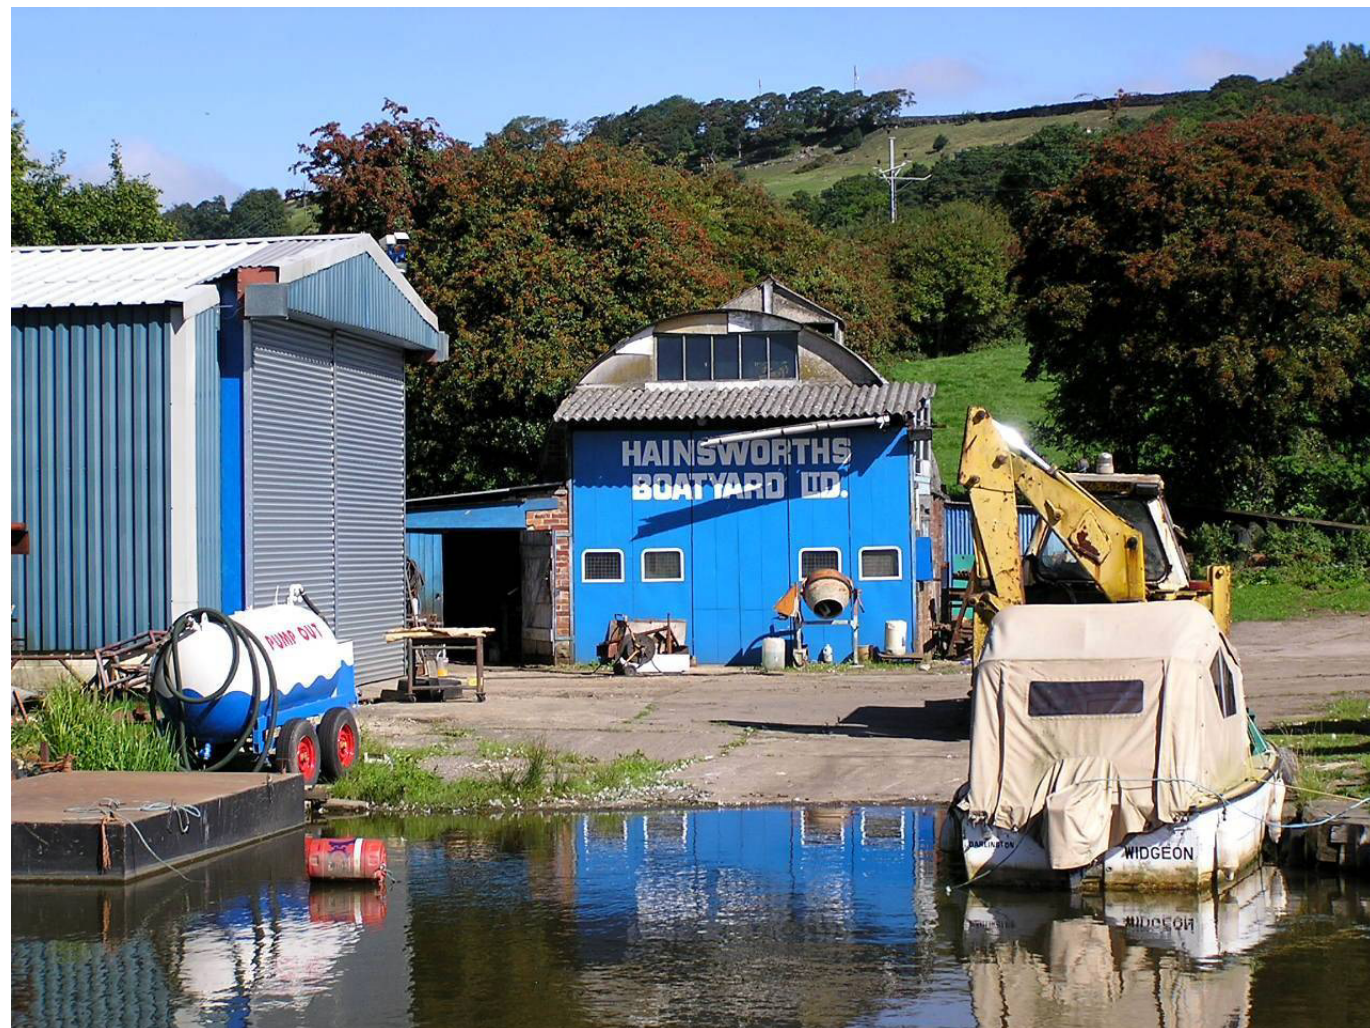
Left: Probably first established in the mid 20th century, Hainsworth's Boatyard adds to the variety of activity in the conservation area and relates directly to the canal's present-day use by pleasurecraft.

7. Hainsworth's Boatyard, Fairfax Road, Bingley: The boatyard occupies a prominent location on the north side of the canal and comprises of a tarmaced slipway access into the canal surrounded by a small group of redbrick and corrugated metal buildings. Several boats stand in the yard or are moored alongside the boatyard in the canal indicating that the yard is still operating commercially. The boatyard is one of the few traditional canal industries still operating locally and makes an important contribution to the character and interest of the canal conservation area.

- ▶ Unattractive modern sheds and untidy yard at Hainsworth's Boatyard.
