Map 27: Thackley - South of Esholt Sewage Works

Character of the Area

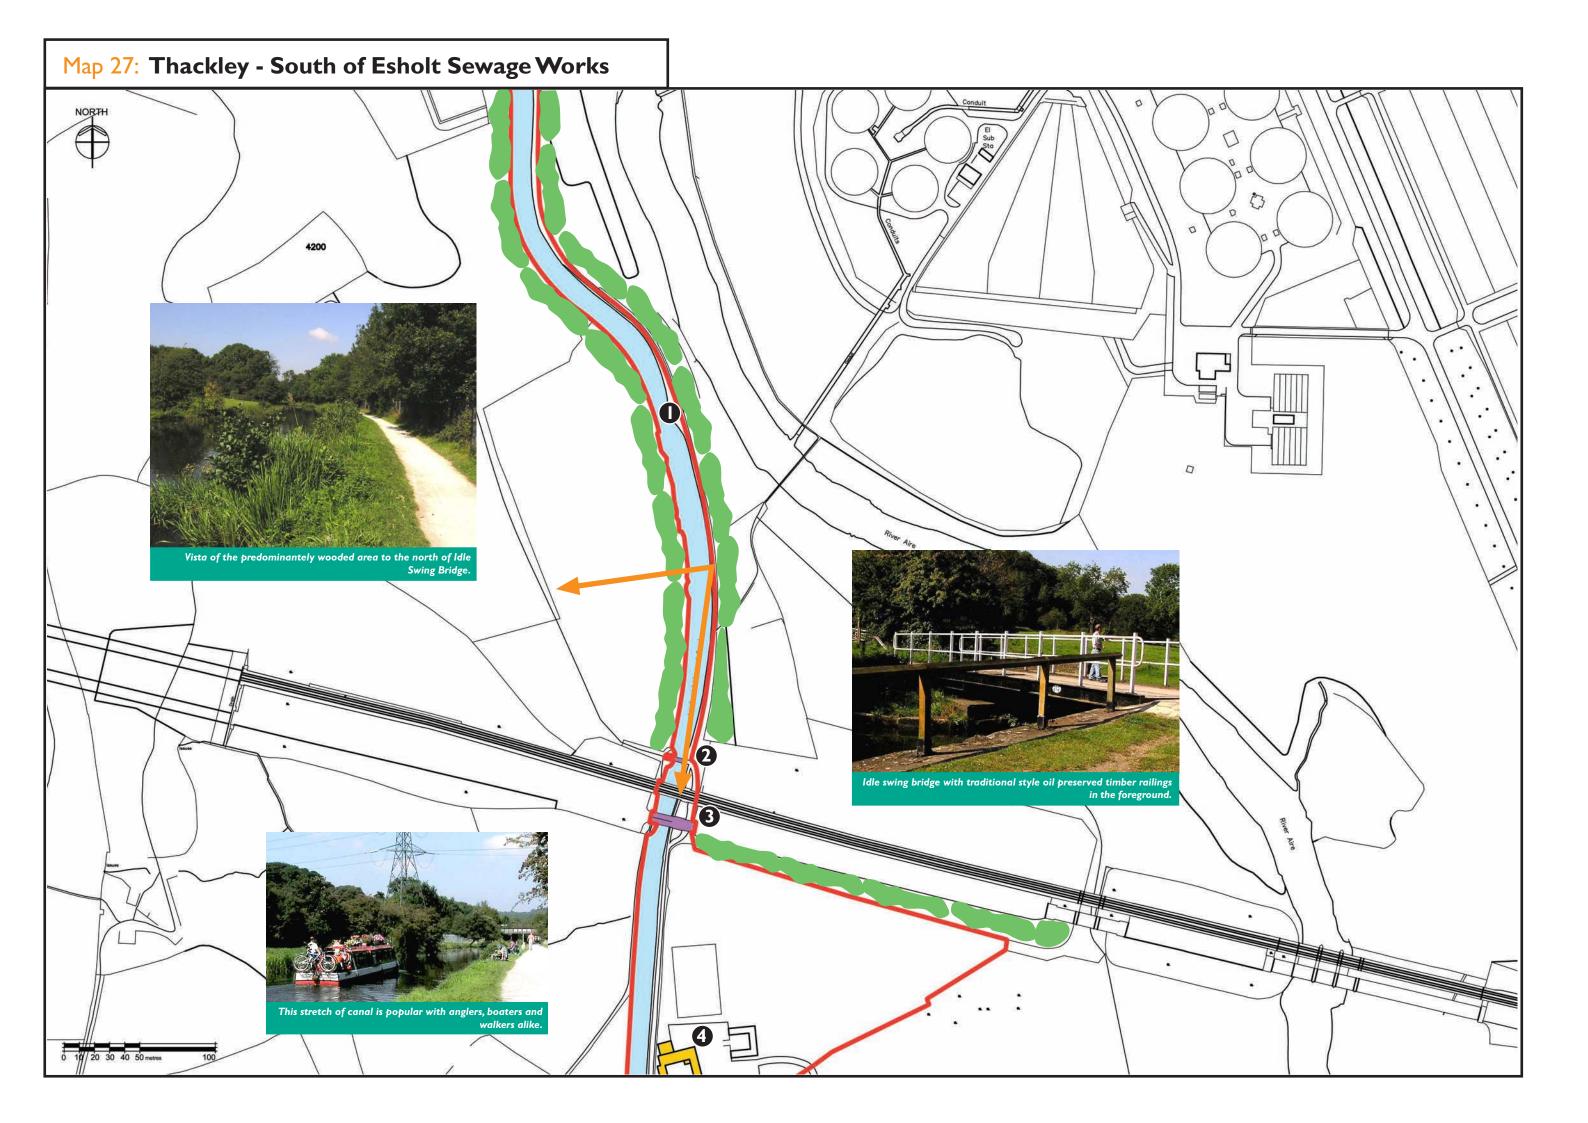
I. Site of swing bridge (211c?): North of Idle Swing Bridge the canal narrows and the towpath rises where there was formerly another swing bridge. This bridge served the long demolished Rockcliffe (or Rawcliff) Farm on the western bank and linked the farm to Apperley Bridge via a track which is no longer in existence. All that remains is the masonry and copings on either bank, which is overgrown.

3. Thackley Canal Bridge (212a): The railway line, which passes through Thackley Tunnel and over the canal, was built in 1846 as the Bradford-Shipley-Leeds line. In the early 20th century the railway was widened from 2 lines to 4 lines, necessitating the widening of the tunnel, embankment and the construction of the second bridge. The older pair of lines has since been closed and the rails removed and as such, the northern bridge is maintained, while the southern bridge has been allowed to deteriorate, though both of these riveted iron bridges are rusty and neglected.

- Overgrown copingstones along canal and at site of former swing bridge.
- Lack of maintenance to Thackley Canal Bridge.
- ▶ The appearance of the vehicle barrier by Idle Swing Bridge.
- The non-traditional door and window details to some of the listed buildings.
- ▶ The modern appearance of Idle Swing Bridge.
- The smell from Esholt Sewage Works is a problem at the northern end of this area.
