Map 28: Apperley Bridge - Milman Bridge and Dobson Locks

Character of the Area

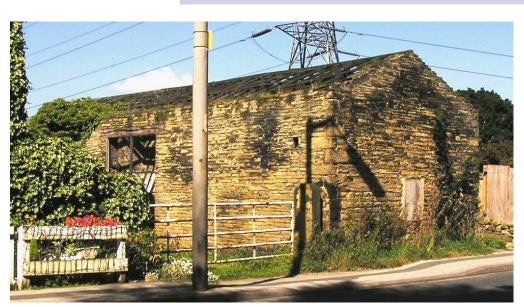
Far right: :This c. 1776 barn was built by the Canal Company.This Grade 11 Listed Building is now semi-derelict and has an uncertain future.

The barn is in a very poor condition as its stone slate roof was removed c. 1995, leaving the

roof timbers exposed to the elements. The uncovered wall tops have vegetation sprouting from them, while the stonework is badly weathered. This ruinous barn has quoined angles, a large cart entrance with a timber lintel on the southern side and various other small window and vent openings.

- Overgrown and neglected stonework at Mitchell Bridge and to the south.
- Patchy tarmac towpath at Dobson Locks and to north.
- The painting and rendering of the stonework of the buildings. Non-traditional door and window details to the non-listed buildings.
- The modern street furniture and appearance of Milman Bridge.
- The poor condition and uncertain future of the barn at 293 Apperley Road.
