Conservation Area Appraisal

Menston

June 2007

City of Bradford MDC

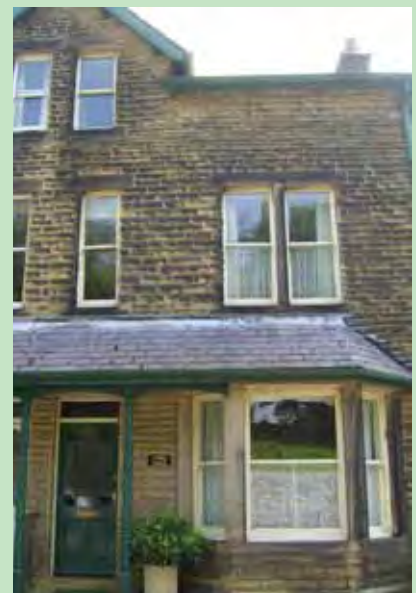
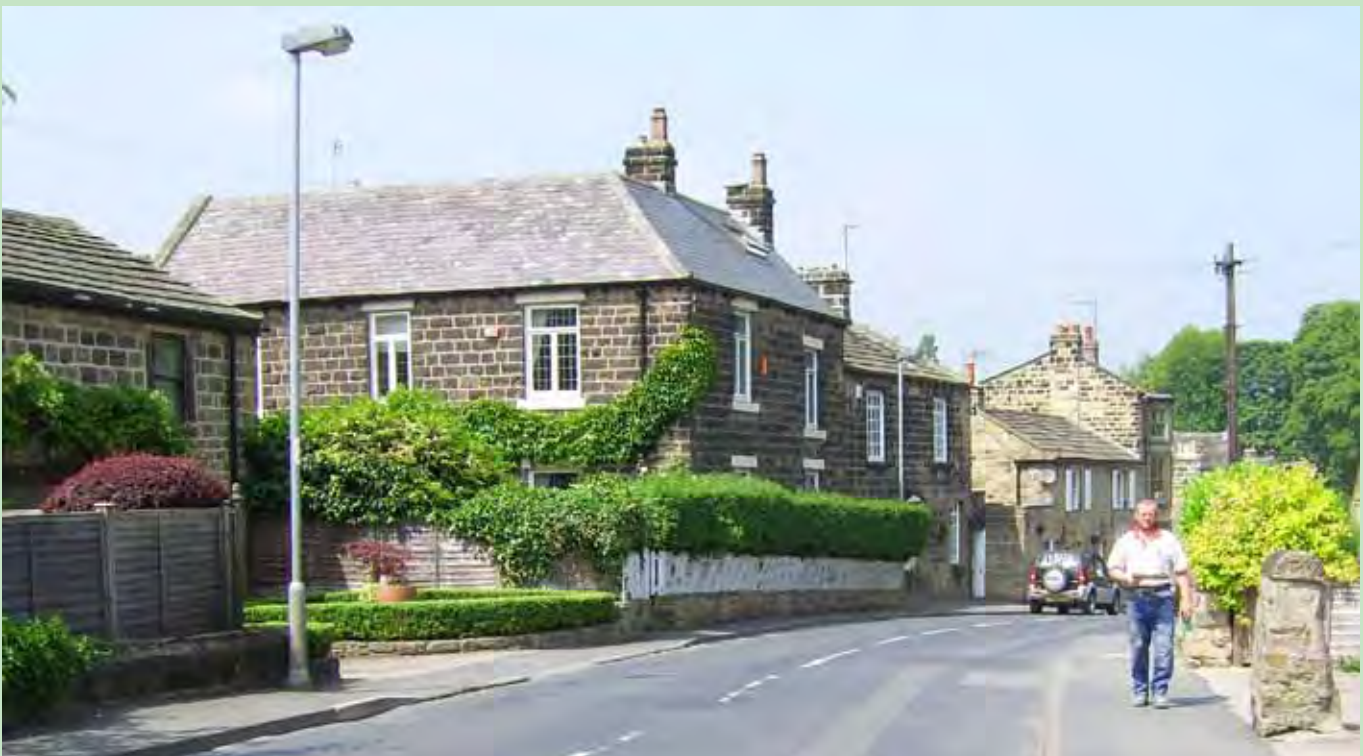
*Right: Well detailed house.
Below: Street scene showing a good use
of natural building materials.*

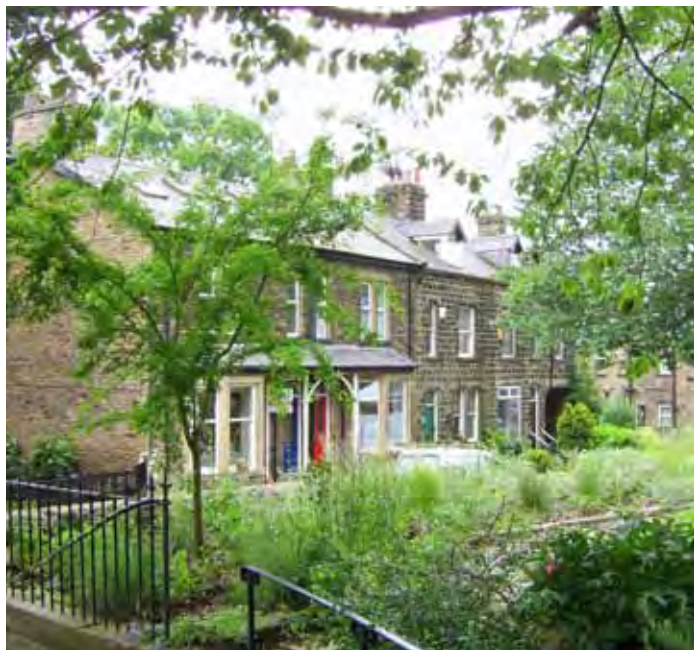
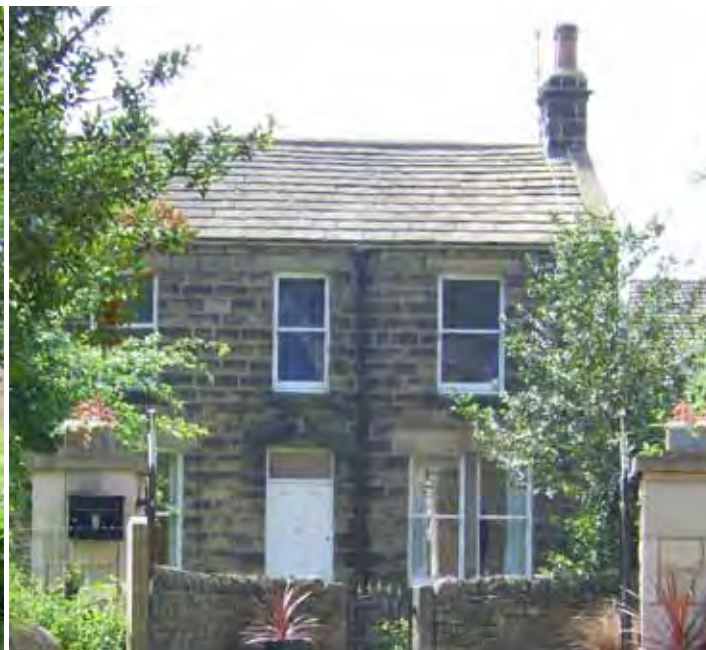
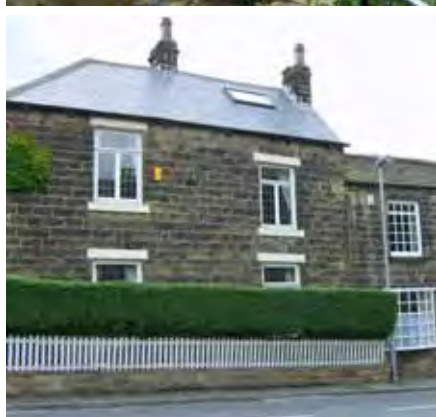
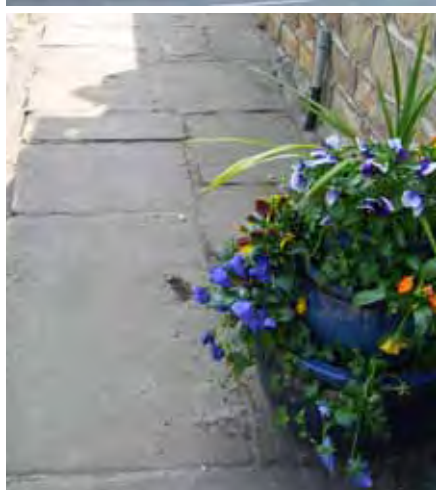
Top right: Traditional timber sash windows and panelled door.

Top: View to Burley Lane showing the historic street layout with minor alterations.

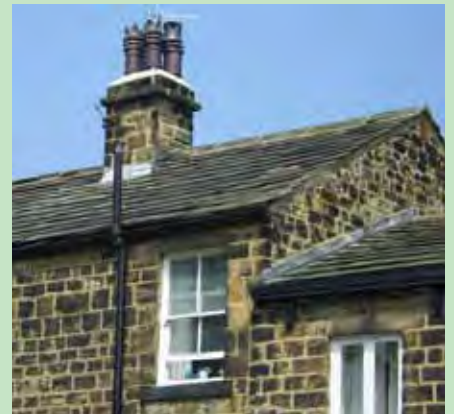
Traditional height chimney and sash detail

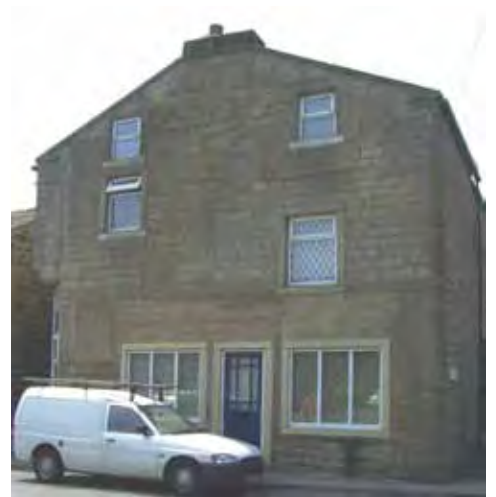
Inappropriate pointing and windows

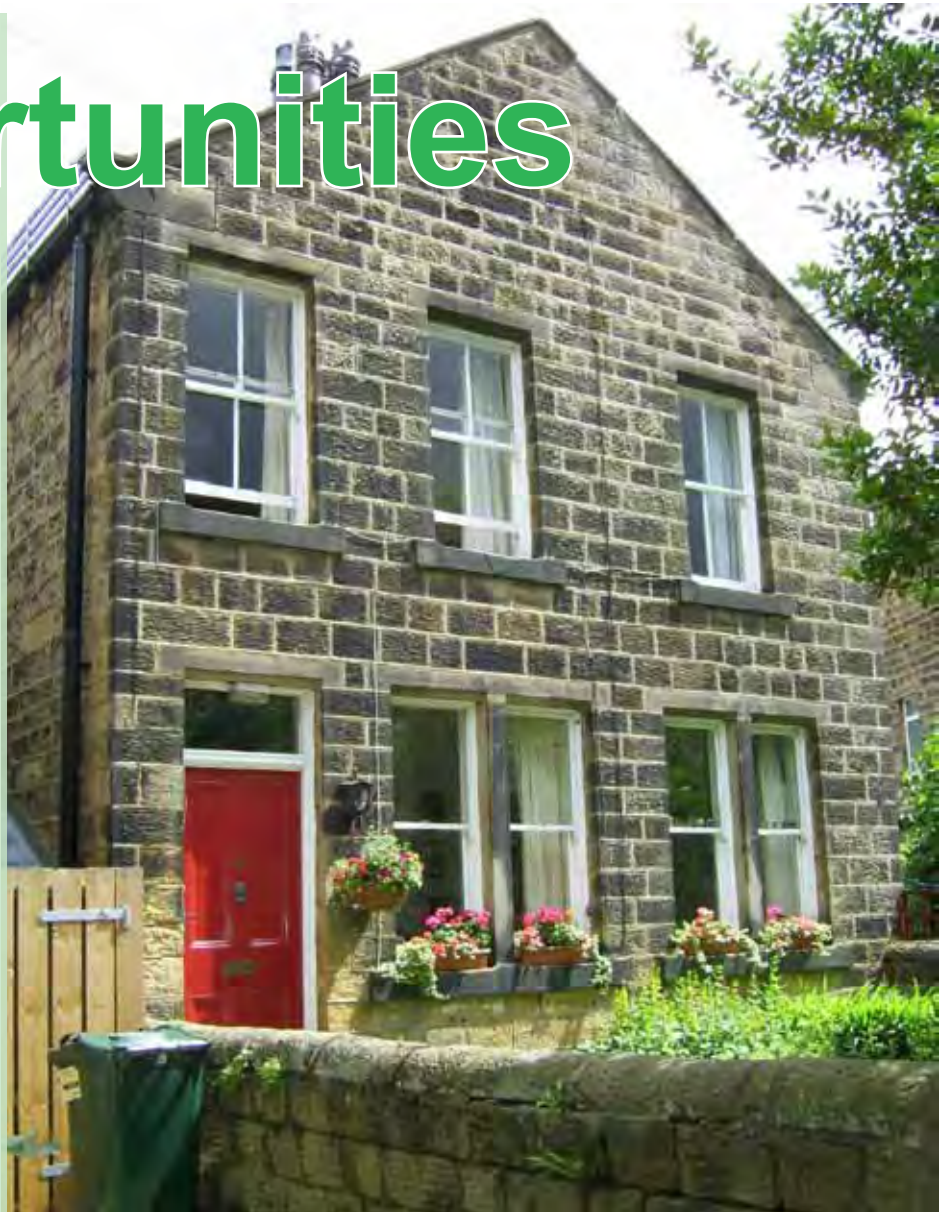
Traditional features well maintained

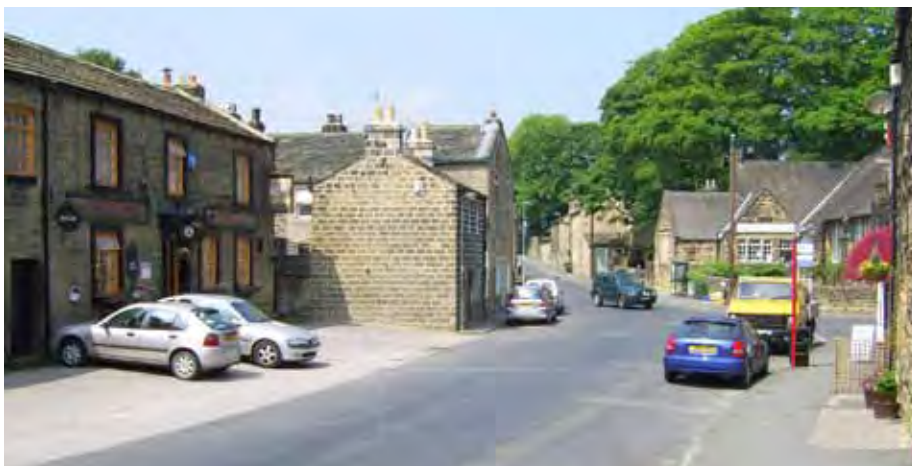
Loss of historic street surfaces

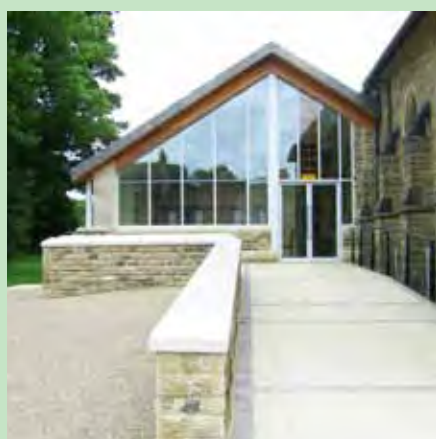
A single storey modern side extension has succeeded in complementing **Menston Methodist Church**. Its good design has been achieved by its suitably subservient appearance, and use of appropriate scale, proportions and materials which allow the structure to blend in rather than competing.

POSITIVE IMPACT

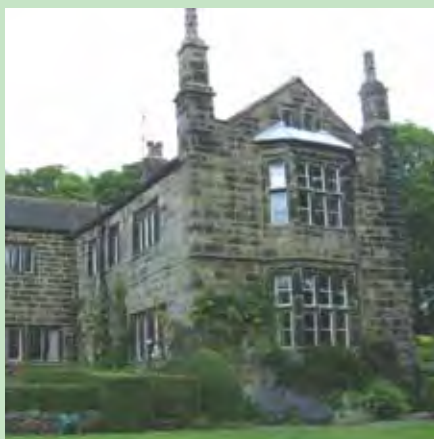
Listed Building Consent was granted in 2007 for the installation of six solar thermal collectors onto an attached outbuilding at **Fairfax Hall**. These panels cannot be seen from a highway, and are suitably placed on an outbuilding therefore do not have a direct impact on the conservation area.

NEUTRAL IMPACT

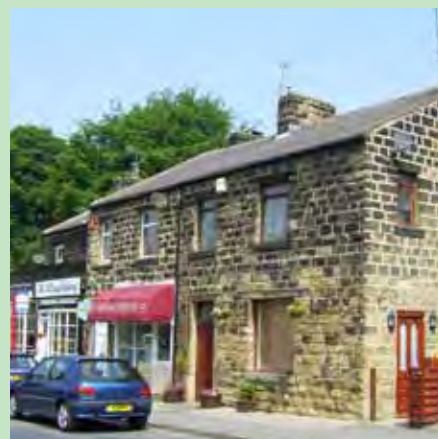
35 Main Street was granted planning permission in 2004 for the change of use from residential to business office at ground level. It is unknown as to whether this development has been carried out as there are no evident signs of this change.

NEUTRAL IMPACT (if residential) / **POSITIVE** (if now business to ground floor)

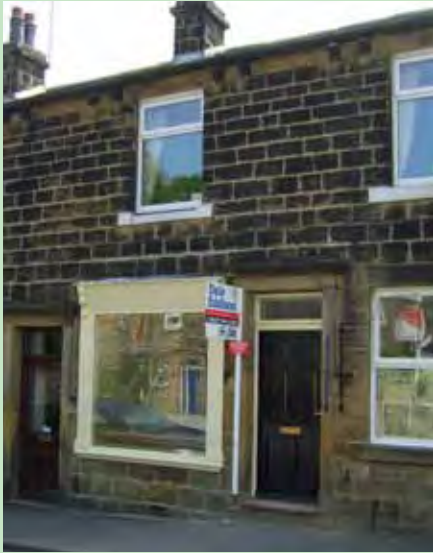
28 Main Street received a grant of planning permission in 2003 for the change of use from ground floor shop premise to residential with no external alterations. This development has been carried out and has resulted in the removal of the traditional shop front detail which has significantly altered the character and appearance of this building.

NEGATIVE IMPACT

Lesson: In the future, decisions on similar buildings should incorporate traditional features within a residential use to maintain the character and appearance of the area.

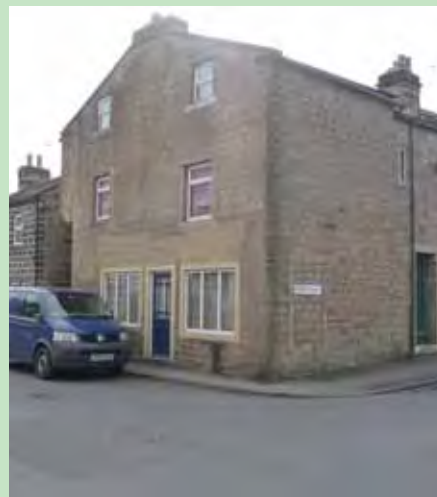
Low Barn, Burley Lane received a grant of planning permission for change of use to offices in 2004. There have been little or no external alterations with this development.

NEUTRAL IMPACT

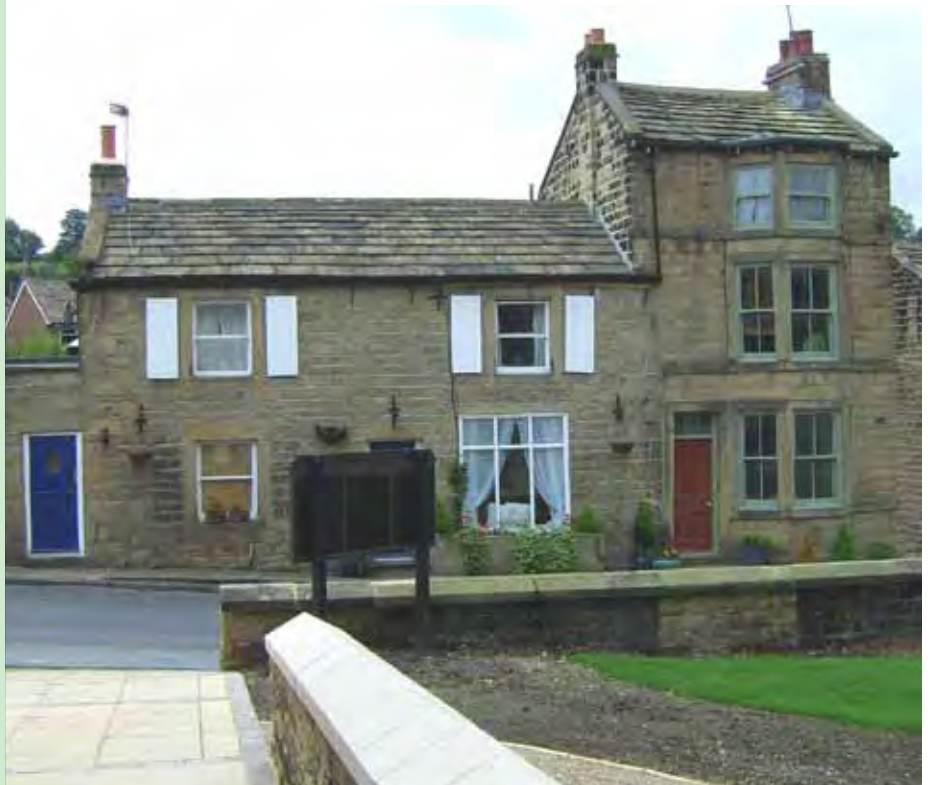
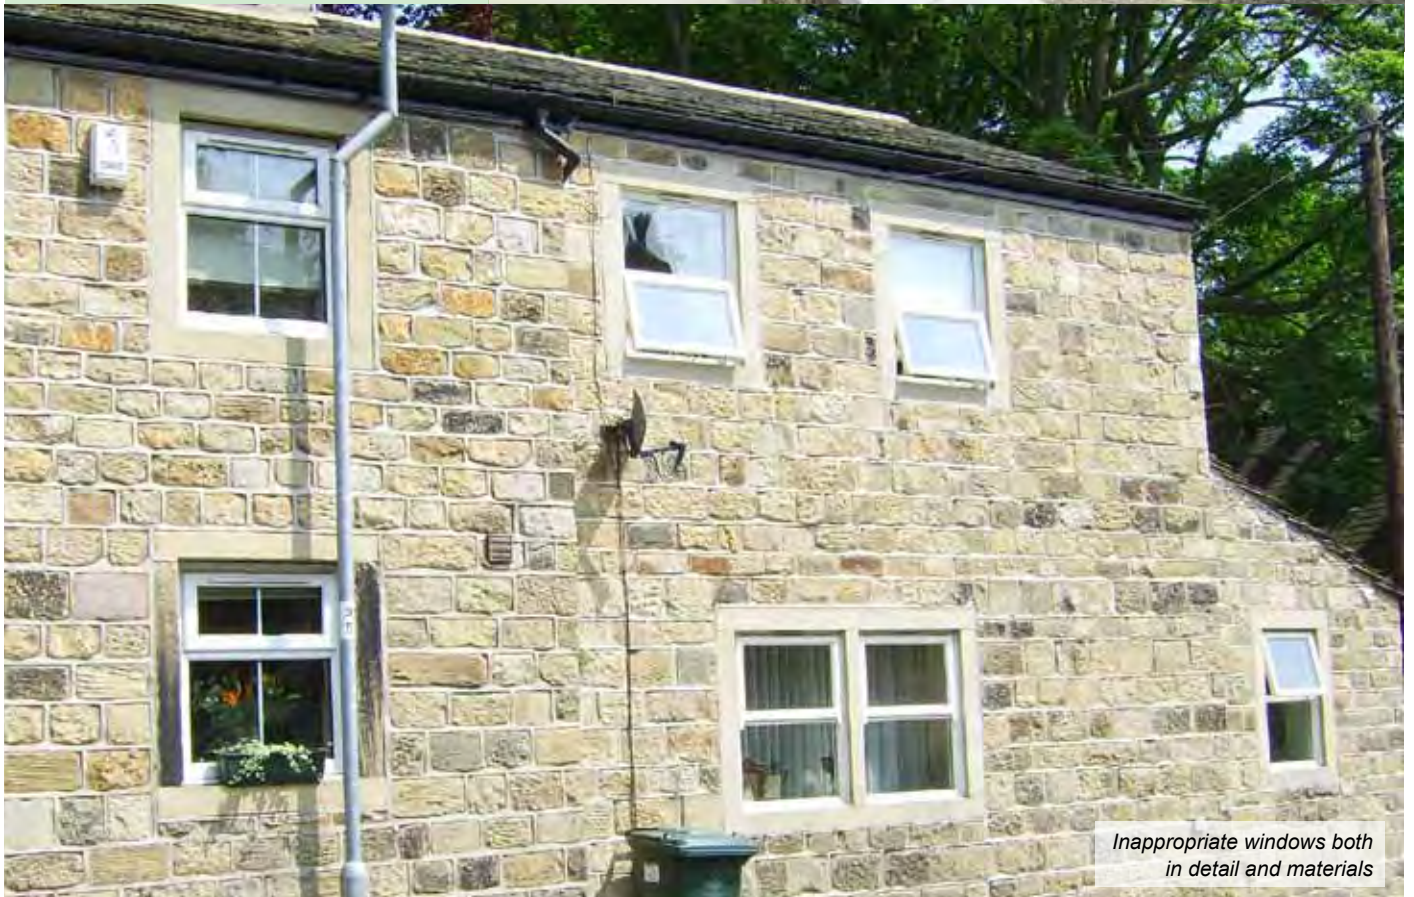
Inappropriate windows both in detail and materials
