Conservation Area Appraisal

Oakworth

January 2008

City of Bradford MDC

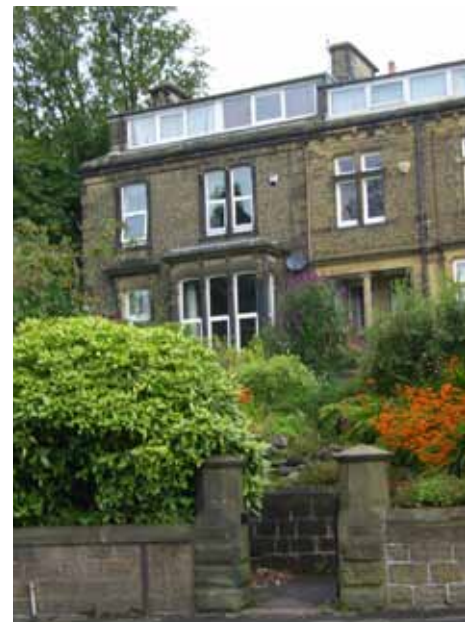
Example of a negative impact on the roofscape

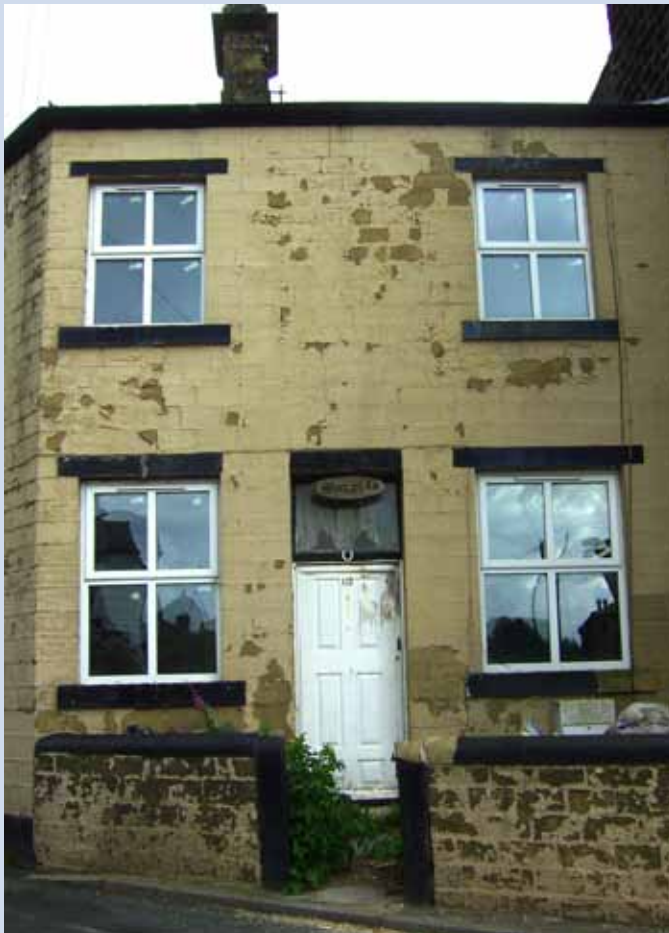
The painting of elevations can damage the property when neglected

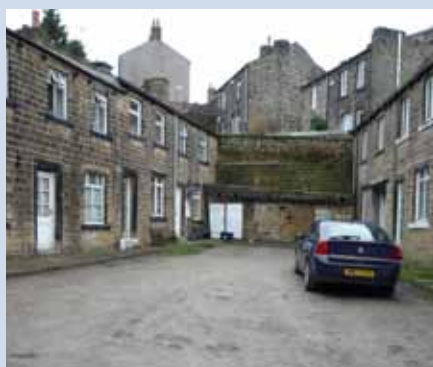
Clough Gate has seen the modernisation of properties 10, 12, 14, 16, 18, 20 and 22 since the 2005 and have now been brought back into use.

POSITIVE IMPACT

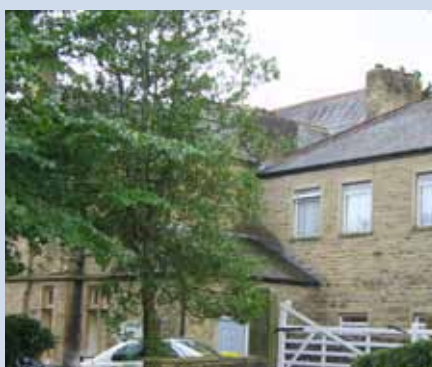
Oakworth Manor Residential Home received planning permission in 2006 to extend the home by 12 bedrooms. This has been completed with little impact on the conservation area.

NEUTRAL IMPACT

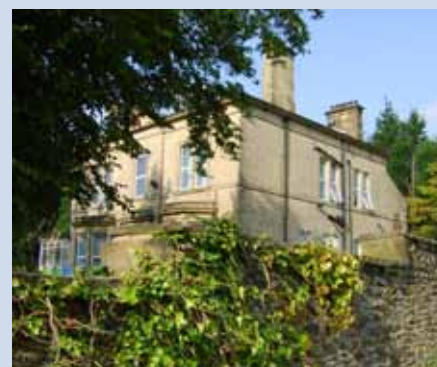
East Royd in 2006 was granted permission to demolish the existing granny flat and playroom to construct a new orangery, kitchen and master bedroom. This has had a minimal impact on the conservation area due to its location and high boundary walls that obstruct view of the property.

NEUTRAL IMPACT

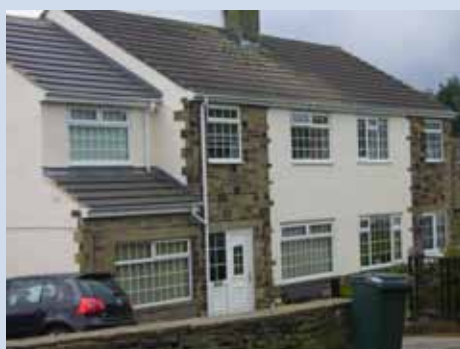
33 Church Street received planning permission for an extension on top of an extension to the side of the property in 2006. The extension uses the same materials as the parent property and has a minimal impact on the conservation area.

NEUTRAL IMPACT

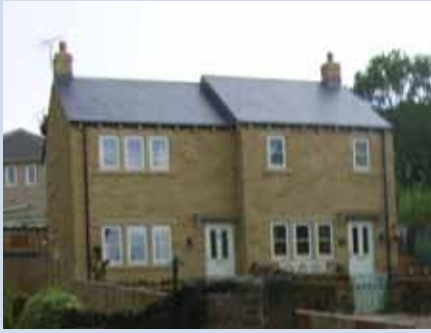
30 Goodley received planning permission in 2006 to erect a semi detached dwelling. The site saw the demolition of a single story workshop. Overall the redevelopment had a positive impact on the conservation area but the design and details could have taken more care and consideration for its surrounding location.

NEUTRAL IMPACT

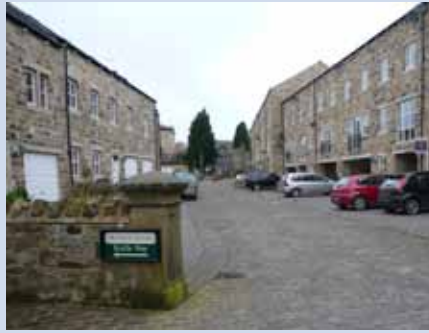
In 2004 the development of 22 new dwellings had been granted planning permission on **Waterwheel Lane**. These have now been complete and take over a significant amount of space that was once occupied by a listed mill.

NEGATIVE CHANGE

LESSON: Decision makers should give greater consideration to the impact of their decisions on the character and appearance of the conservation areas.

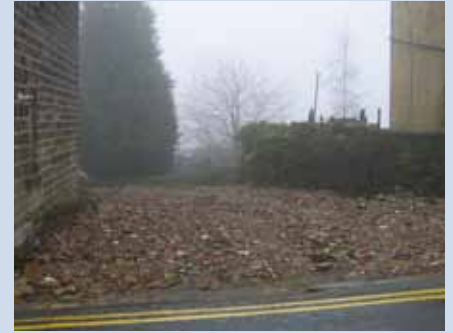
The boundary wall to the cemetery along **Colne Road** has been demolished. Several planning applications have been refused in order to develop this land. The boundary wall was a feature of this road and the demolition has seen the loss of character.

NEGATIVE CHANGE

LESSON: Developers should consult the Design and Conservation Team prior to carrying out demolition within the Conservation Area. In this instance the Council could take enforcement action at any time.

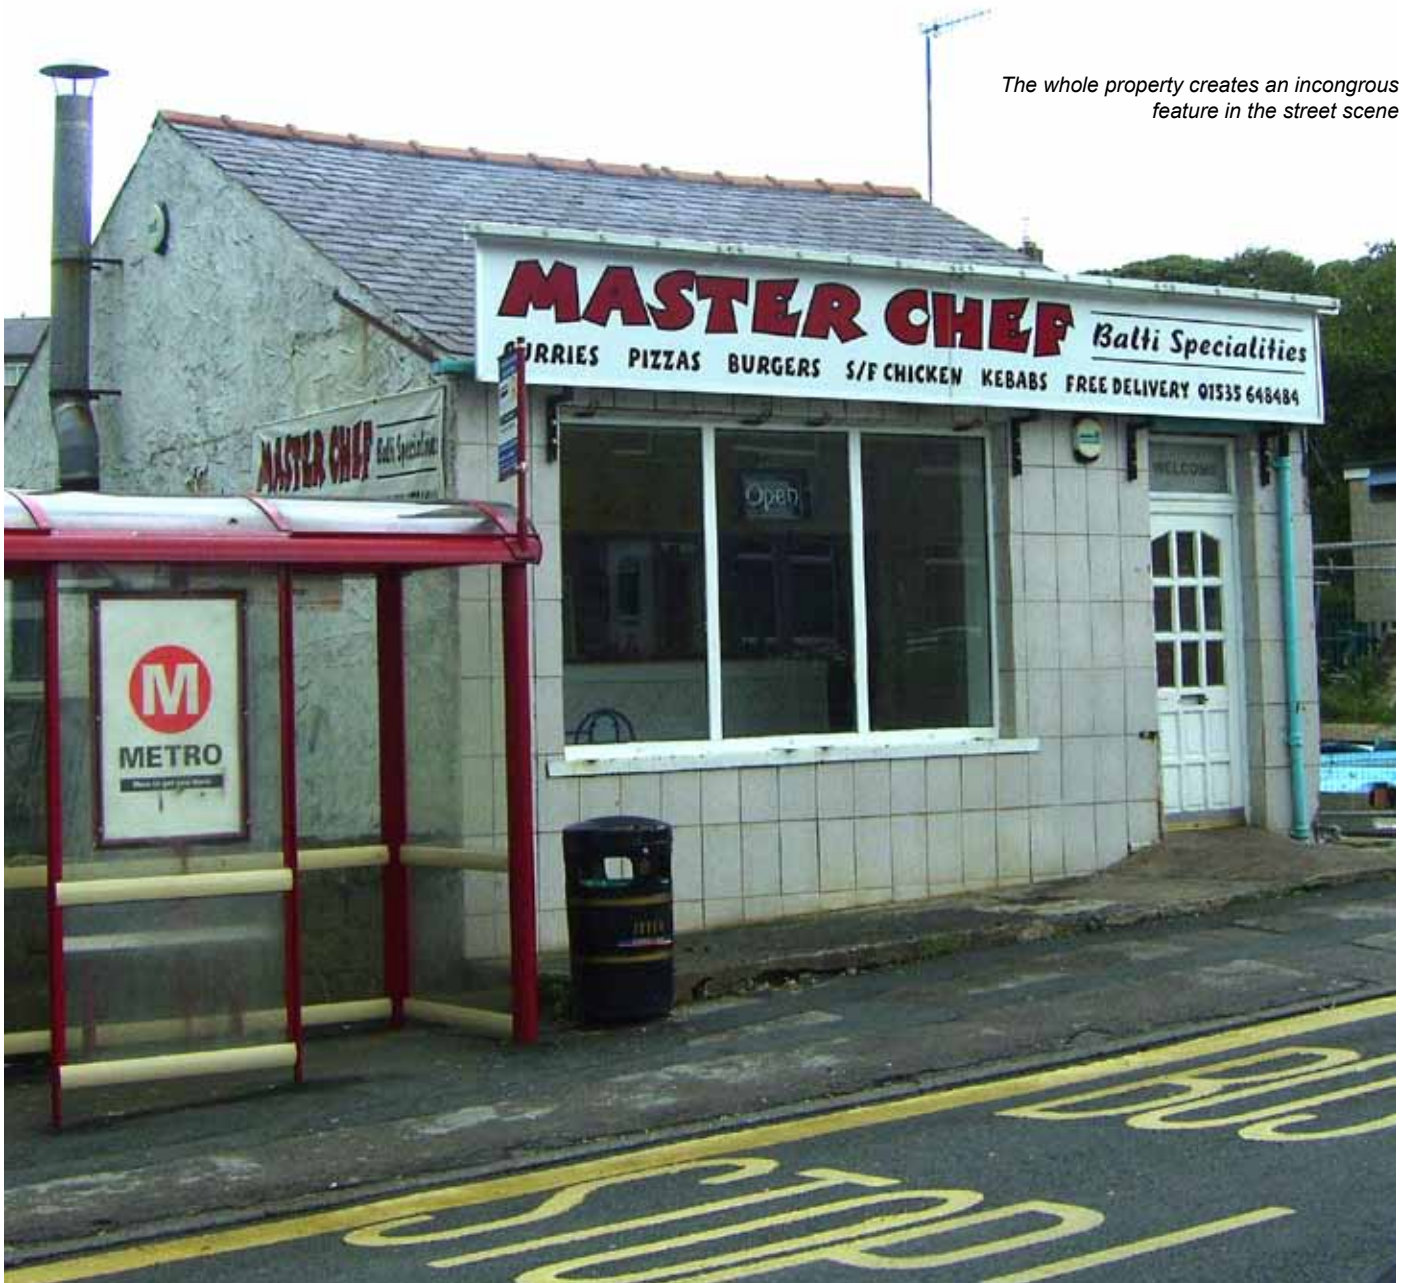
The whole property creates an incongruous feature in the street scene
