## Conservation Area Appraisal

# Ryecroft

**June 2009**

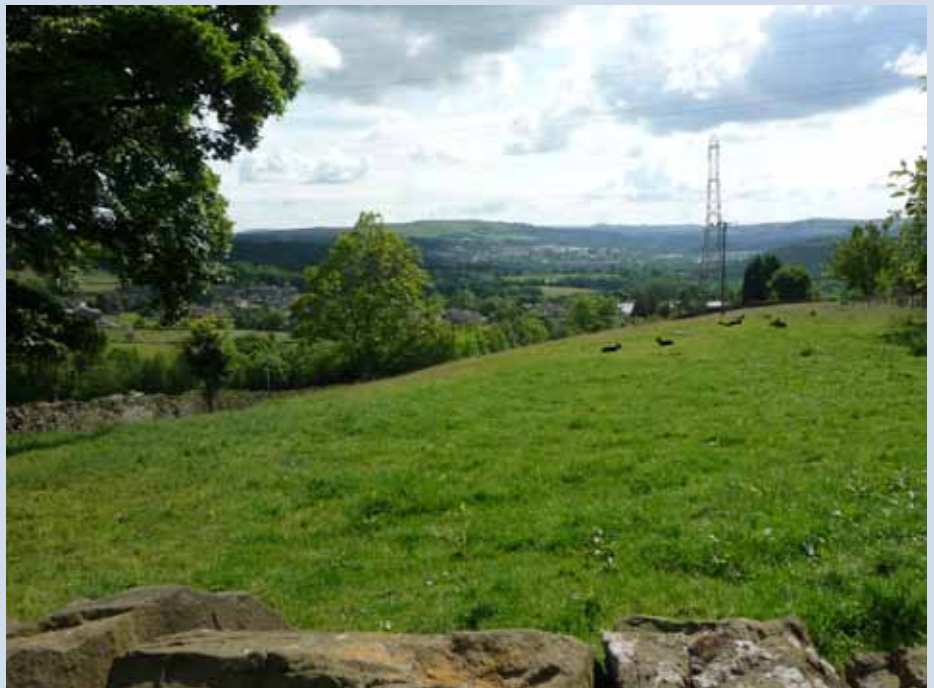
*Top: Impressive views eastwards towards Harden.*

*Middle: 21 Ryecroft, a Grade II listed converted barn.*

*Below: 1-3 Ryecroft make a characterful entrance to the hamlet.*

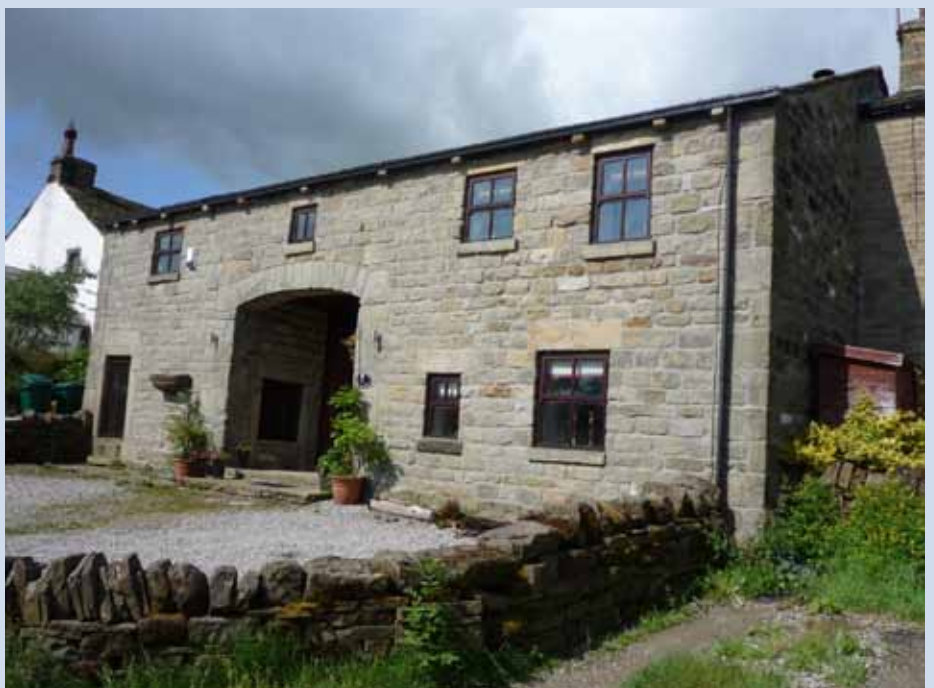
Interesting vernacular feature on  
Ivy House Farm

The existing single storey stable attached to **Ivy House Farm (Grade II listed)** was subject to an application in 2007 to be converted into part of the dwelling house with the addition of a pitched roof. The previous extension (which may have originally been a cottage attached to the farmhouse) had been altered over the years and the odd arrangement of windows and flat roof failed to enhance the conservation area or the setting of the listed building. The permission has since been implemented and the building compliments the special character of the adjoining listed building.

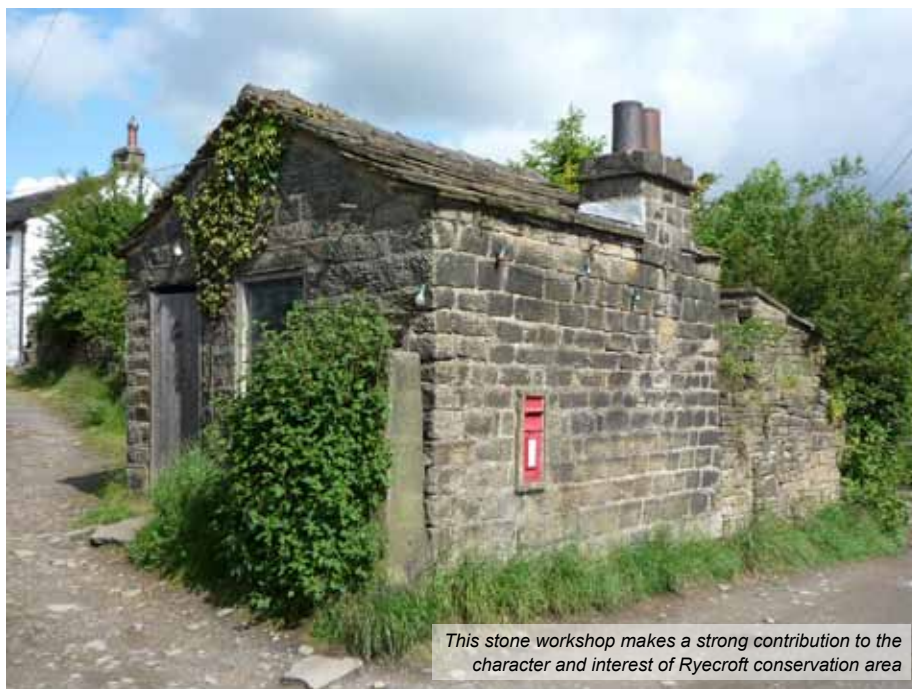
*This stone workshop makes a strong contribution to the character and interest of Ryecroft conservation area*

- **25 Ryecroft** – however builders appear to be preparing the property for sale and therefore the building is likely to be in use again shortly.
- **The workshop to the north of 5 Ryecroft** is vacant but appears to be used for storage and is in reasonable condition so not of concern at this point in time.
- The characterful **red telephone box** at the entrance to the hamlet has been removed due to vandalism.

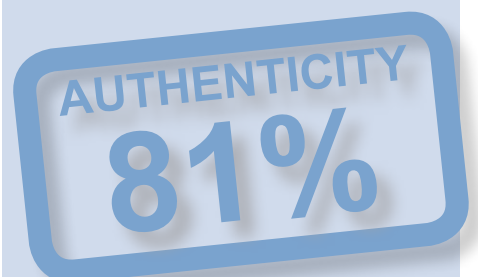
A breakdown of the authenticity assessment shows which features and details in particular are being retained and/or maintained and where there are the greatest threats.

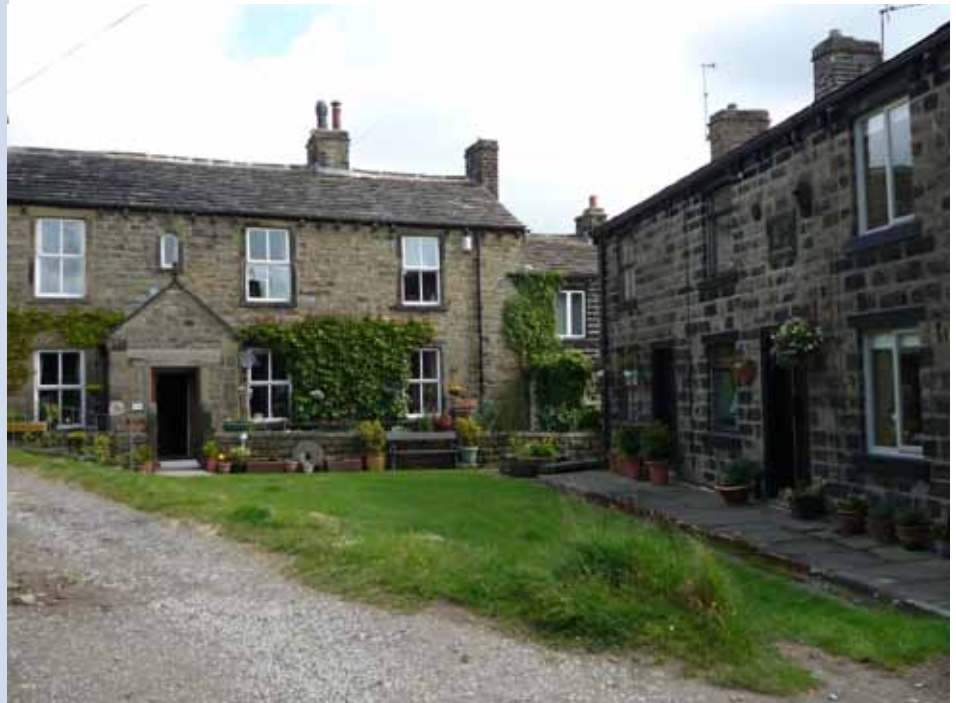
*19th century cottages around the 'green'*

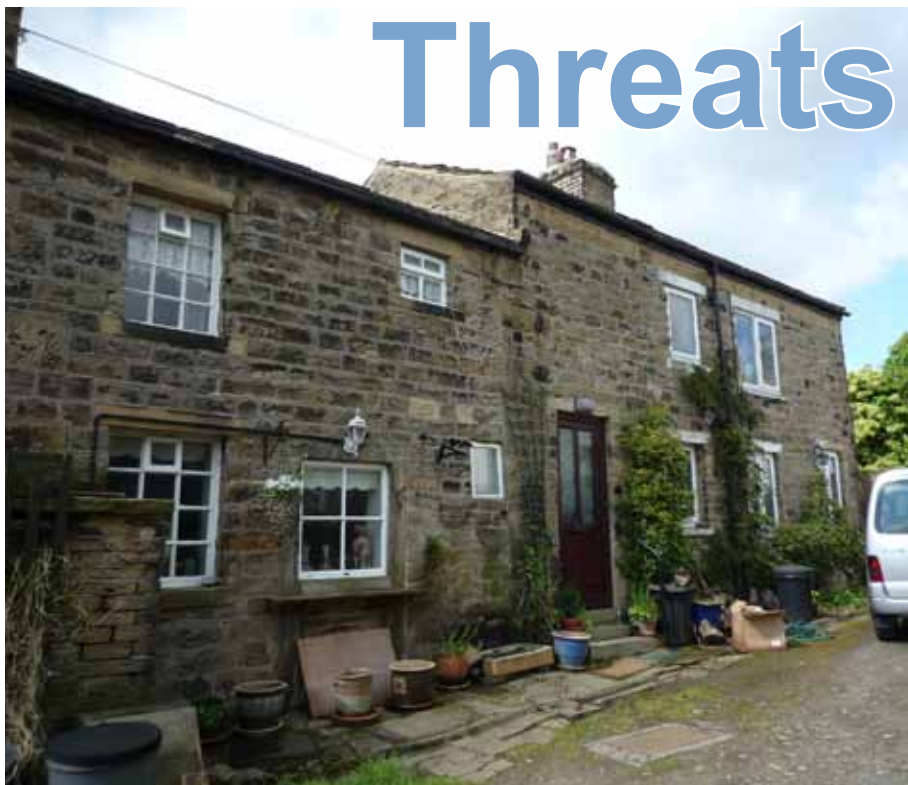
*Rear elevations of 5 - 9 Ryecroft demonstrate some loss of traditional details*

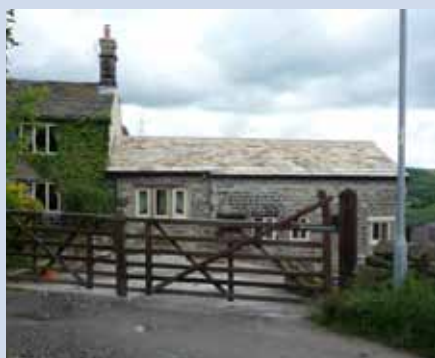
**POSITIVE CHANGE**

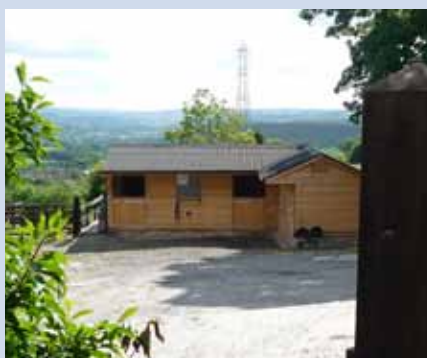
A timber stables and manege have been constructed in the yard of **Ivy House Farm**, a short distance to the southeast of the listed building. The stables are of timber construction and take the form of an 'L' shape. They are set down and away from the building and do not impact on views down the lane towards the farmhouse. The stables are therefore considered to have a neutral impact on the character and appearance of the conservation area.

**NEUTRAL CHANGE**

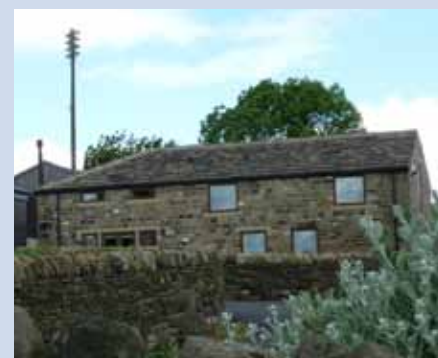
The former barn at **Well House Farm** has been converted into residential use. The barn had been subject to previous applications for its conversion but has only recently been implemented. The demolition of two modern farm buildings that previously stood in front of the barn has been undertaken to facilitate its conversion. Whilst the removal of the farm buildings was a positive step the conversion has not been particularly sympathetic to the character of the agricultural building and the style of openings are more suburban in character than agricultural.

**NEUTRAL CHANGE**

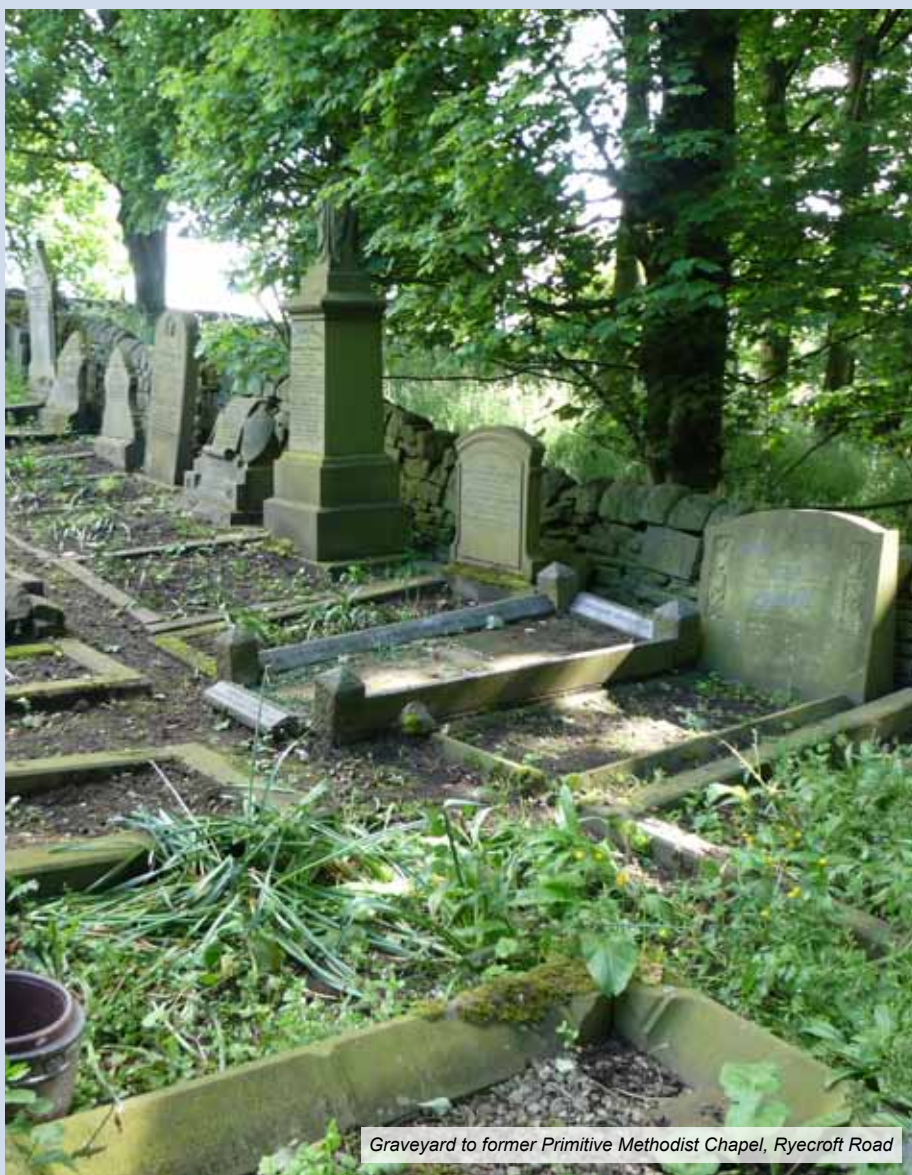
Since the last assessment was written the **graveyard on Ryecroft Road** has been cleared of overgrown vegetation, a seat installed and some of the leaning gravestones set straight. The graveyard makes a more positive impact on the conservation area due to the hard work put into its maintenance.

POSITIVE CHANGE

Graveyard to former Primitive Methodist Chapel, Ryecroft Road

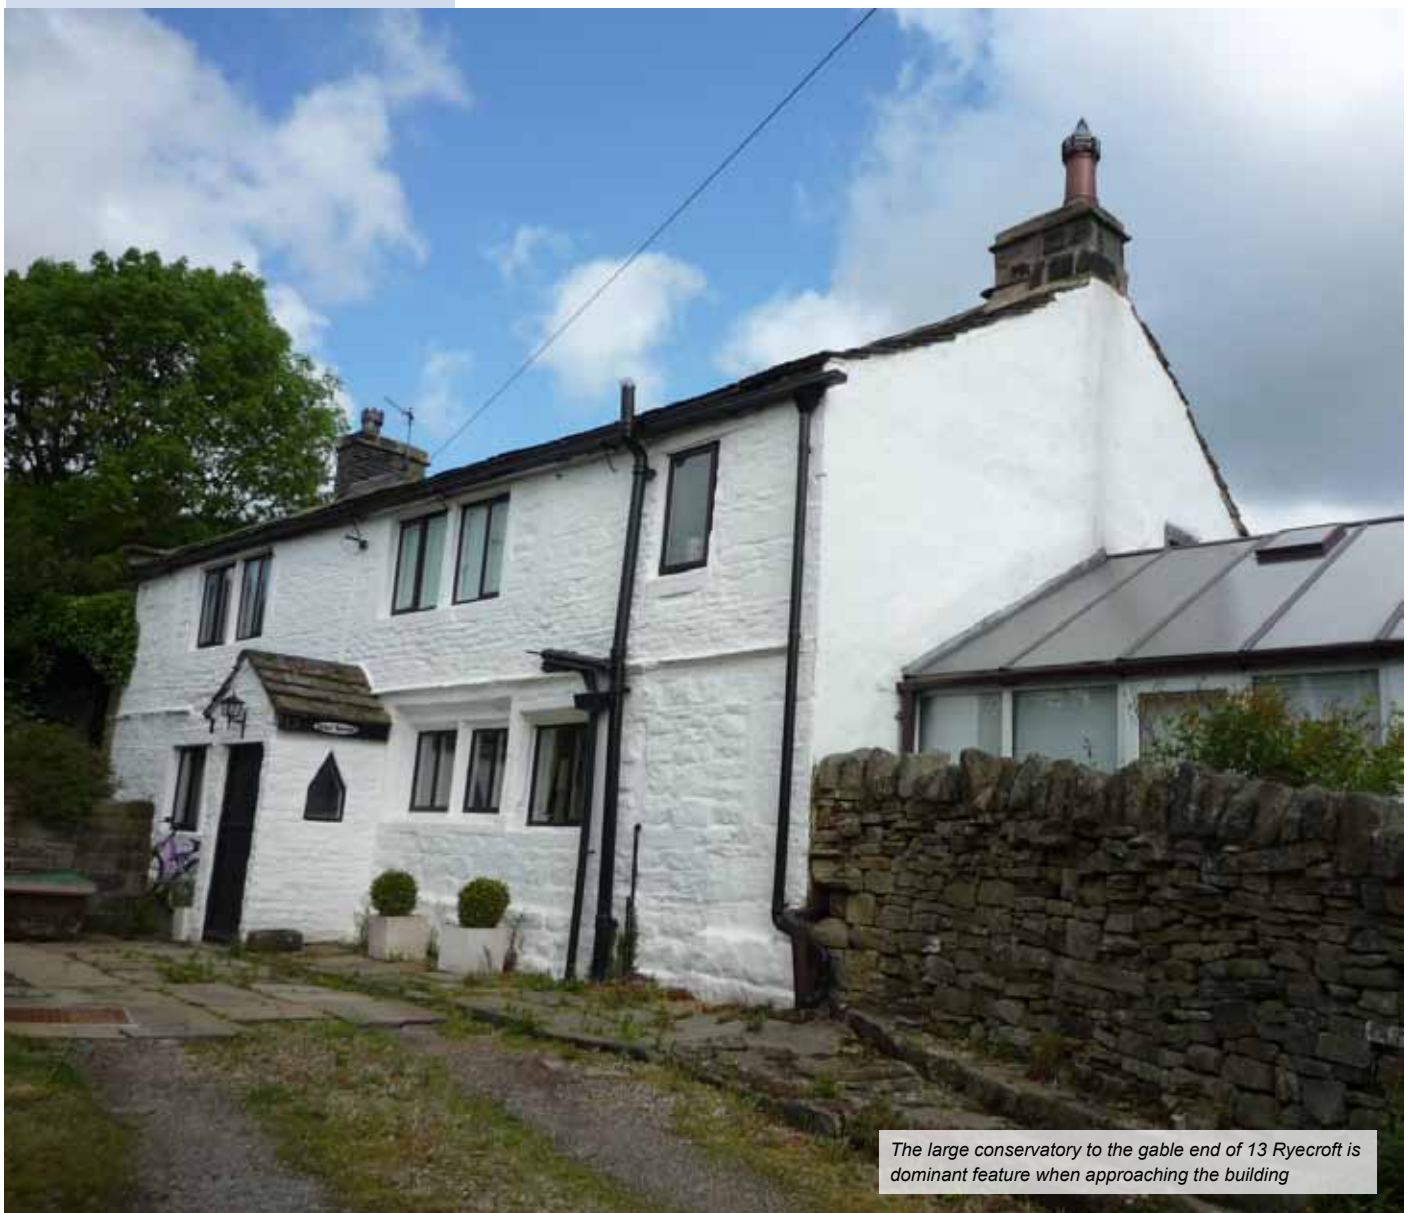
*The large conservatory to the gable end of 13 Ryecroft is dominant feature when approaching the building*
