Conservation Area Appraisal

Thornton

December 2006

City of Bradford MDC

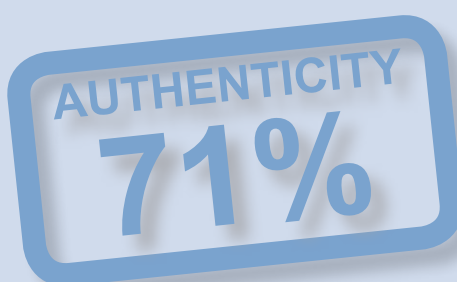
AUTHENTICITY 71%

A breakdown of the authenticity assessment shows which features and details in particular are being retained and/or maintained and where there are the greatest threats.

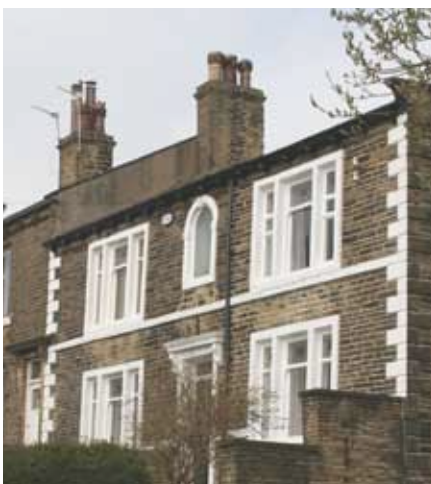
Left: Painting of stonework undermines the historic character of a conservation area.

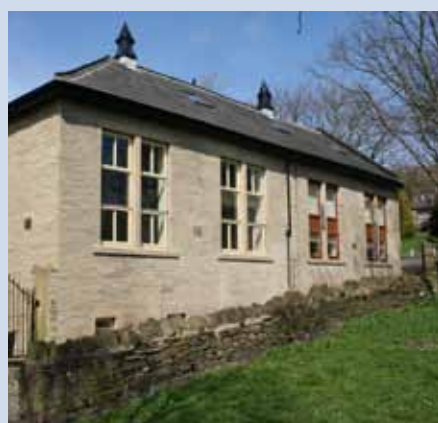
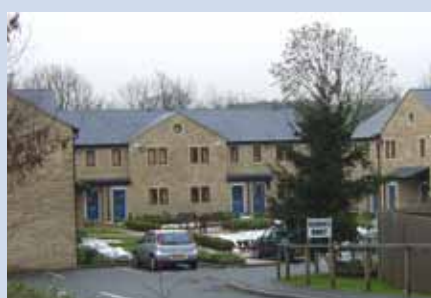
The former Church School at Market Street / Havelock Square has been converted to flats and re-named **Ellingham Court**, with a pair of semi detached houses built in the former school grounds. The conversion is generally appropriately detailed and the new build is stone built. The brown uPVC replacement glazing and panelling to some of the dwellings is a jarring feature.

POSITIVE / NEUTRAL CHANGE

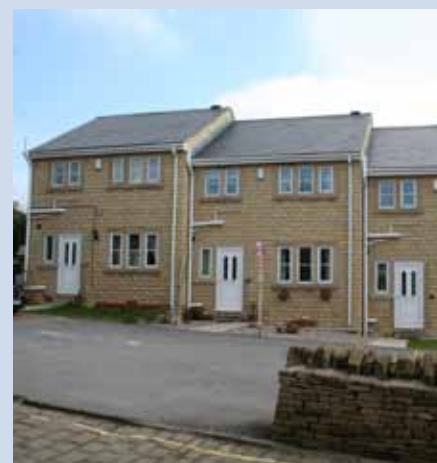
The terrace of three houses at **14-18 Sappgate Lane** was completed c.2004. The houses are built from artificial stone with slate roofs and uPVC windows and are fronted by an open area of parking.

NEGATIVE CHANGE

LESSON: Decision makers should consider the character of the conservation area when determining planning applications. Here the inappropriate materials, detailing and site layout have introduced an uncharacteristic bland development in one of the strongest parts of the conservation area.

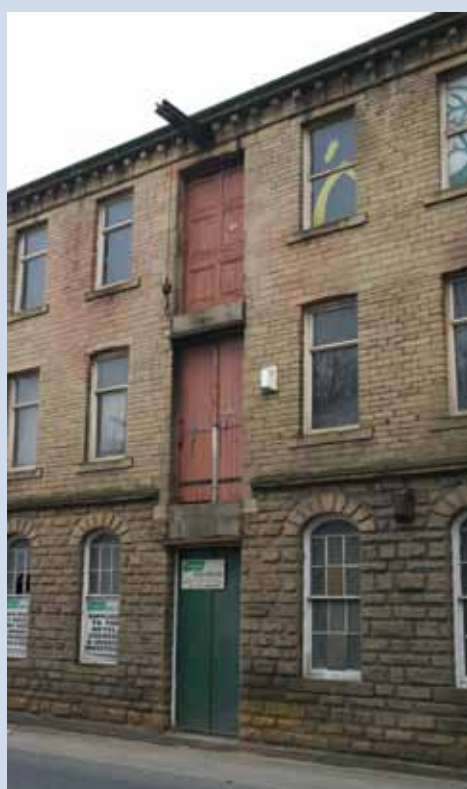
Prospect Mill, Thornton Road

- 5 Bridge Street;
- 1 Market Street / 2 Green Lane;
- 2-4 Market Street;
- 33a Market Street;
- 39 Market Street;
- 46 Market Street;
- Prospect Mills, Thornton Road;
- 482 Thornton Road (shop unit only).

The prolonged vacancy or underuse of these buildings makes their longer term future uncertain, and presents an atmosphere of neglect in the place. The conservation area would benefit if these buildings were returned to use.
