Conservation Area Appraisal

Undercliffe

May 2010

City of Bradford MDC

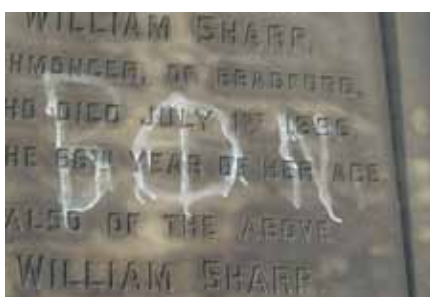
Above: Graffiti is an ongoing problem and is regularly cleaned from monuments

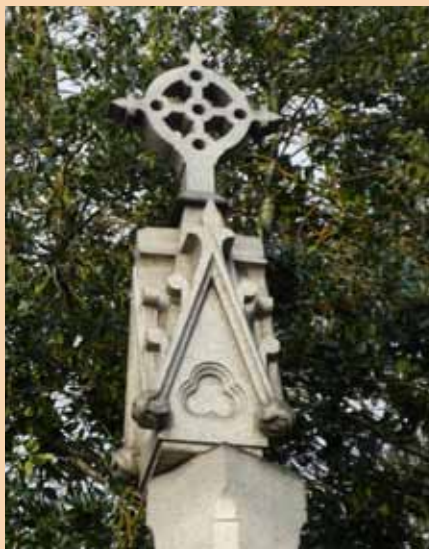
The pinnacle of this monument, located at the eastern end of the main promenade, needs to be re-fixed. The work will cost approximately £2,000.

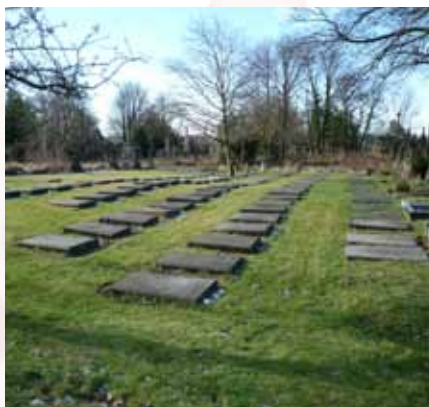
The Quaker Monuments, within the southeast section of the cemetery, would soon become hidden by vegetation without regular maintenance

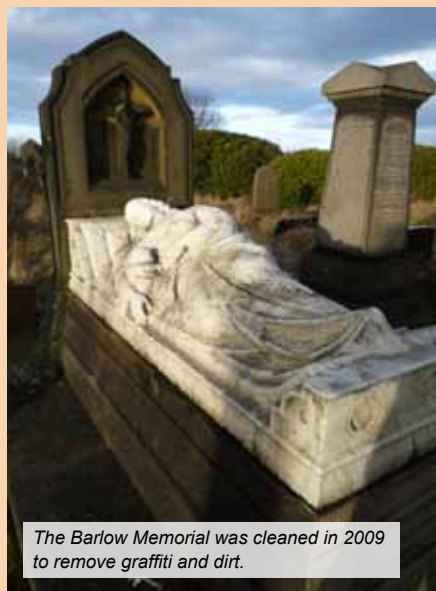
No significant repairs have been done to historical monuments. However, approximately 30 monuments have been cleaned each year to remove graffiti and a lesser number are cleaned to remove accumulations of dirt.

The Barlow Memorial was cleaned in 2009 to remove graffiti and dirt.

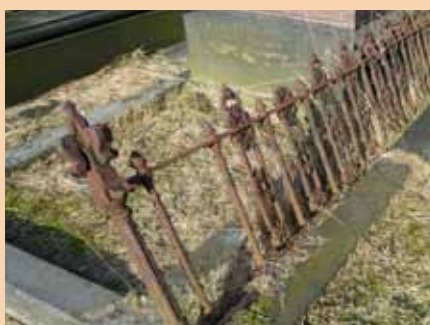
Due to weathering and small scale vandalism a number of monuments, including some along the main promenade and within the historic core, have deteriorated over recent years and require remedial work to secure their future.

Left: Many of the iron railings are missing from monuments or are in need of restoration.

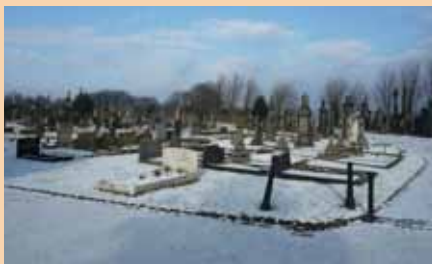
Section A consecrated (adjacent to Lodge) has been cleared and is now regularly maintained.

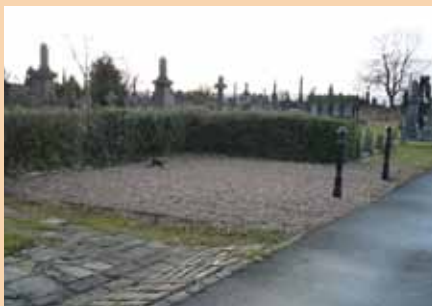
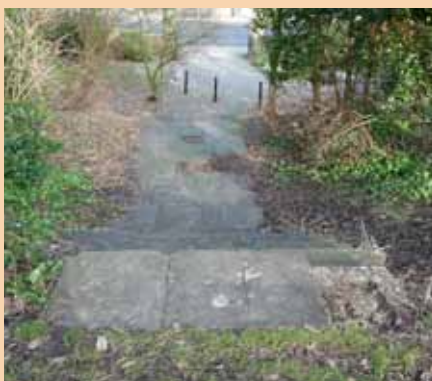
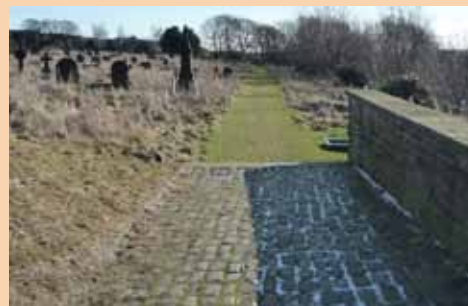
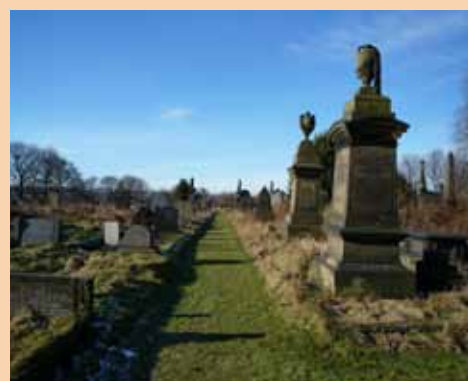
An area of flags adjacent to the site of the former Consecrated Chapel have been stolen and replaced with gravel as an interim measure.

Some of the Yorkshire stone flags have been stolen from the steps opposite the Otley Road entrance.

Some cobbles to the viewing platform at the end of the main promenade have come loose.

Clockwise from top left: Stolen flags have been replaced with gravel as an interim measure.

These cobbles require maintenance.

Well maintained grass path.

Stone flags have been stolen from these steps.

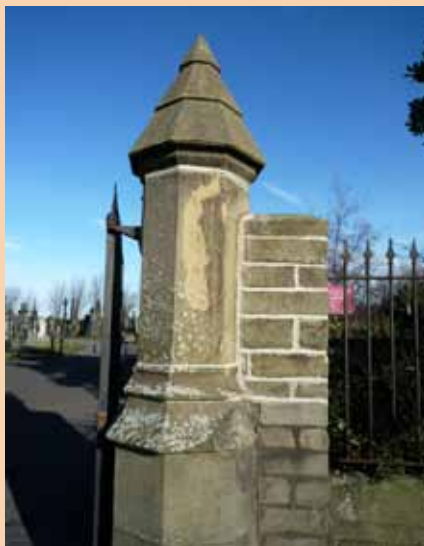
The gates and piers to the Undercliffe Lane entrance were damaged during an attempted burglary but have now been repaired by the Council's Highway Department.

Left: Repaired gate pier to Undercliffe Lane entrance.

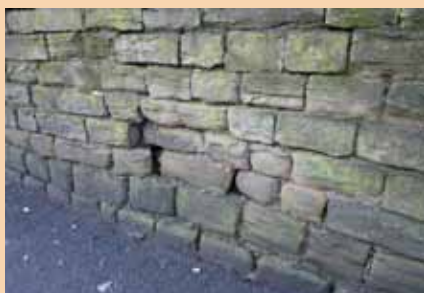
A section of wall close to the junction of Undercliffe Lane with Newlands Place has been weakened by a car accident, repairs have not yet been made.

Below left: Perimeter wall damaged by car accident close to junction of Undercliffe Lane with newlands Place.

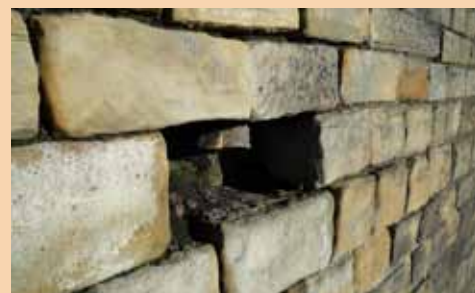
Many sections of the perimeter walls require numerous small scale repairs, including the replacement of missing stones and extensive re-pointing.

Below: Missing stone block from perimeter wall.

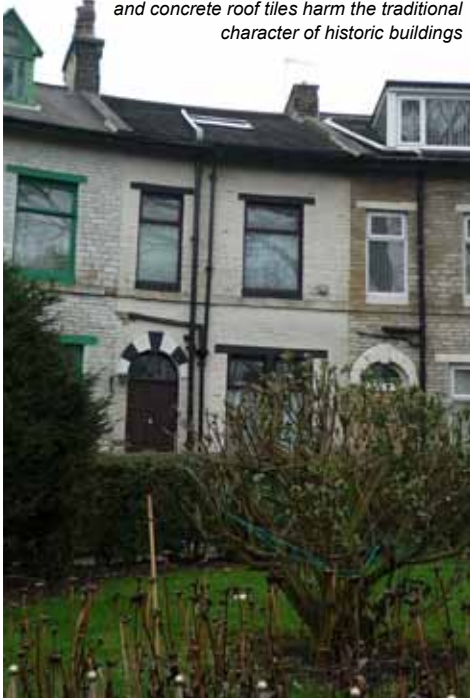
Stone painting, modern dormer windows and concrete roof tiles harm the traditional character of historic buildings

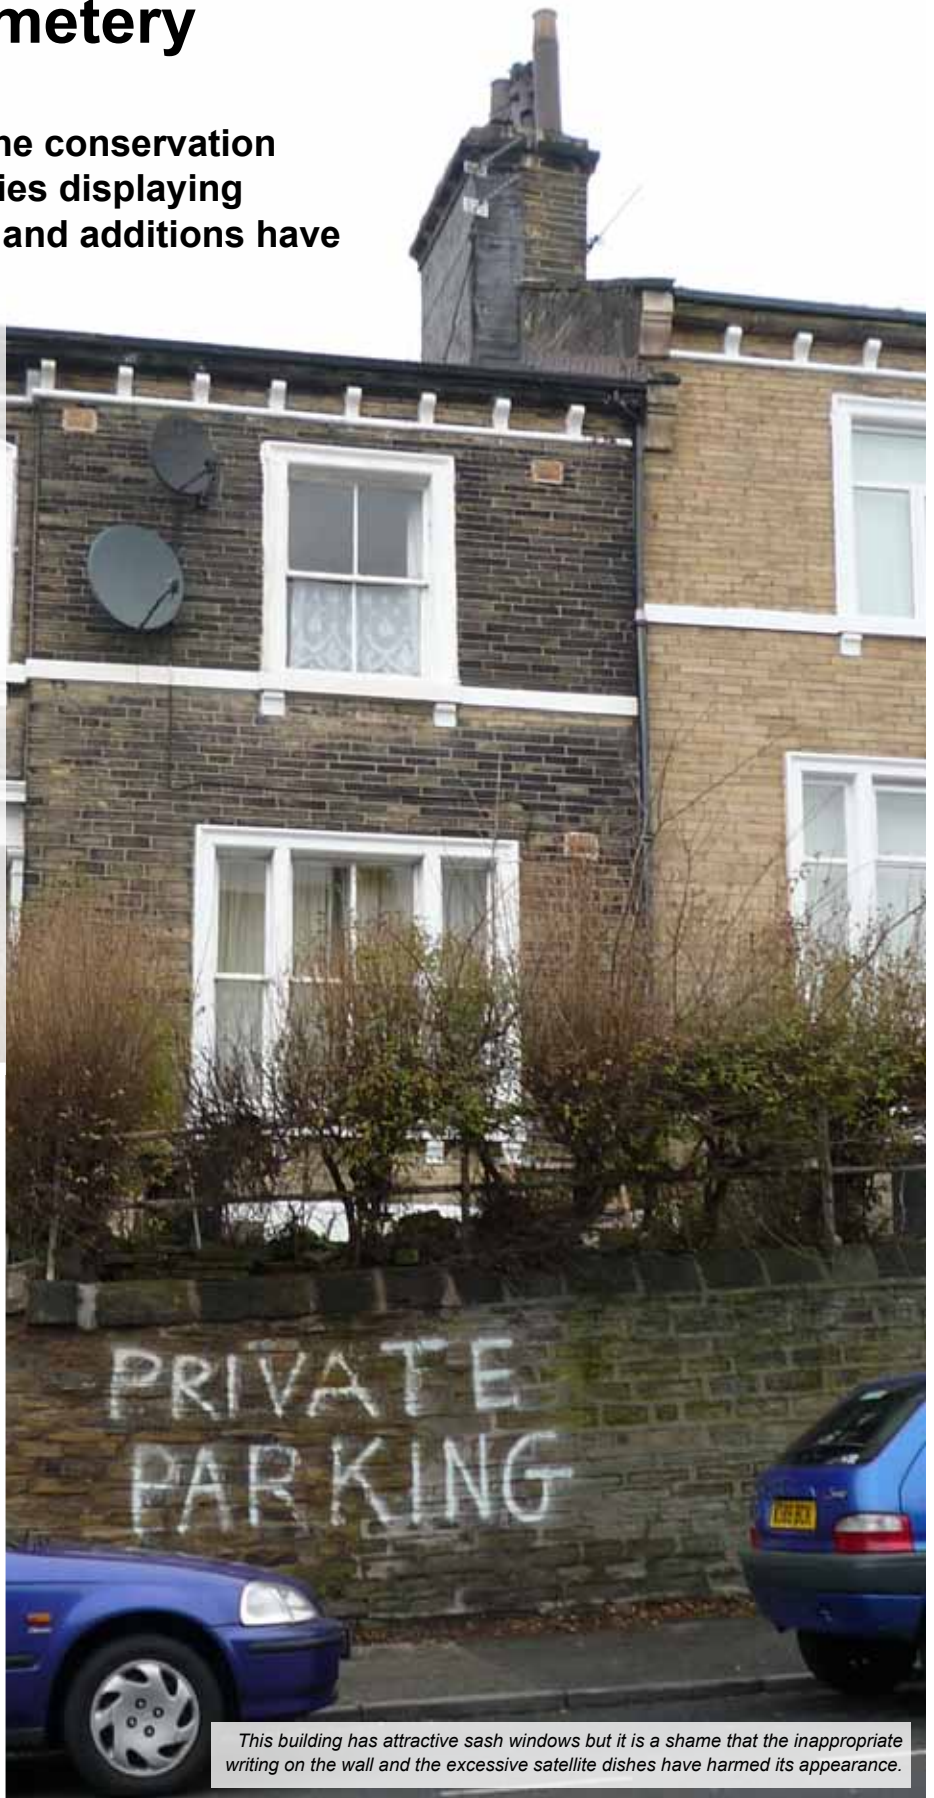
This building has attractive sash windows but it is a shame that the inappropriate writing on the wall and the excessive satellite dishes have harmed its appearance.
