Queensbury Tunnel Study

0451189 | Final v2

April 2021

Highways England - Historical Railways Estate

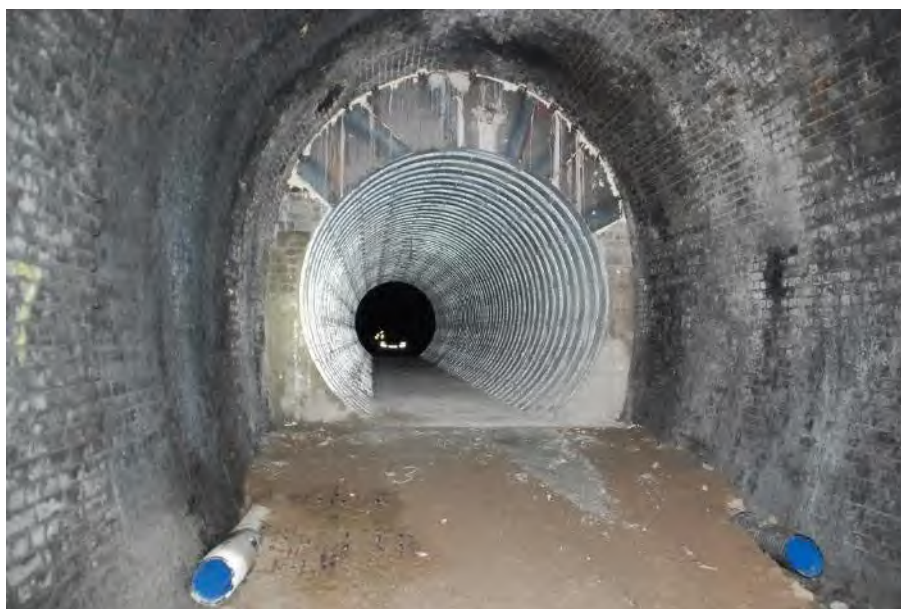
Where there is significant deformation to the profile of the tunnel arch, a spray applied concrete lining may not be appropriate. It is therefore proposed to install a corrugated steel pipe within the tunnel. The steel pipe will have a diameter circa 5.0m and the void between the pipe and tunnel will be filled with concrete. See figure below for an example of a corrugated steel pipe installed within a tunnel.

A layer of concrete will be placed in the invert of the pipe to create a level surface. A structural invert may be required, subject to further surveys and analysis. Small ramps will be built up from granular fill at each end of the pipe for access. Exposed concrete faces can be clad with bricks or stone as appropriate. It is proposed to install a corrugated steel pipe at the following locations:

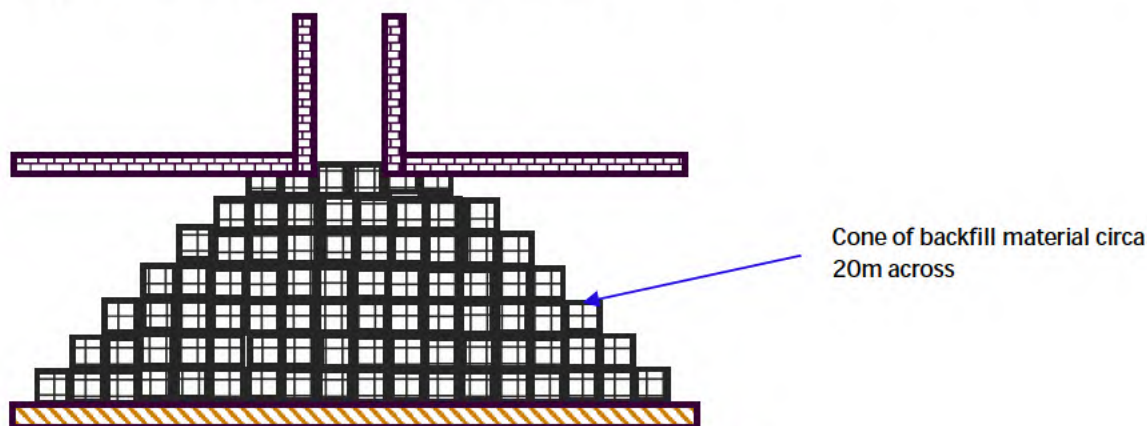
Figure 8: Indicative detail of proposed backfill below Shaft No.3

Therefore, three different options have been identified for the creation of a passage through the backfill. i) creation of a hand mined timber/steel framed heading through the backfill and the creation of an inner tunnel lining. ii) excavation through the backfill with a mini closed-face boring machine or iii) installation of a stitch-drilled steel section reinforced soffit under which an inner lining is formed. All of these options are preceded by a stage to grout and stabilise the baskets as necessary.

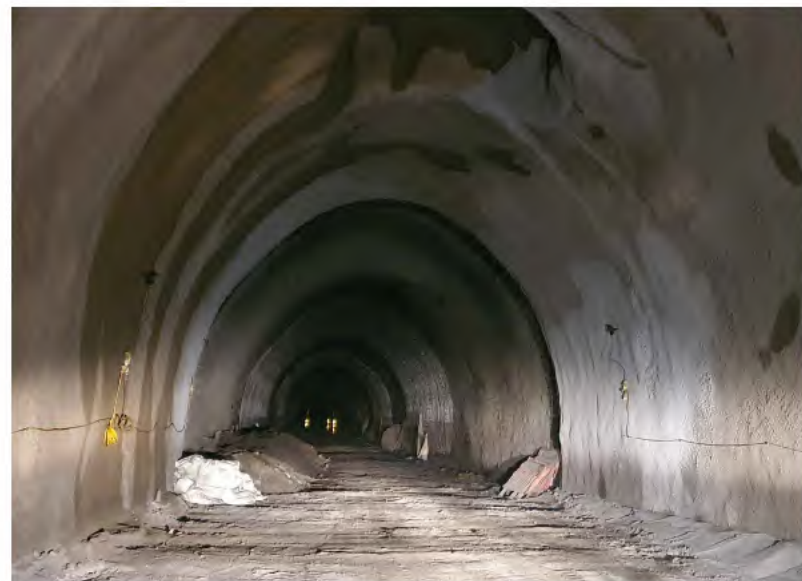
Photo 1: Typical example of spray applied concrete lining at shafts (Shaft 4)

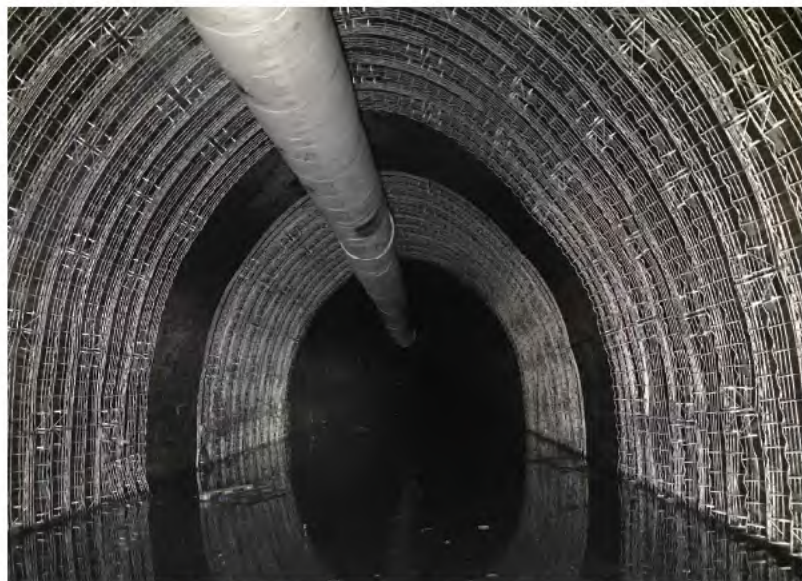
Photo 2: Example of Ramarch (between markers 99 and 100 shown)

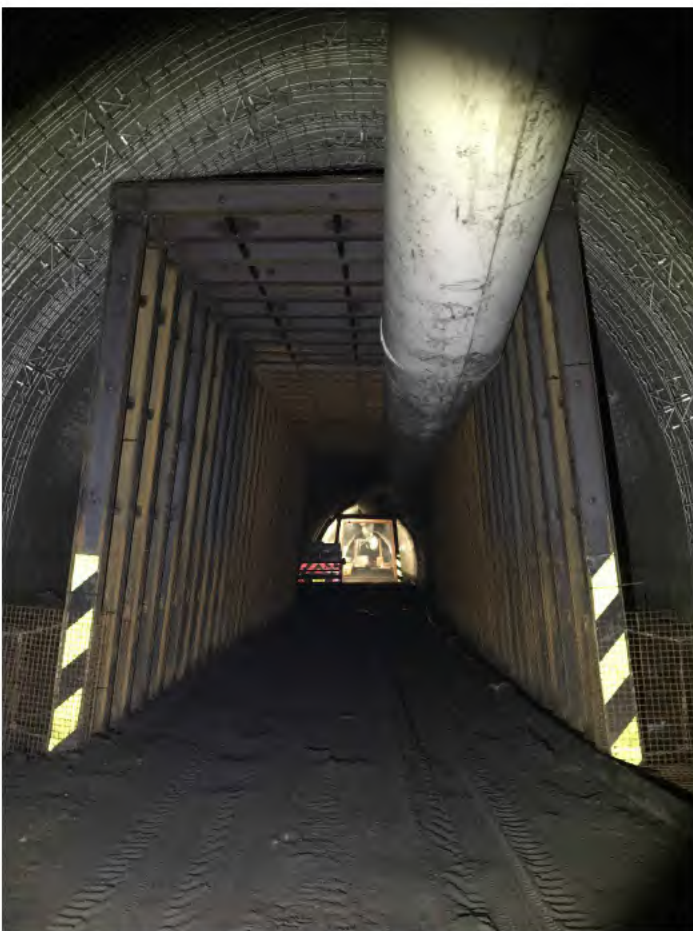
Photo 3: Example of Colliery Arches

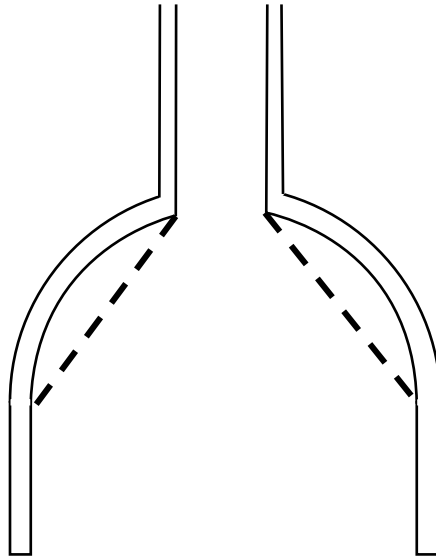
The general agreement is that the angle of repose for crushed stone granular fill with medium to low flow properties is  $45^\circ$ . With this in mind we can assume that the fill at shaft 2 will have an appearance similar to that shown in fig1+2 below:

Figure 1: Cross section of tunnel showing base of fill at full width of tunnel but not filling the haunches

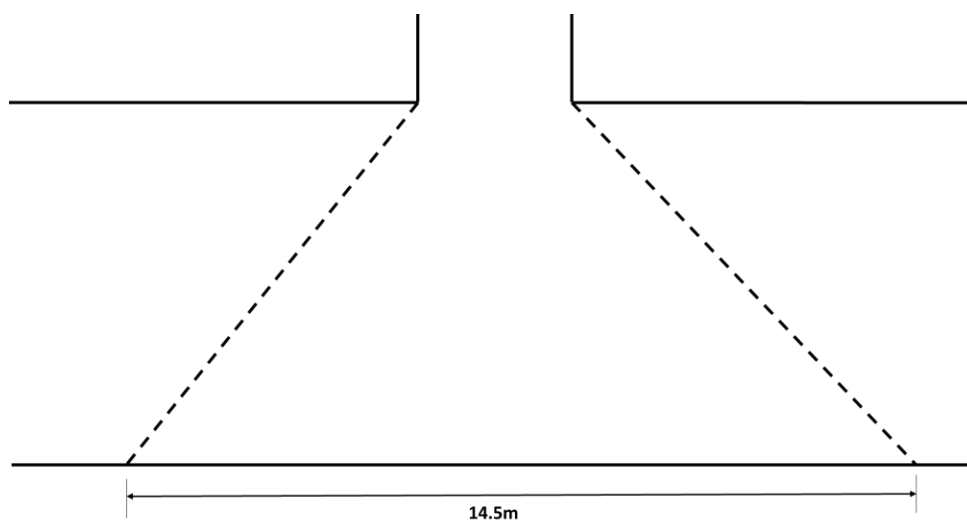
Figure 2: Longitudinal section of tunnel showing base of the fill extending to approximately 14.5m along the tunnel based on an angle of repose of  $45^\circ$  and a shaft diameter of 2.5m
