# Bradford Initial assessment report

## Esholt

### September 2016

Yorkshire Area Initial Assessment:  
Esholt

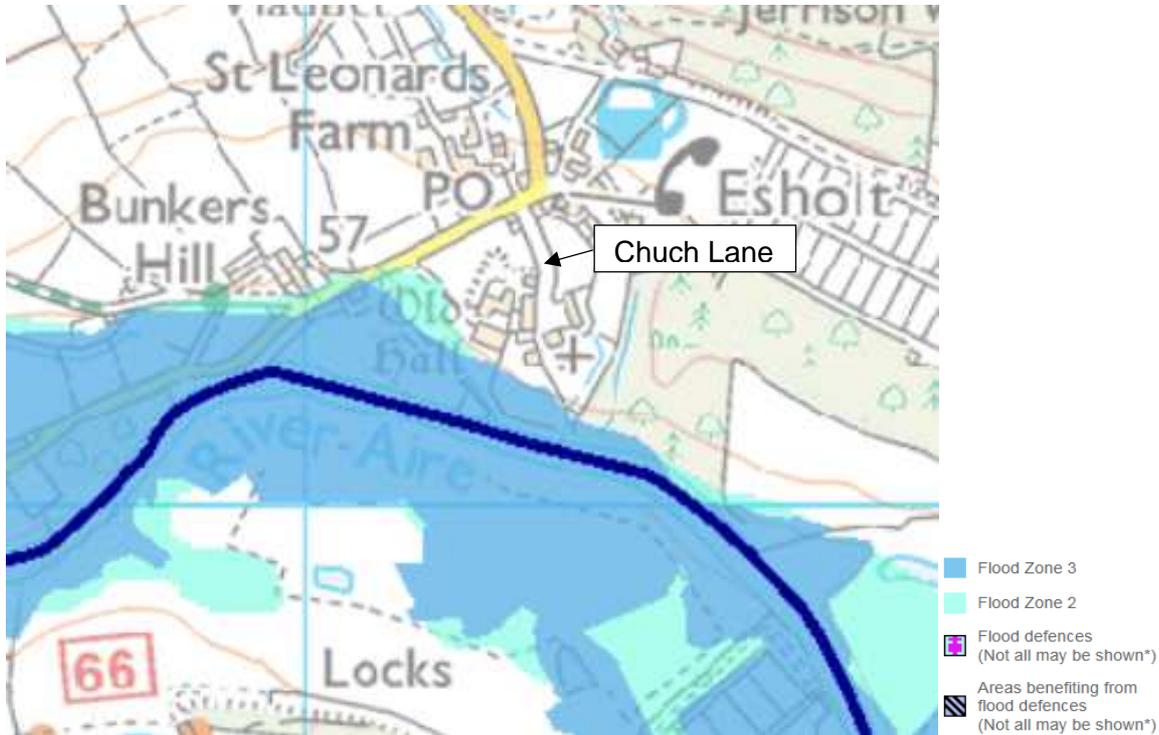
Figure 1 – Flood Map for Planning (Rivers and Sea)

Church Lane and the majority of properties within the village are located in Flood Zone 1, see Figure 1. Anecdotal evidence, provided by the EA and BMDC, during the site visit for this initial assessment, suggests the flooding was most likely caused by surface water and drainage related issues. The EA reported that during the event, the River Aire overtopped its banks adjacent to the sports grounds on Esholt Lane. It was not clear if the Aire overtopped its banks further downstream to the south of Church Lane. LiDAR data, obtained through the EA's geostore,

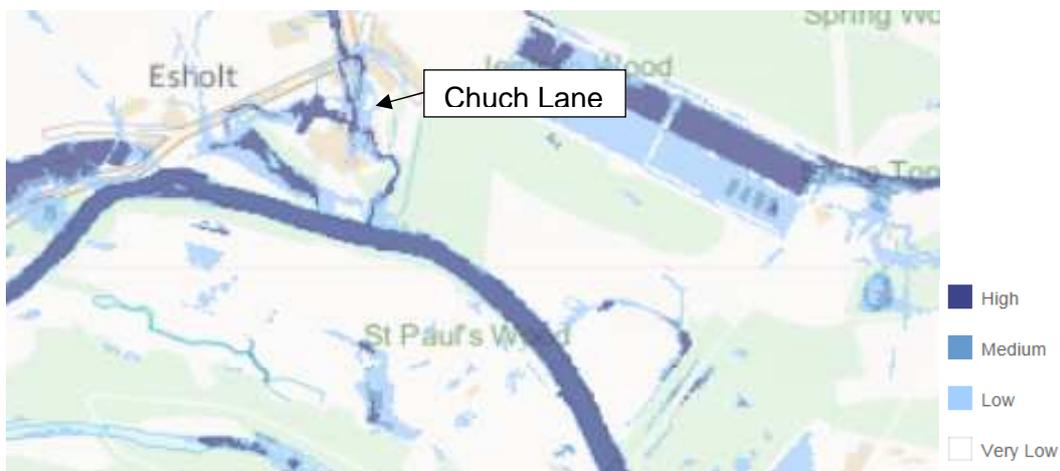
Figure 2 – Risk of Flooding from Surface Water

There are areas of the village designated at high risk of surface water flooding on the EA Risk of Flooding from Surface Water mapping, see Figure 2. The high risk classification means that the study area has a greater than 3.3% (1 in 30) chance of surface water flooding in any given year.
