# **Independent review of Menston flooding problems**

Dr Duncan W Reed

11 December 2014

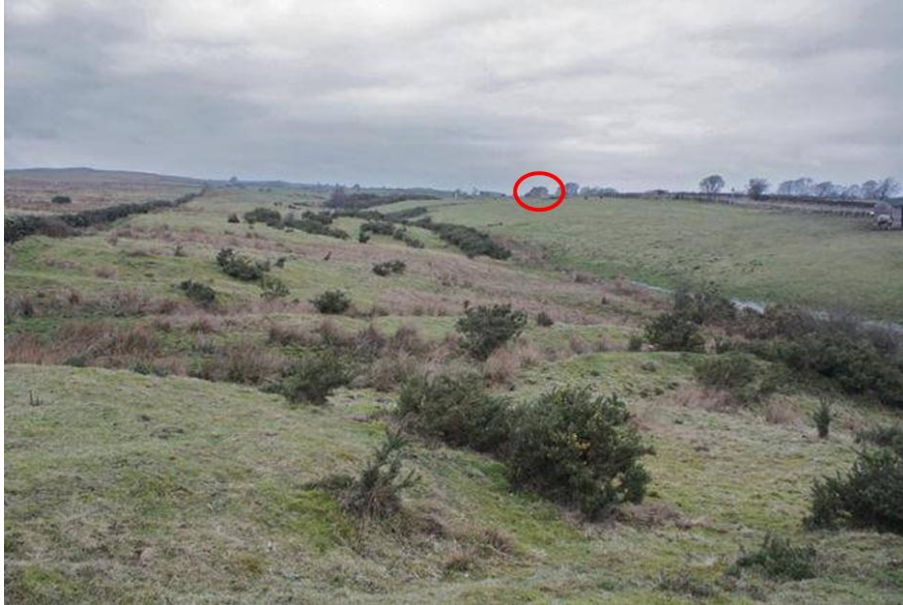
*Photo 3.1: Middle section of Matthew Dike (looking upstream)*

Photo 3.1 (copied from <https://geolocation.ws/v/E/2288806/matthew-dike-menston/en>) provides an excellent view of the incised middle section of Matthew Dike, with “hummocky” a good description of the moorland topography in this area.

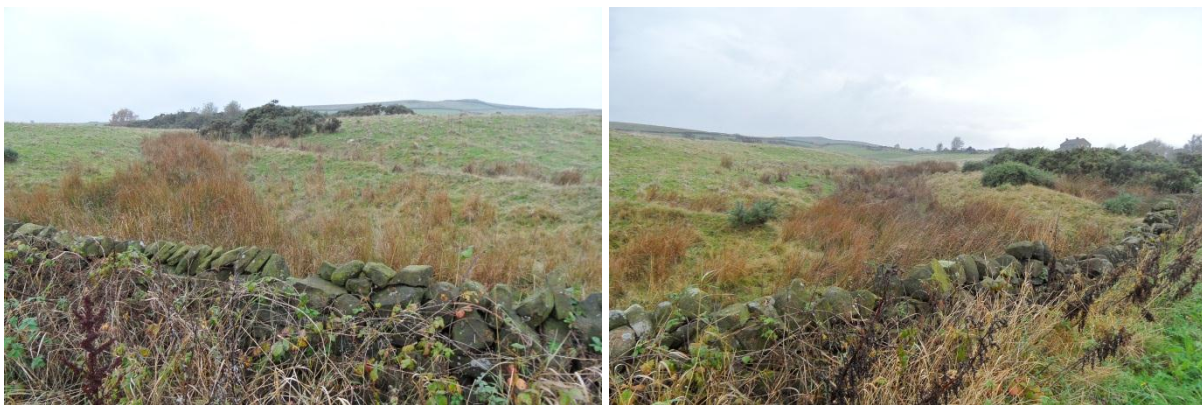
The flooded location is marked as Site H in Photo 3.2. The area upstream is characterised by short and long rush-covered drains descending to Hillings Lane. Views of these from Site H are shown in Photos 3.3, which almost do justice to the near 90° angle between the two arms. I took these fog-free photos during my preliminary site visit on 30 October 2014.

*Photos 3.3: Short and Long drainage arms viewed from their confluence at Site H*

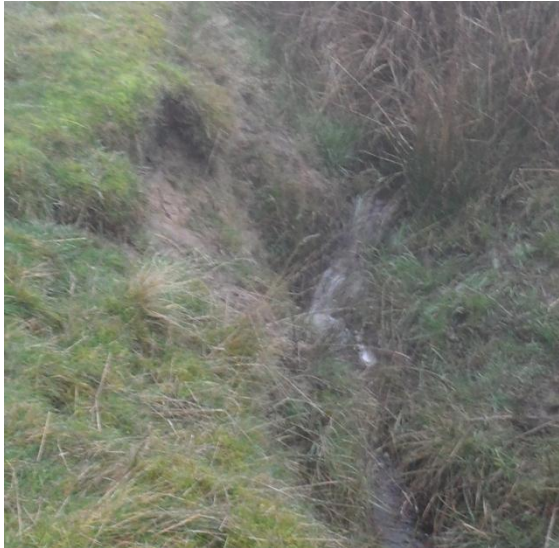
I explored further down Matthew Dike and found the channel to be of modest cross-section. I noticed two small waterfalls (one is shown in Photo 3.4) and then realised that the channel has been dredged relatively recently. CSB marks a concrete slab bridge.

*Photo 3.4: Minor waterfall in dredged section between OSB and CSB*

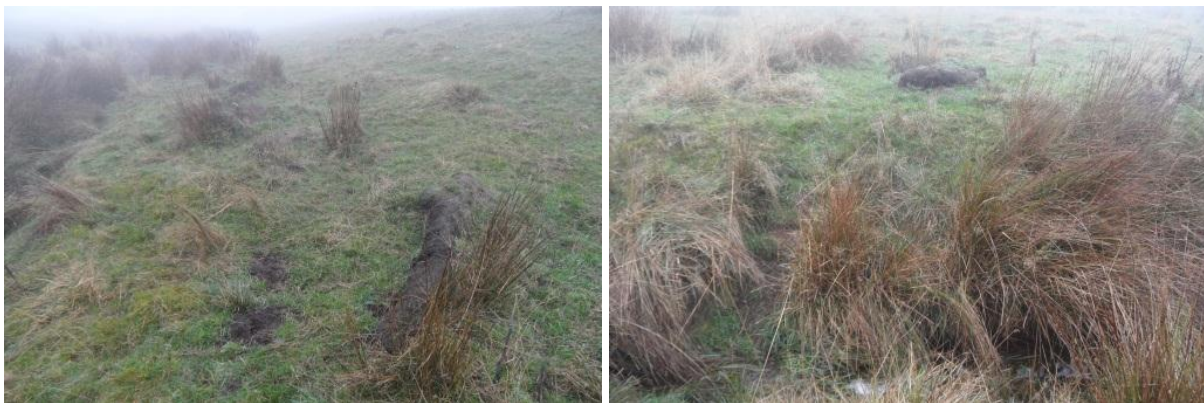
The dredging was evident from excavated “slugs”, with the majority deposited on the SW side of the watercourse. I refer to them as slugs in view of their typical (roughly cylindrical) shape. I do not know a more appropriate term. Photos 3.5 do not show them very clearly.

*Photos 3.5: Excavated “slugs” from Matthew Dike, seen between sites OSB and CSB*

To my untutored eye, the slugs appeared to be of mixed age. Some were almost bare of vegetation while others showed abundant regrowth. I later learned from the Armstrongs that all the dredging had been carried out soon after the September 2012 event, when they realised that Matthew Dike had overflowed. I guess that vegetation is established more on some “slugs” than others because of soil and exposure differences.

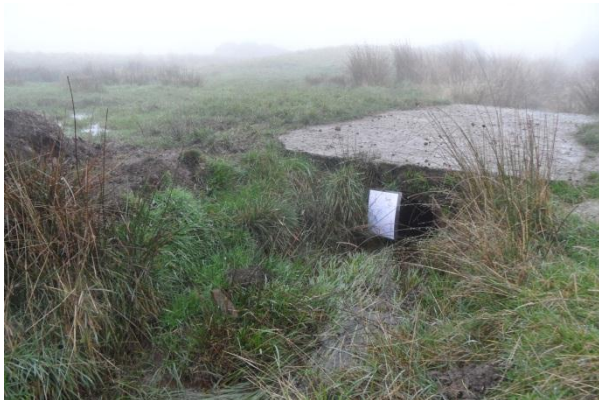
The slugs are somewhat more numerous towards the concrete slab bridge at CSB, seen in Photo 3.6. I judge that Matthew Dike overflowed at (and just upstream of) Site CSB, most likely because of limited capacity or partial blockage of the culvert under the concrete slab.

On this basis, I judge that the excess floodwater reached Site H by the Shorter Arm rather than the Longer Arm.

*Photo 3.6: Concrete slab bridge (CSB) viewed from upstream, with A4 sheet for scale*

It would be illogical to blame the Armstrongs for not routinely digging out Matthew Dike. When a large flood occurs, it will overflow here again. Were Matthew Dike dug deeper it would soon refill with sediment. The longitudinal gradient in this reach is relatively mild, with an average gradient of less than 1:50.

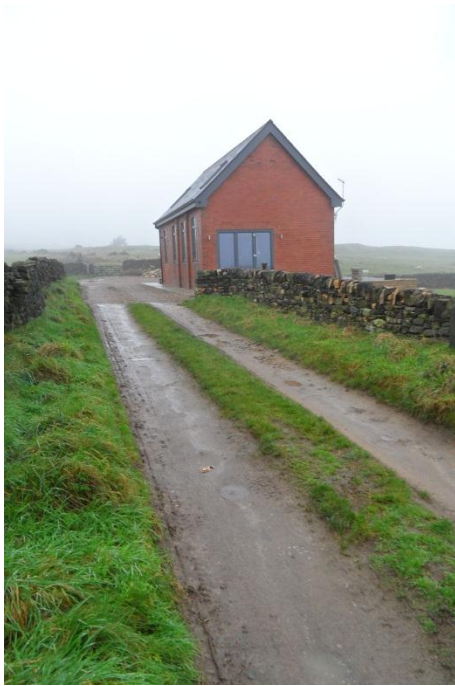
*Photo 3.7: Redeveloped Pump House, Occupation Lane*

The matter concerns the headwaters of Dry Beck which cross Occupation Lane just beyond the newly redeveloped Pump House, seen in Photo 3.7. Field G (referred to above) lies immediately to the left in the photo. Just beyond the gate straight ahead, the headwaters of Dry Beck pass through a culvert under Occupation Lane.

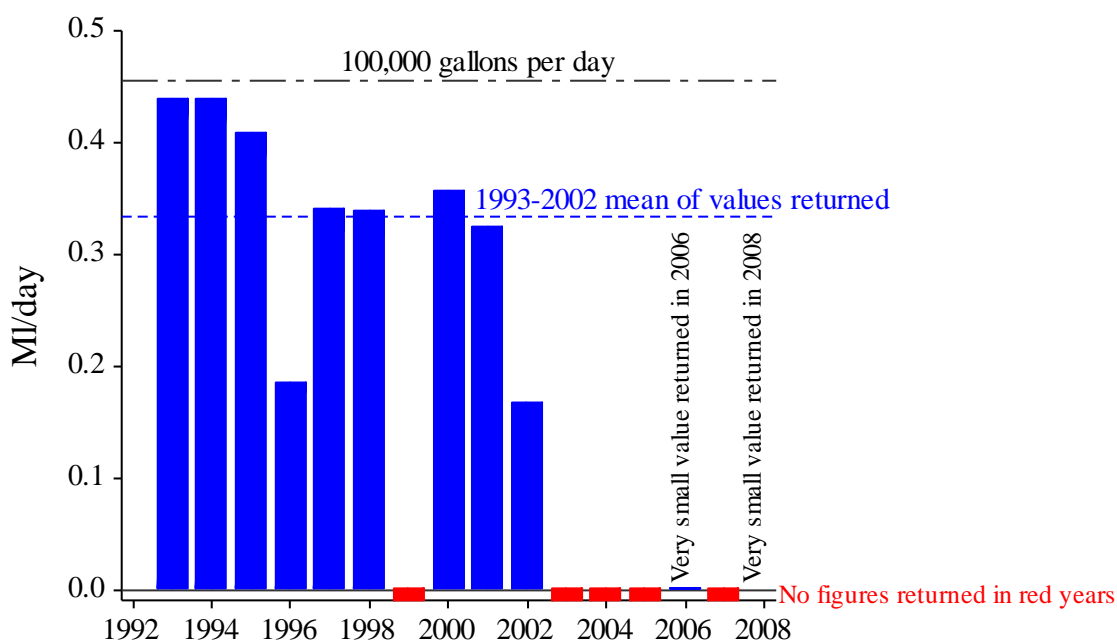
The time series of annual quantities returned is presented in Figure 4.3. These figures were sought from the EA, and handled and supplied as a Freedom Of Information request. The reference value of 100,000 gallons per day shown is the maximum daily abstraction permitted under the licence. [I might instead have marked a reference value of 82,200 gallons per day, which is the maximum annual average abstraction permitted under the licence: terms which the current licence implies have stood since the licence was issued to Leeds Community & Mental Health Authority on 26 June 1993.]

**Figure 4.3: Annual average rates of groundwater abstraction at the HRH borehole**

The average rate of abstraction recorded over 1993-2002 – for which records are almost complete – was 0.333 MI/day. This corresponds to the typical usage expected of say 1650 people at 200 l/head/day: confirming that the abstraction rates are realistic.

According to the statutory returns to the EA shown in Figure 4.3, groundwater abstraction under Licence Serial No. 2/27/19/172 continued until HRH closed in early 2003. Returns for 1999, 2003, 2004 and 2005 are missing. The return for 2002 shows a considerable reduction on the typical quantities returned previously. This appears consistent with running down of HRH prior to its closure in February 2003.

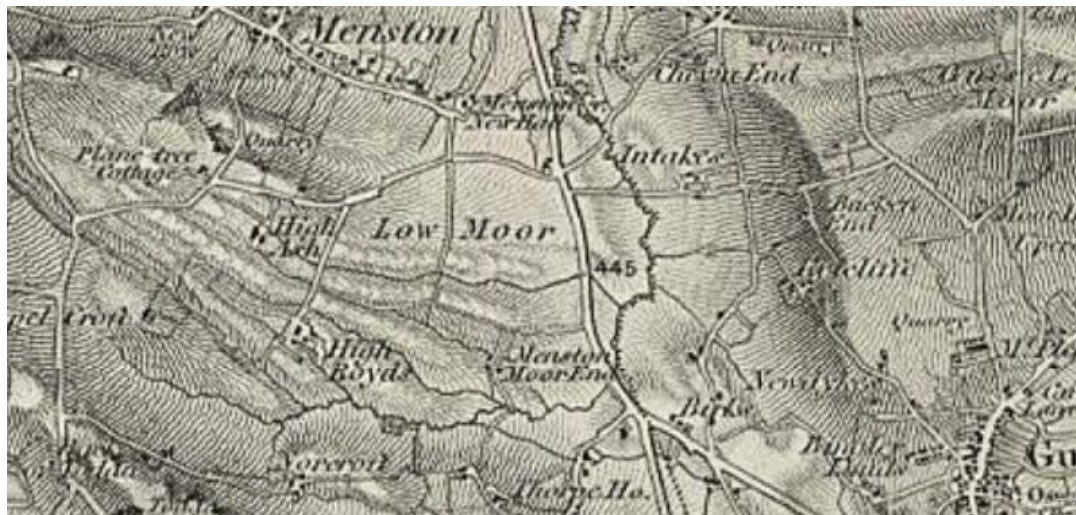
**Map 4.2: OS First Series 1:63360 map, 92 SE – Skipton (1858)**

parallel watercourses running West-East south of Bingley Road and north of High Royds Hall appear on Map 4.2. These watercourses do not appear on the 1:10,560 map of 1906-1907, seen in the Groundsure Report which forms Appendix B to the Sirius C3545 Geoenvironmental Appraisal of the Bingley Road site prepared for Taylor Wimpey UK in December 2009.

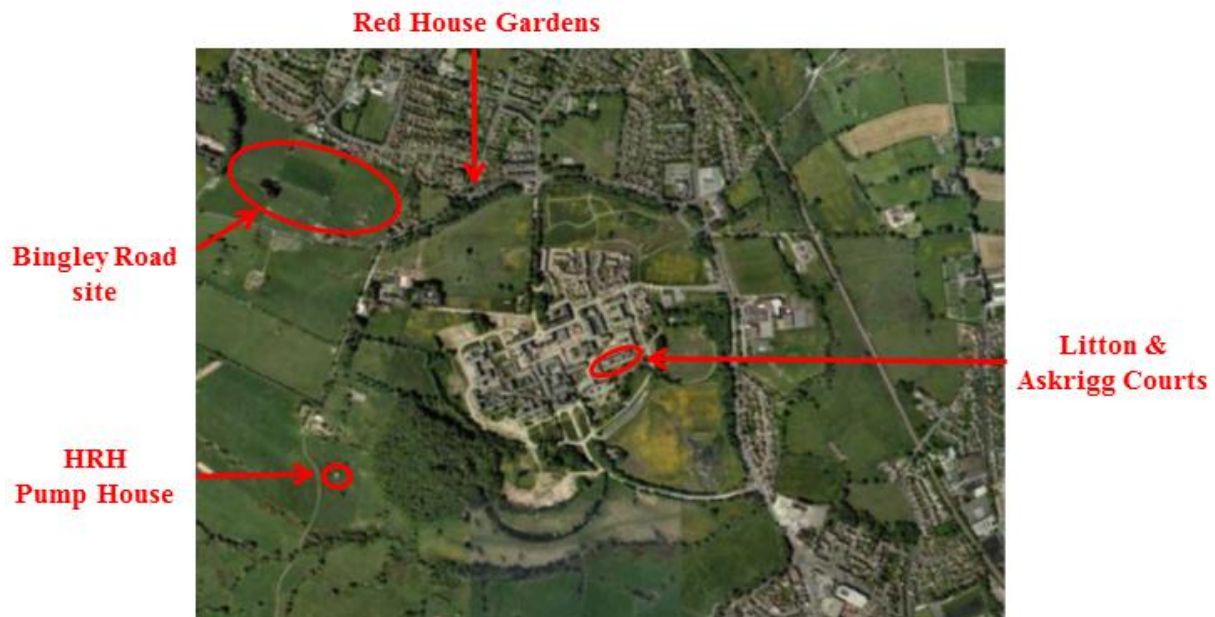
One might argue that saturated ground within the Bingley Road site – not least close to Red House Gardens – is further evidence that spring water is more of a problem than formerly. Red House Gardens lies about 800 metres from the HRH borehole. The Bingley Road site as a whole lies 550 to 875 metres from the borehole. The sites are roughly marked in Photo 4.1.

*Photo 4.1: Aerial view copied from LCC Planning Application 14/05510/FU*

groundwater levels (see Photo 4.1). The significance lies in both the greater spring flows and the wetter soil conditions to be routinely experienced since cessation of the groundwater abstraction.

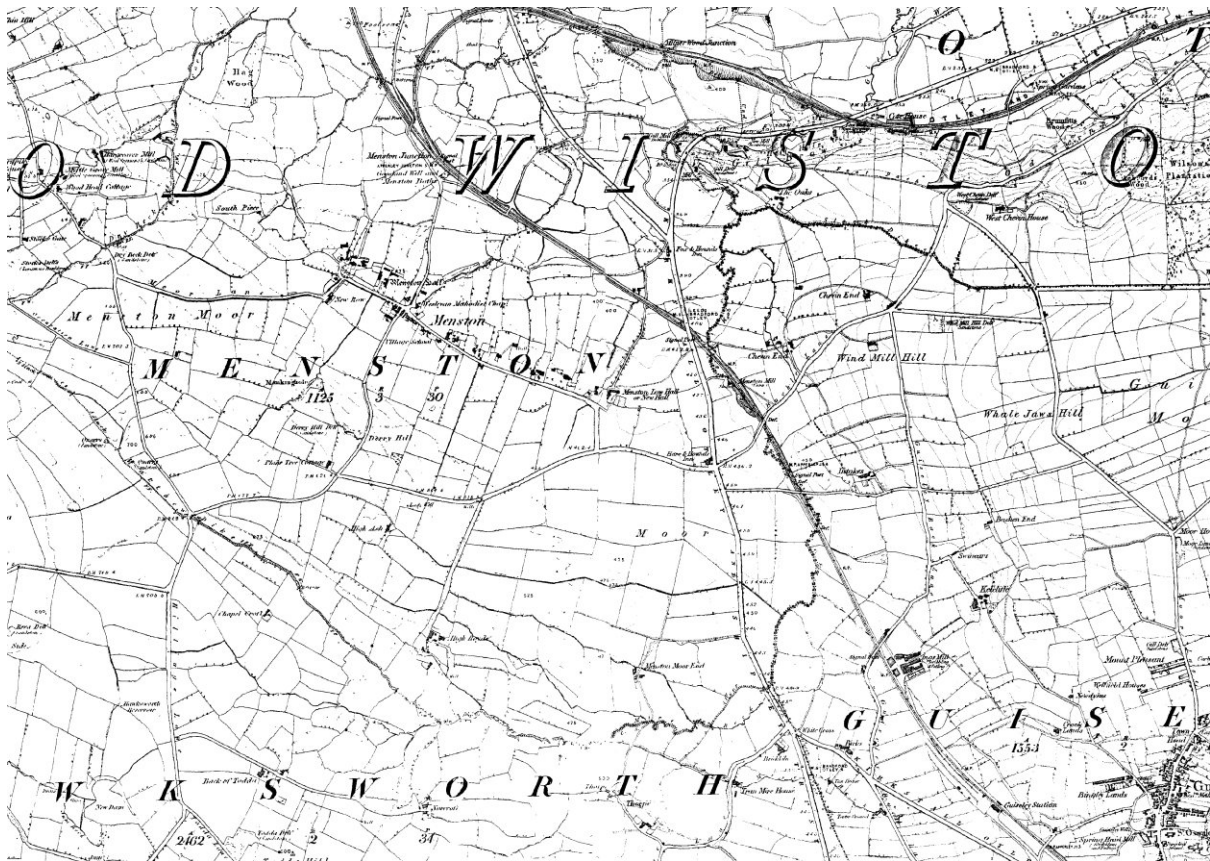
**Map 7.1: OS 1851 1:10,560 map**

The distinctive situation at Menston – in contrast to Burley in Wharfedale, Ben Rhydding and Ilkley – largely reflects the unique configuration of Matthew Dike (see Chapter 3) in intercepting much of the moorland water ... at least most of the time.

Wells just south of Bingley Road are marked Lady Well and Well on the 1851 1:10,560 map (see Map 7.1) but do not appear on the 1906-1907 1:10,560 map cited above. In addition, the well south of High Royds Hall – close to where the HRH groundwater abstraction borehole was sunk – is now marked “Pump House”.

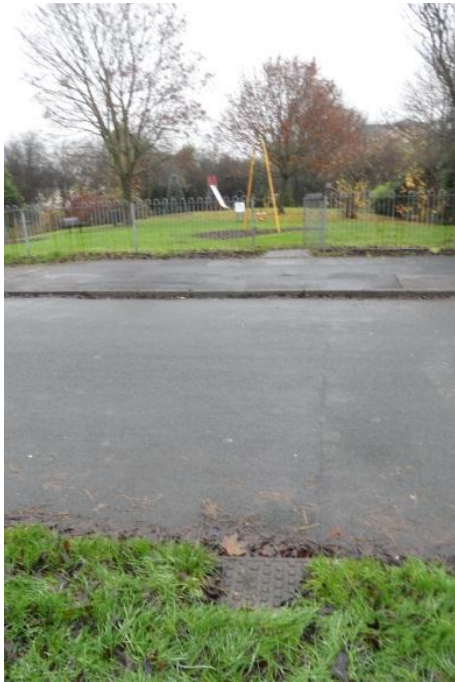
An example I came across by chance is of land on Derry Lane now used for recreation. This has clearly been raised above natural ground levels (see Photo 7.1). The local authority will presumably know whether this was done because the land was too often unacceptably wet or to meet some other amenity, landfill or special purpose.

*Photo 7.1: Playground on north side of Derry Lane*

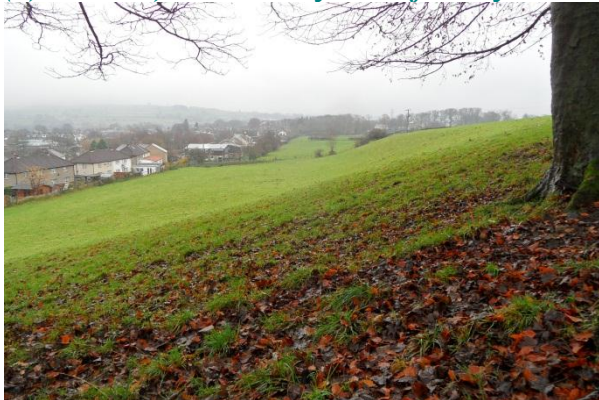
The description (see Box 8.1) of ME/002 as a level area of land is incomprehensible. Immediately east of Derry Hill, the land is steeply sloping (see Figure 8.1a).

*(a) ME/002, immediately east of Derry Hill*

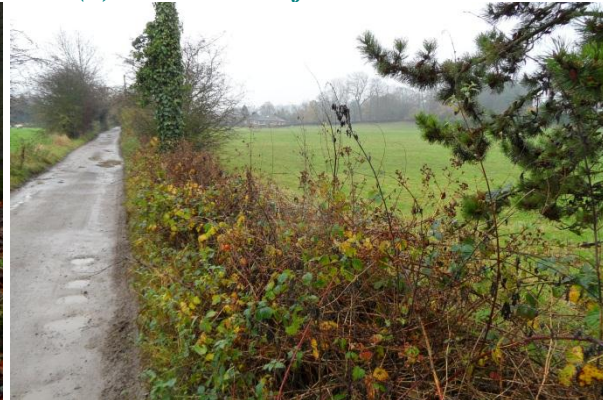
The current designation of ME/008 (land north of Bleach Mill Lane) as unsuitable is understandable, not least given the difficult access via Bleach Mill Lane. However, undesignated land south of Bleach Mill Lane is less steeply graded (see Figure 8.1b) and might be accessible via Moor Lane.

*(b) Land south of Bleach Mill Lane*

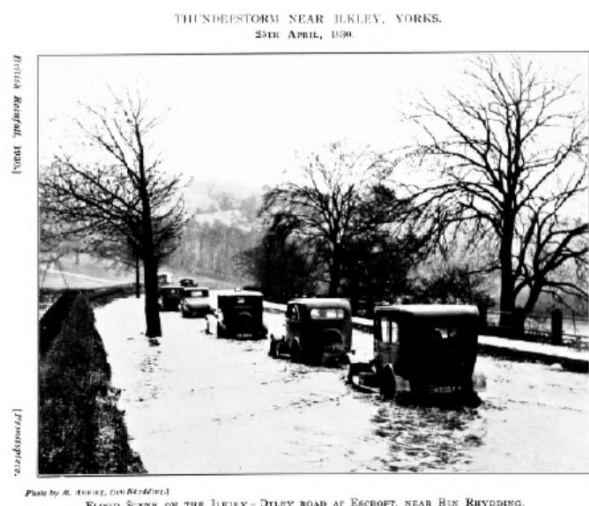
**25 April 1930:** Severe thunderstorm storm in Ilkley reported in *British Rainfall 1930* "...when about 1.84 inches of rain and hail fell in 30 minutes." The raingauge was sited in Ben Rhydding. The Frontispiece to the yearbook shows flooding of the Ilkley-Otley Road "at Escroft, near Ben Rhydding" (see Photo G.1). The correct location is Esscroft, just west of Burley in Wharfedale.

Photo G.1: Flooding at Escroft, just west of Burley in Wharfedale

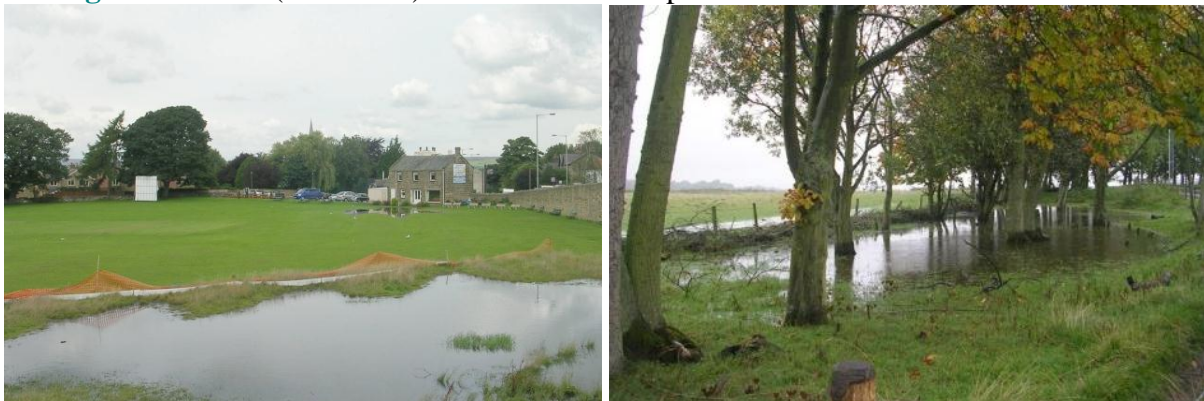
**15 Aug 2008**: Photo (LH below) of flooded cricket pitch at the Fox and Hounds.

**7 Oct 2008**: Photo (RH above) of flooded woodland at Thorpe Lane. Note that tide marks indicate a recent higher depth.
