Conservation Area Appraisal

Eldon Place

November 2007

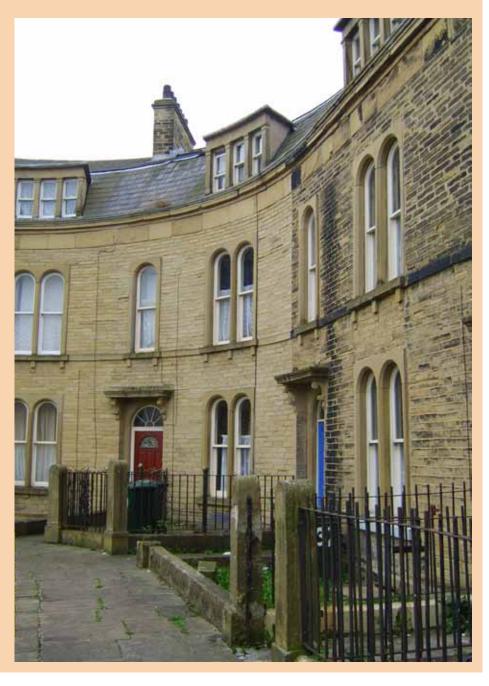
Sweeping curve of traditional terraced houses on Hanover Square.

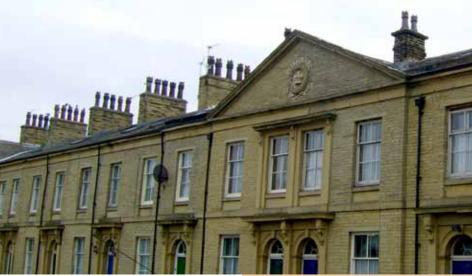
Top right: Good example of a traditional roofscape with unaltered chimneys along Peel Square. Top left: Decorative bargeboards would have been a feature of the area. Above: Retention of traditional features such as sash windows and pillar details along Hallfield Road.

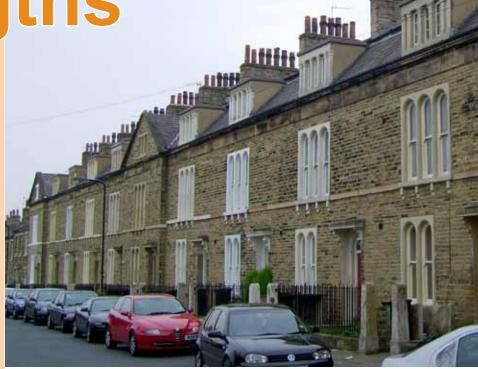
Well detailed buildings along Hanover Square.

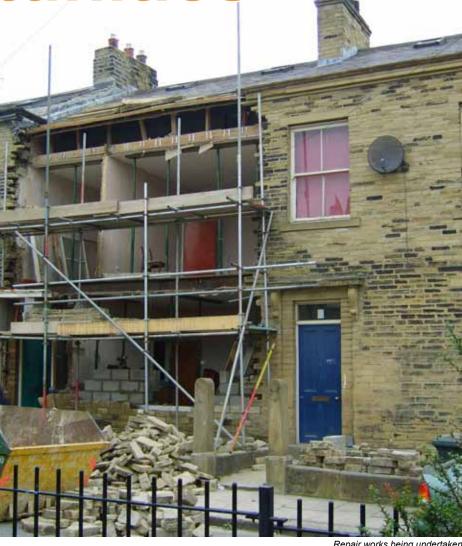
Repair works being undertaken on Hanover Square

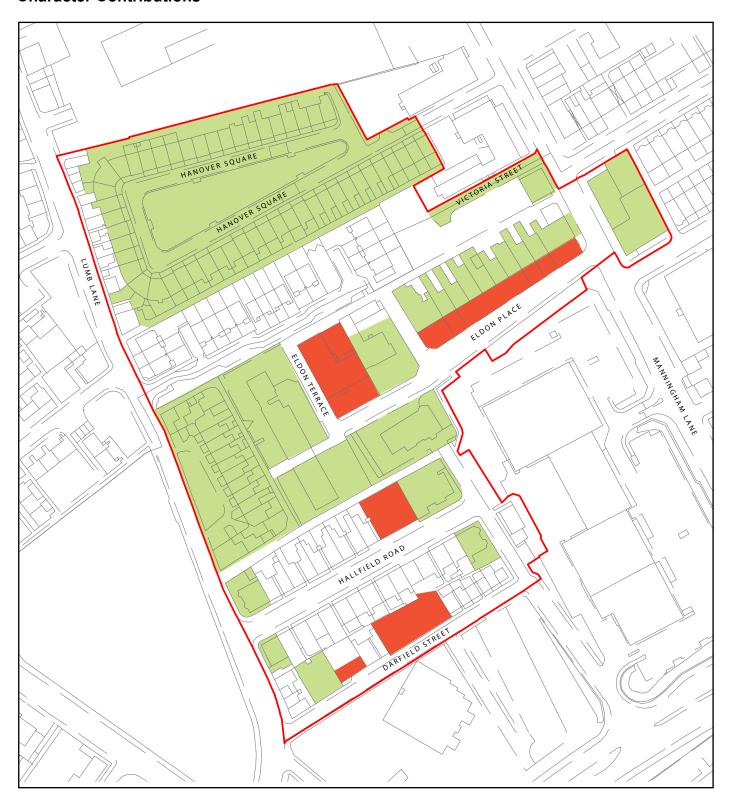
Character Contributions

Areas providing a neutral contribution to character

NB The 'positive', 'negative' and 'neutral' areas relate to the contribution the site/building currently makes to the character of the Conservation Area. The classification in no way means that the site/building has no special architectural, historic or archaelogical interest.

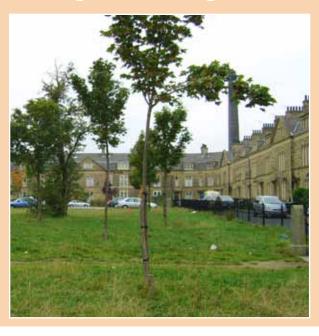
The only significant changes are at Hanover Square where half of the open space has been changed from grassed land to gravel and is now used for a car park.

NEGATIVE CHANGE

LESSON: When alterations are undertaken they should be done so in a sensitive manner to the conservation area.
