Conservation Area Appraisal

North Park Road

November 2007

City of Bradford MDC

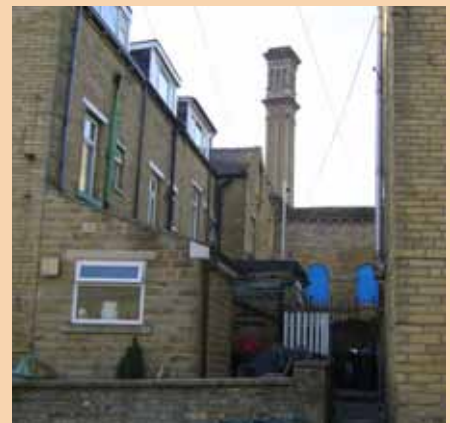
*Right: Vista looking at back of terraces to Manningham Mills chimney.
Below: Grade II Listed gate house to the entrance of Lister Park.*

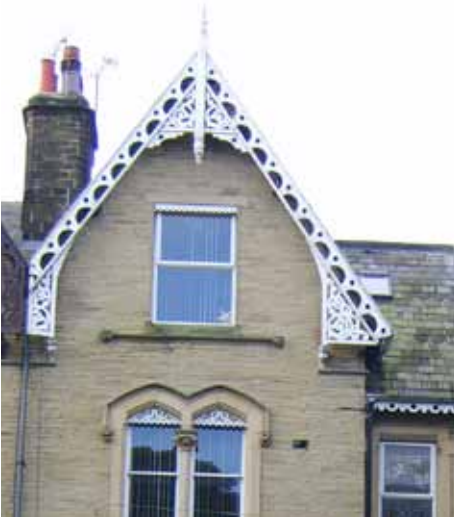
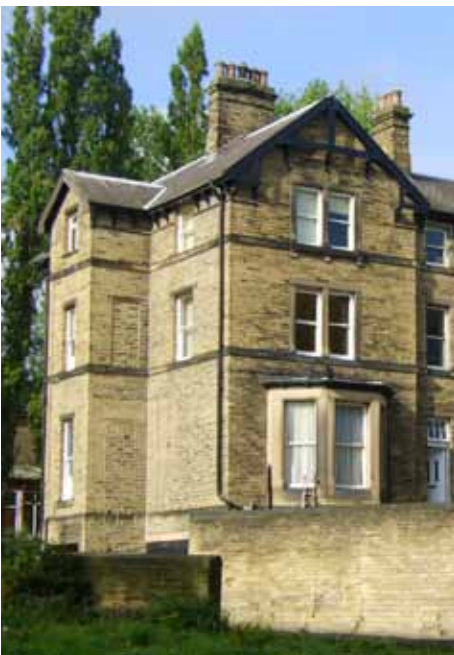
Anti-clockwise from top: A pitched roof dormer with all original details. Ashburnham Road with its villas and tree lined avenue. Decorative bargeboards retained. A large villa property with most original features retained such as chimney, windows and rainwater goods.

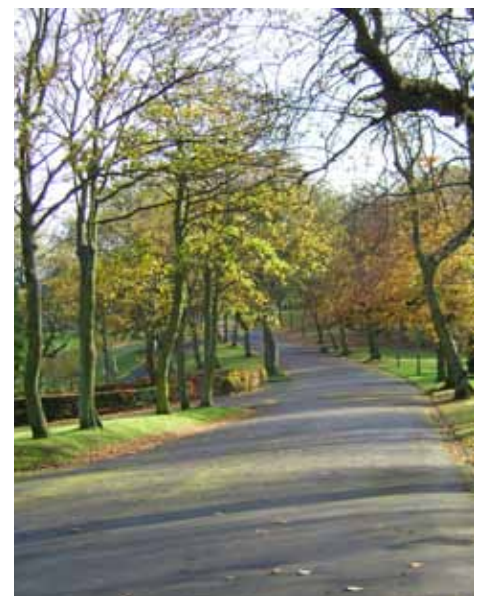
Top: Victorian villas styled property retains most of its original features.
Above: Lister Park with its large tree avenue.

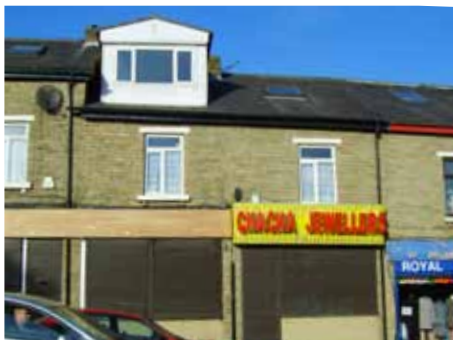
Vacant shops detrimental to the Conservation Area. Large dormer and fascias are inappropriate features.

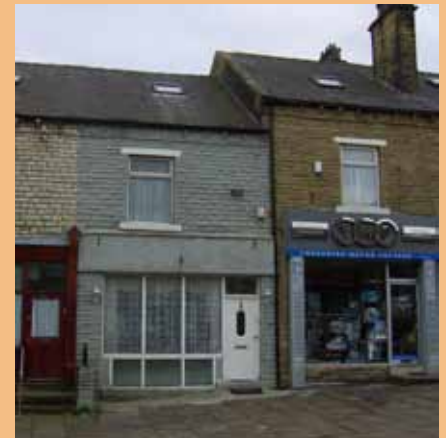
Vacant building, painted elevation and modernised shopfront all inappropriate features.

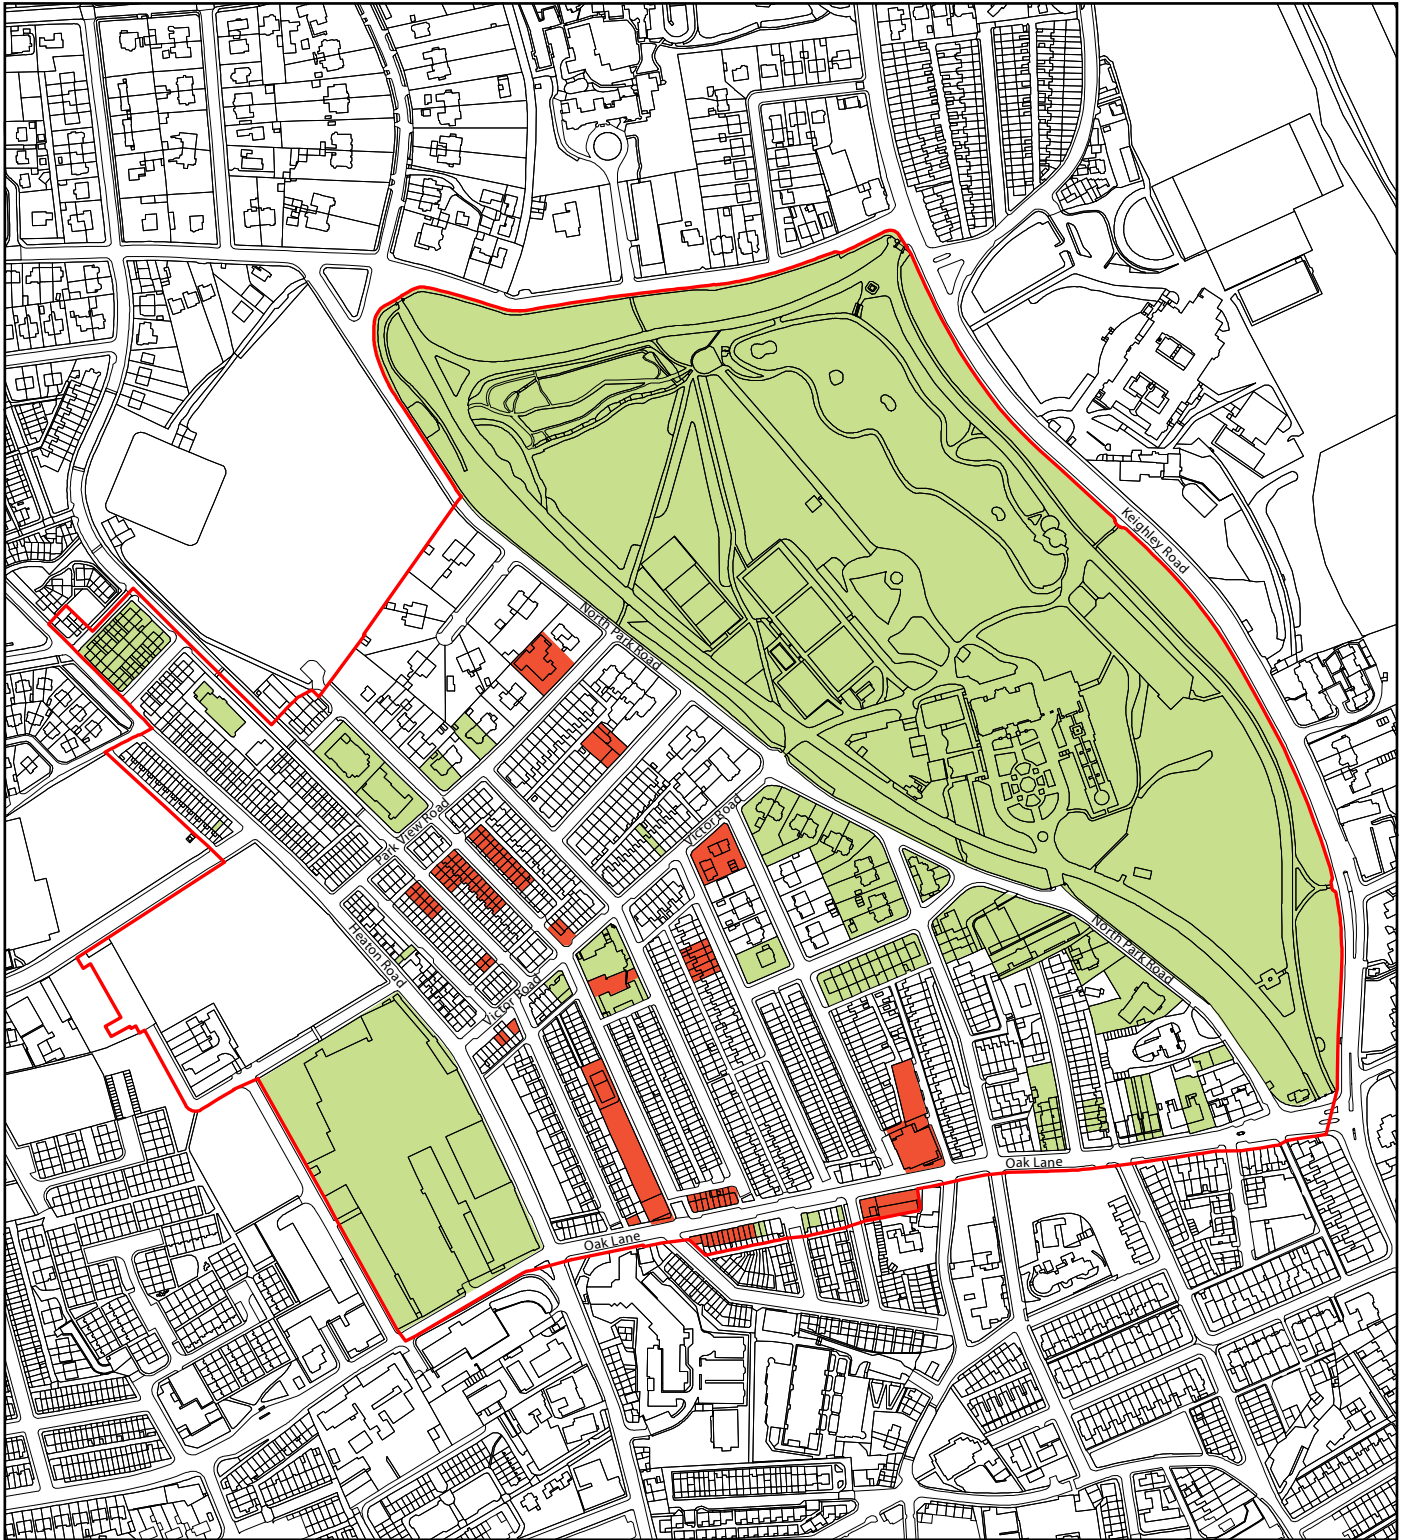
Character Contributions

NB The 'positive', 'negative' and 'neutral' areas relate to the contribution the site/building currently makes to the character of the Conservation Area. The classification in no way means that the site/building has no special architectural, historic or archaeological interest.

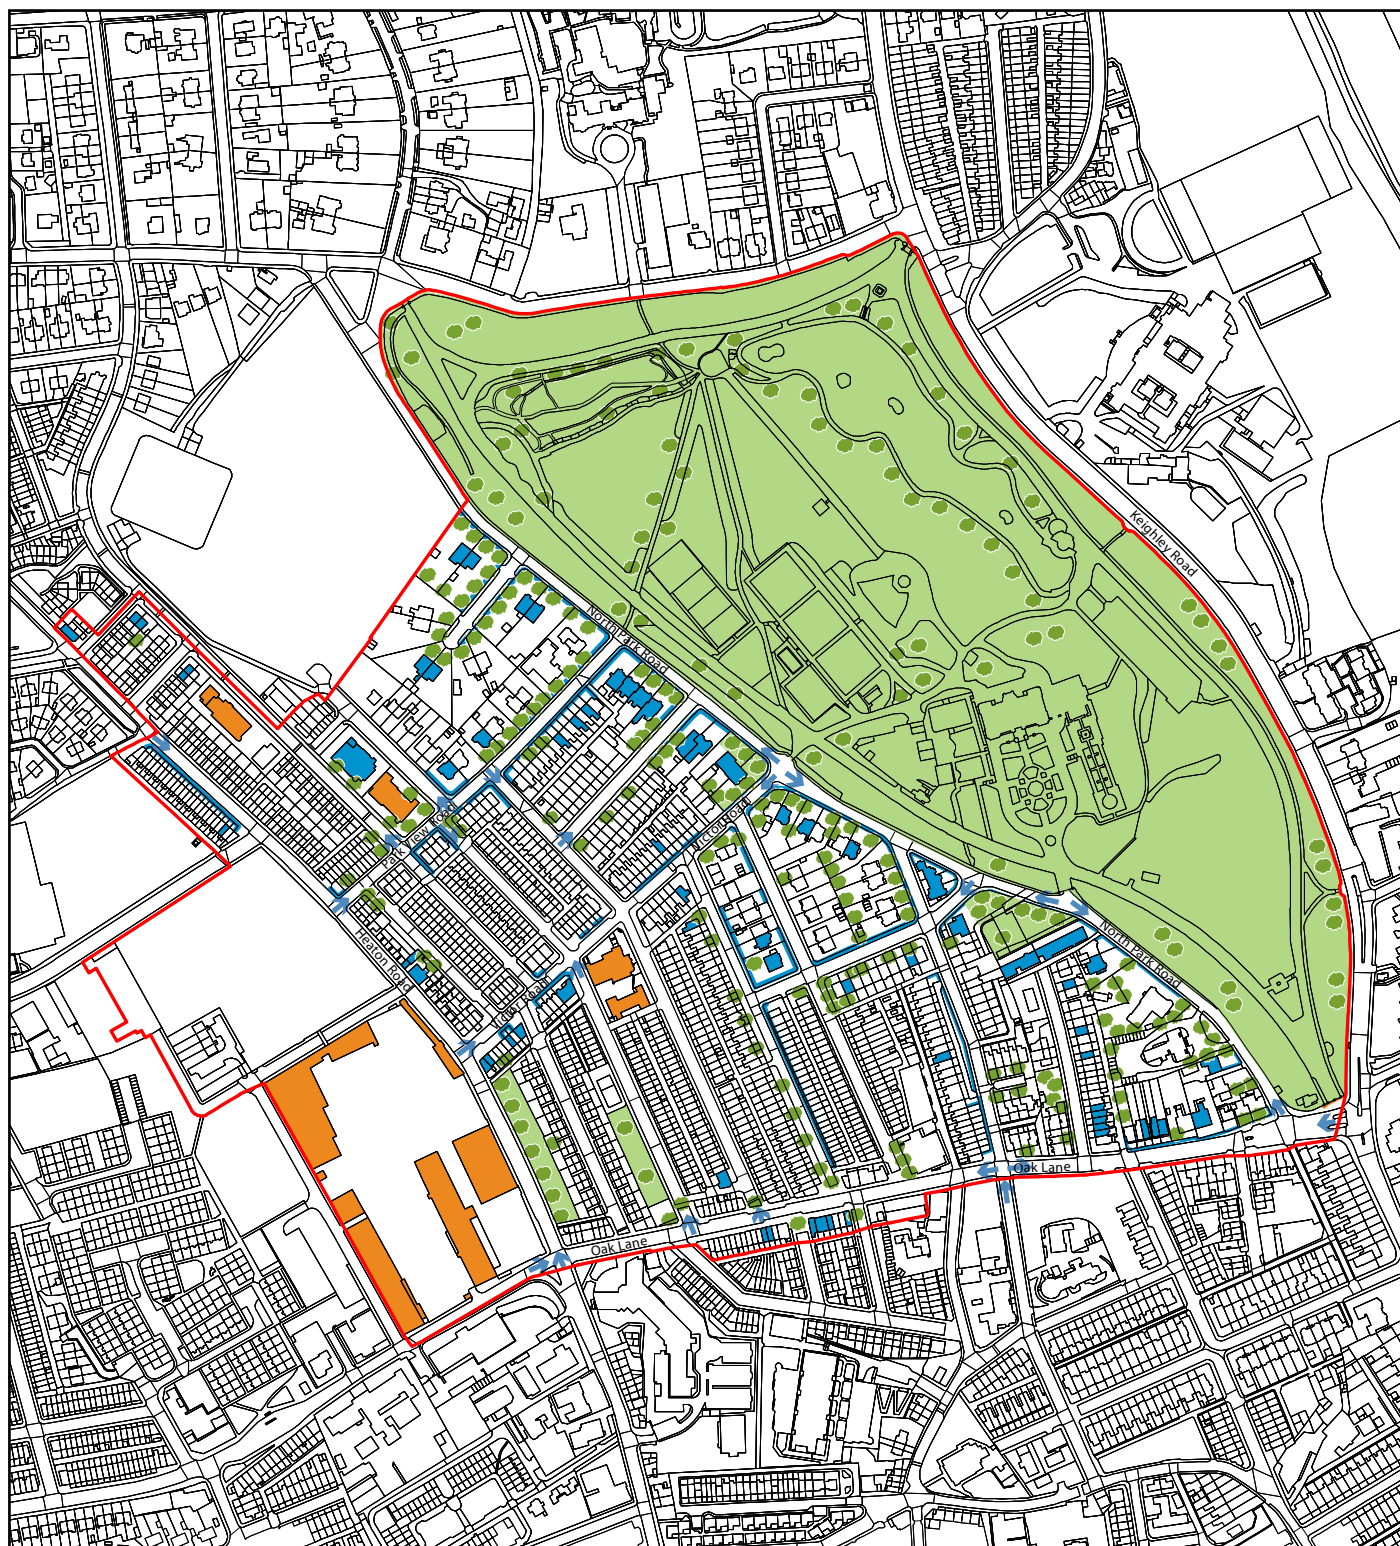
Open Spaces, Trees, Views, Listed and Key Unlisted Buildings

NB This map does not identify key trees individually, but merely indicates where there is at least one important tree.

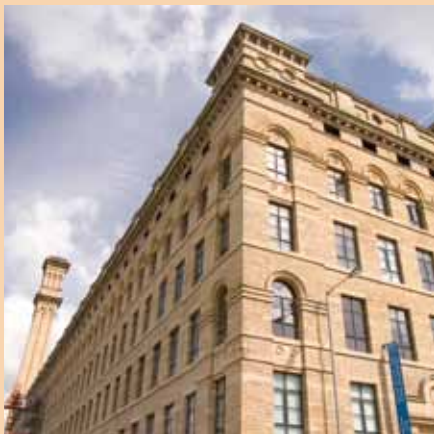
- **Manningham Mills** which was formerly vacant and neglected has been partially converted to apartments. The works to the building and former mill yard are appropriate.

POSITIVE CHANGE

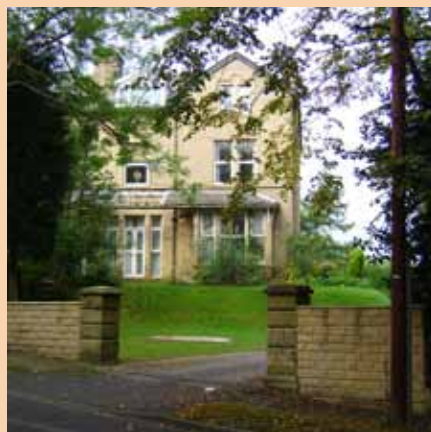
- **7 Asburnham Road** Replacement Wall - The gate posts and wall have been demolished and replaced with an artificial stone boundary wall. The wall does not maintain the original character of the street scene in the conservation area.

NEGATIVE CHANGE

LESSON: Home owners should check whether they need planning permission or conservation area consent before carrying out. In this case the Council would be within its powers to undertake enforcement action

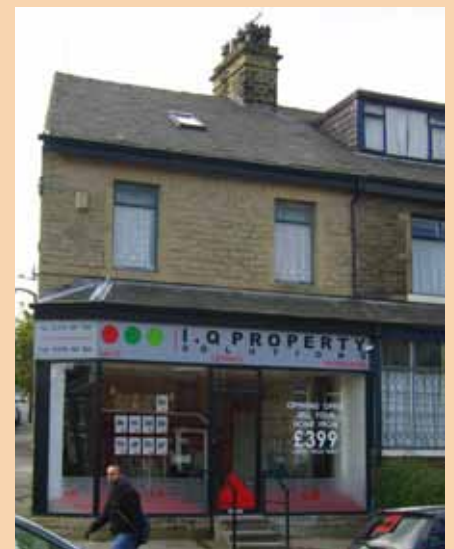
- **105 Heaton Road** Completely new shop front - The traditional shop front of 105 Heaton Road has been completely replaced an inappropriate modern shop front.

NEGATIVE CHANGE

LESSON: Planning permission is required for the replacement shop front. Its design and materials should conform to the guidance contained in the draft Shop Front Design Guide SPD. In this case the council would be within its power to carry out enforcement

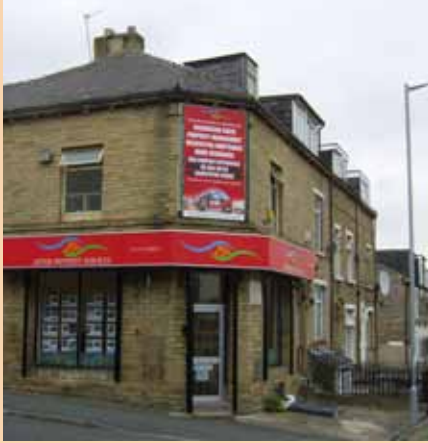
- **230 Heaton Road** new fascia sign, roller shutters, shop windows and hoarding. New fascia sign and advert signage present. The design and materials of the shop front and signage are inappropriate to the character and appearance of the Conservation Area

NEGATIVE CHANGE

LESSON: Advertisement Consent is required for new signage and advertisements. Planning permission is required for roller shutters and replacement shop windows. In this case the council would be within its power to carry out enforcement

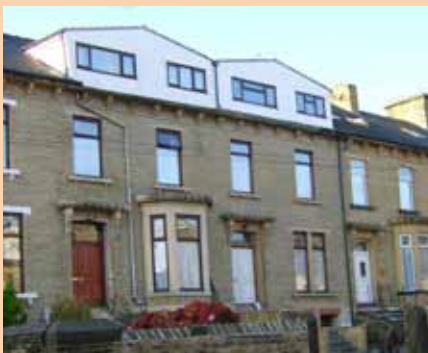
- **53-55 St Mary's Road** Both of the flat roof dormer windows have been increased in size as they now have a pitched roof.

NEGATIVE CHANGE

LESSON: Homeowners should check whether their proposed works require planning permission or not. In this case the Council would be within its power to take enforcement action

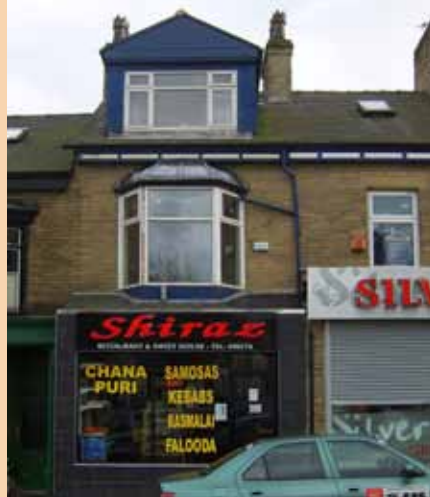
- **113 -115 Oak Lane** - Originally these two properties were restored under the shop front grant scheme. Now both shop fronts have been replaced with a modern shop front and roller shutters and modern windows have also been installed. Planning permission has not been sought for the works.

NEGATIVE CHANGE

LESSON: Shops and the accommodation over shops do not have permitted development rights therefore planning permission is required to any external alterations. The Council would be within its powers to enforce against these unauthorised alterations.

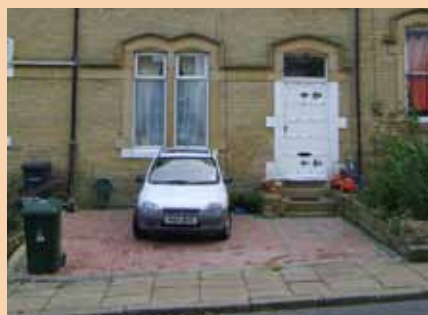
- **33 Park View Road** The front wall has been demolished. A hard standing driveway has been laid.

NEGATIVE CHANGE

LESSON: Home owners should consider the impact of their alterations on the character and appearance conservation area. The repairs and maintenance Guidance containing helpful advice.

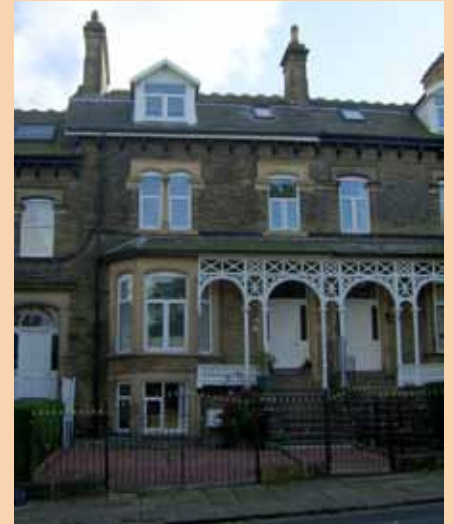
- **5 Selborne Terrace** Original boundary feature replaced with metal railing fence. A hard standing driveway has been laid.

NEGATIVE CHANGE

LESSON: Homeowners should check whether their proposed alterations require planning permission. In this case the new fence and gates do require planning permission and the Council would be within its powers to undertake enforcement action.

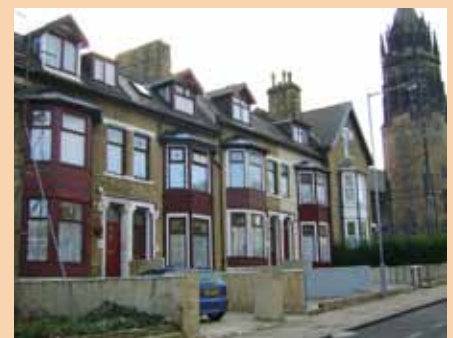
- **19-25 Victor Road** Complete removal and partial replacement of boundary walls. New areas of hard standing created.

NEGATIVE CHANGE

LESSON: Homeowners should check whether their proposed alterations require planning permission. In this case the new fence and gates do require planning permission and the Council would be within its powers to undertake enforcement action.

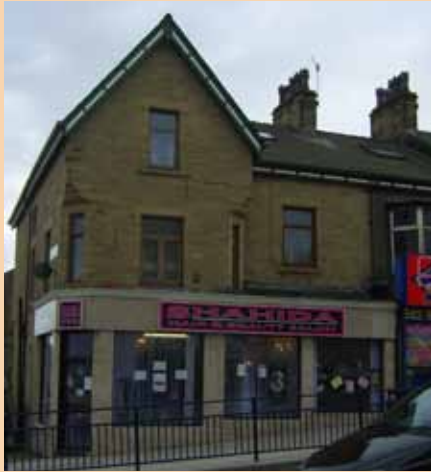
- **103 Oak Lane** At the time of the conservation area assessment was being prepared (2005) the shop front had been removed without planning permission, An unsympathetic modern shop front has since been installed.

NEGATIVE CHANGE

LESSON: Shop owners should seek planning permission when replacing shop fronts. In this case the Council would be within its powers to enforce an appropriate replacement shop front.

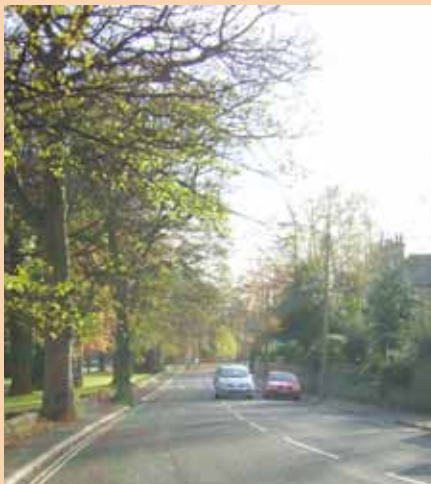
Two trees have been cut down on the frontage of 5 Mount Pleasant

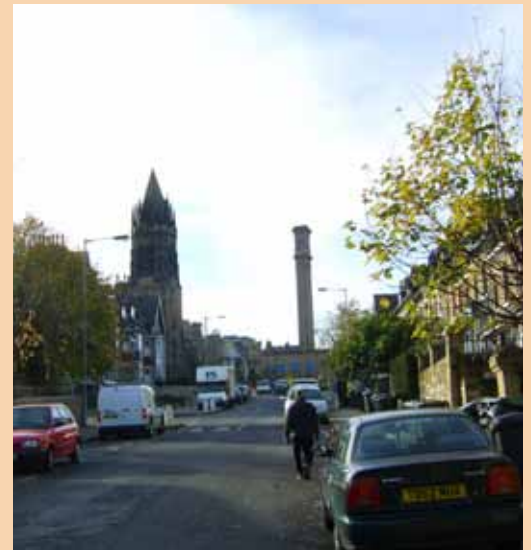
Victor Road public realm environmental enhancement scheme to pavements and boundary walls. This includes replacing inappropriate walls in terms of their size and materials and replacing them with the appropriate design to the conservation area. Also re-introducing stone flagged pavements which are level which tidies up the appearance of the conservation area.

POSITIVE CHANGE
