Conservation Area Appraisal

St Paul's

November 2007

City of Bradford MDC

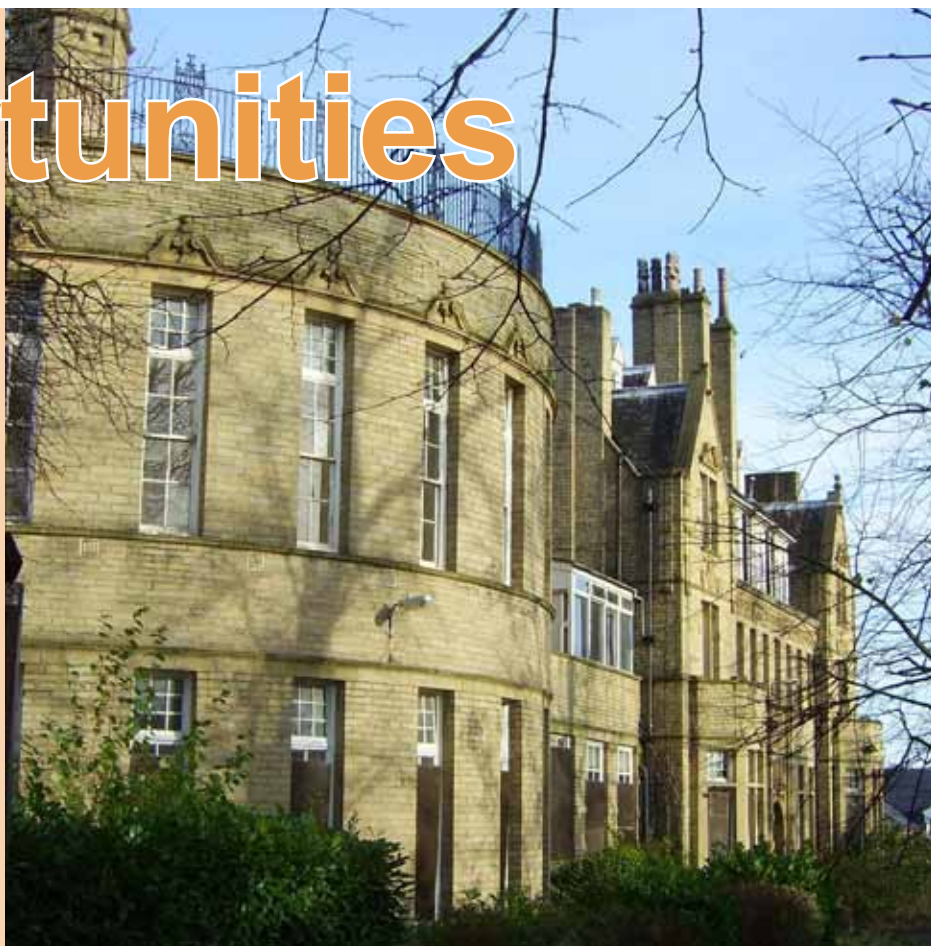
The Listed former Children's Hospital is vacant but has clear potential for re-use.

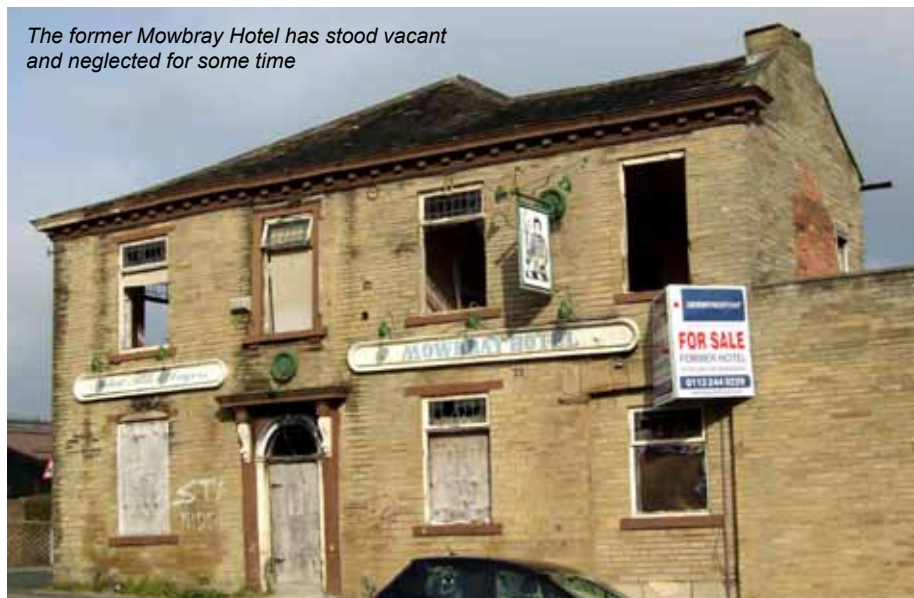
The former Mowbray Hotel has stood vacant and neglected for some time

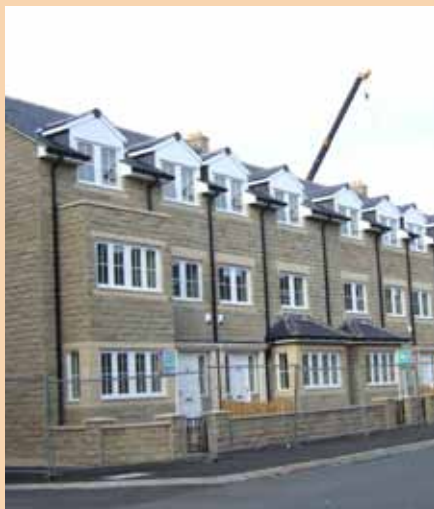
- Part of the **vacant site opposite 52-68 Bertram Road** has been redeveloped to accommodate a terrace of new two-and-a-half storey stone built houses. The form, materials and massing of the houses is generally appropriate.

POSITIVE CHANGE

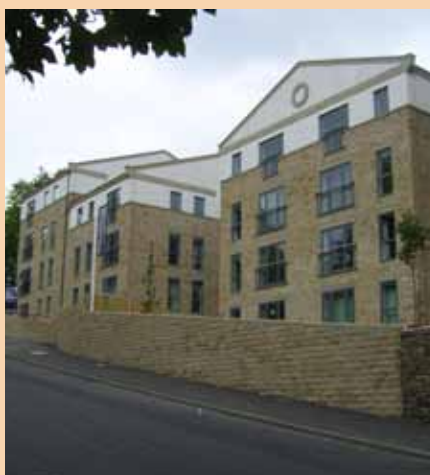
- Following a fire, the **vacant club building on Cunliffe Road** was demolished and its site redeveloped as two blocks of apartments called Lister Court. The development has improved the character and appearance of the site.

POSITIVE CHANGE

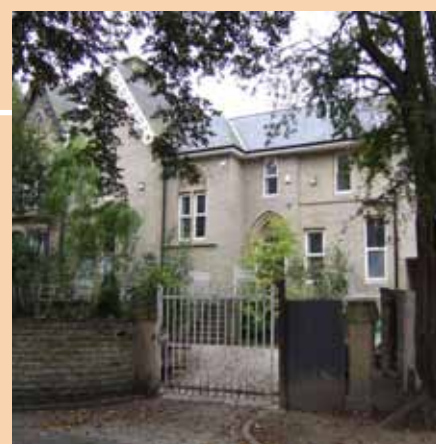
- Planning Permission for a two-story side extension to **6 Oak Villas** was granted in 2004. While the scale and massing of the extension is acceptable, some of the detailing, such as uPVC windows and the eaves are out of keeping with the character of the building.

NEUTRAL CHANGE

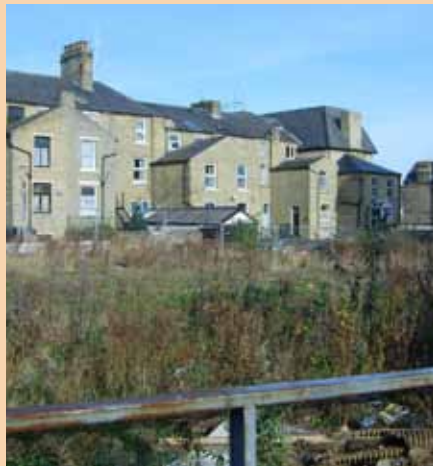
- The **partially occupied warehousing on Church Street** (behind 3-19 Bertram Road) was demolished following a fire. No Conservation Area Consent application has been made and the site is currently cleared and vacant.

NEGATIVE CHANGE

LESSON: The Planning Service should be involved when fires damage buildings in conservation areas to ensure that the character and appearance of the conservation area is considered when decisions with regard to demolition are made. In this case the Council could take enforcement action.

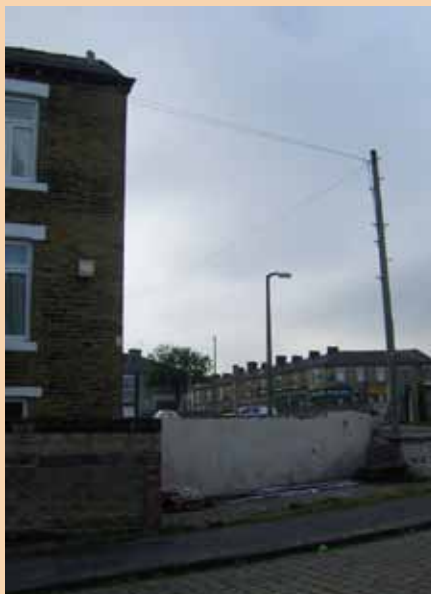
- The buildings adjoining and to the rear of **9 Trees Street** have been demolished without Conservation Area Consent. The site now appears to be used as a car park.

NEGATIVE CHANGE

LESSON: The Planning Service should be involved when fires damage buildings in conservation areas to ensure that the character and appearance of the conservation area is considered when decisions with regard to demolition are made. In this case the Council could take enforcement action.

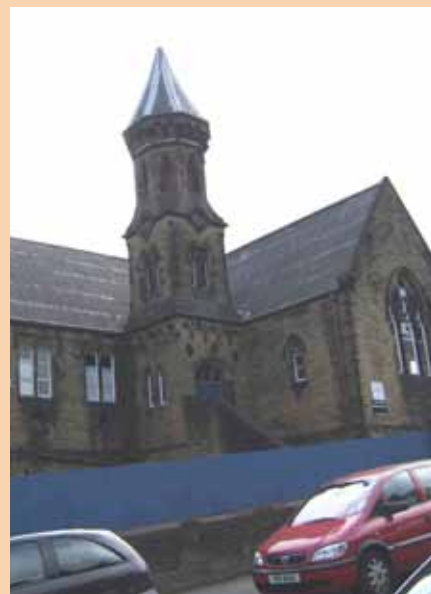
- A solid fence has been erected above the boundary wall to the **Grade II Listed Tarbiyah Preparatory School** on Ambler Street without Planning Permission or Listed Building Consent.

NEGATIVE CHANGE

LESSON: The owners of Listed Buildings should liaise with the Design and Conservation Team if they intend to alter their property as works may require Listed Building Consent. Enforcement action against the inappropriate unauthorised fence could be undertaken at any time.

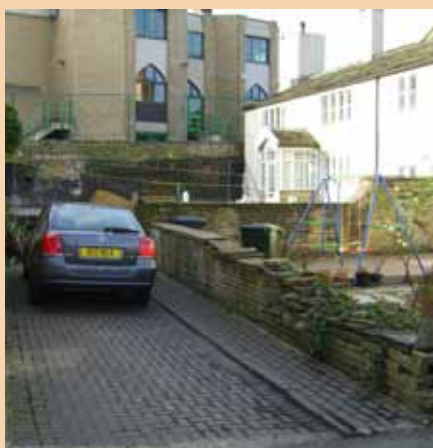
- The vegetation from the front gardens of **8-10 Ashdowne Place** and replaced with clay pavers. The stone flags to this private road have been removed and replaced with stone pavers.

NEGATIVE CHANGE

LESSON: The owners of Listed Buildings should liaise with the Design and Conservation Team if they intend to alter their property as works may require Listed Building Consent. Similarly, notice must be given to the Council's Trees Team before works to trees in conservation areas are undertaken. The Council could take enforcement action against these inappropriate alterations at any time.

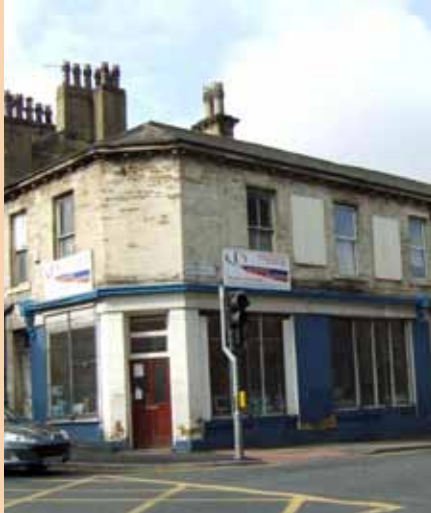
- The vacant lock-up shop at **2 Church Street** has been returned to use, but the elevation and boundary wall have been completely painted, a new modern style shopfront has been installed, and a roller shutter added. None of these works have planning permission.

NEGATIVE CHANGE

LESSON: Whilst the reuse of vacant buildings is supported, physical changes to commercial buildings should not harm the character and appearance of the conservation area. In this case, the Council is within its powers to carry out enforcement action against the unauthorised alterations.

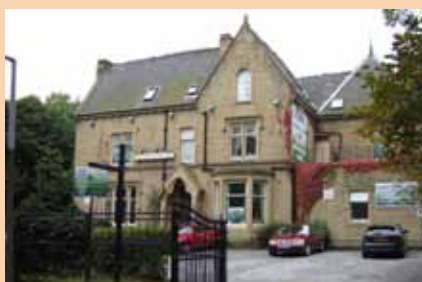
- **4 Oak Avenue** was converted from a hotel to an Islamic educational and cultural centre without planning permission, though a change of use application has since been submitted following a complaint. New signage including a large banner has been attached to the building and new boundary railings and gates erected.

NEGATIVE CHANGE

LESSON: Property owners should consult the Planning Service before converting buildings and carrying out other alterations otherwise the Council may take action against unauthorised changes. In this instance the complaint has led to a planning application being submitted, which should see the issues at this property being addressed.

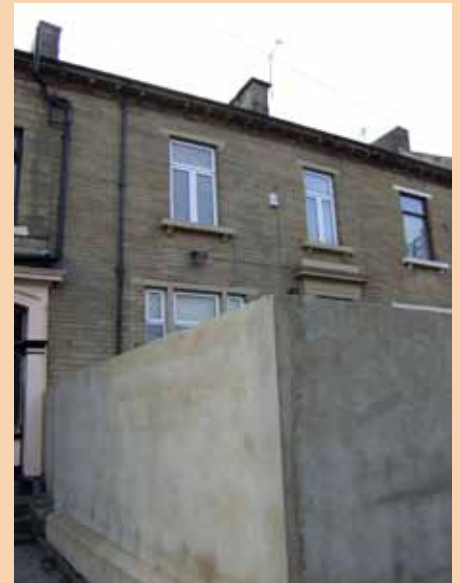
- Rendered front boundary walls over 2m in height have been built at **2 and 3 Highfield Place** without Planning Permission. They strongly detract from the street scene and group value of the houses.

NEGATIVE CHANGE

LESSON: Homeowners should consider the character and appearance of the conservation area and ascertain whether their proposals need planning permission prior to carrying out works. The Council would be within its powers to enforce against this unauthorised development.

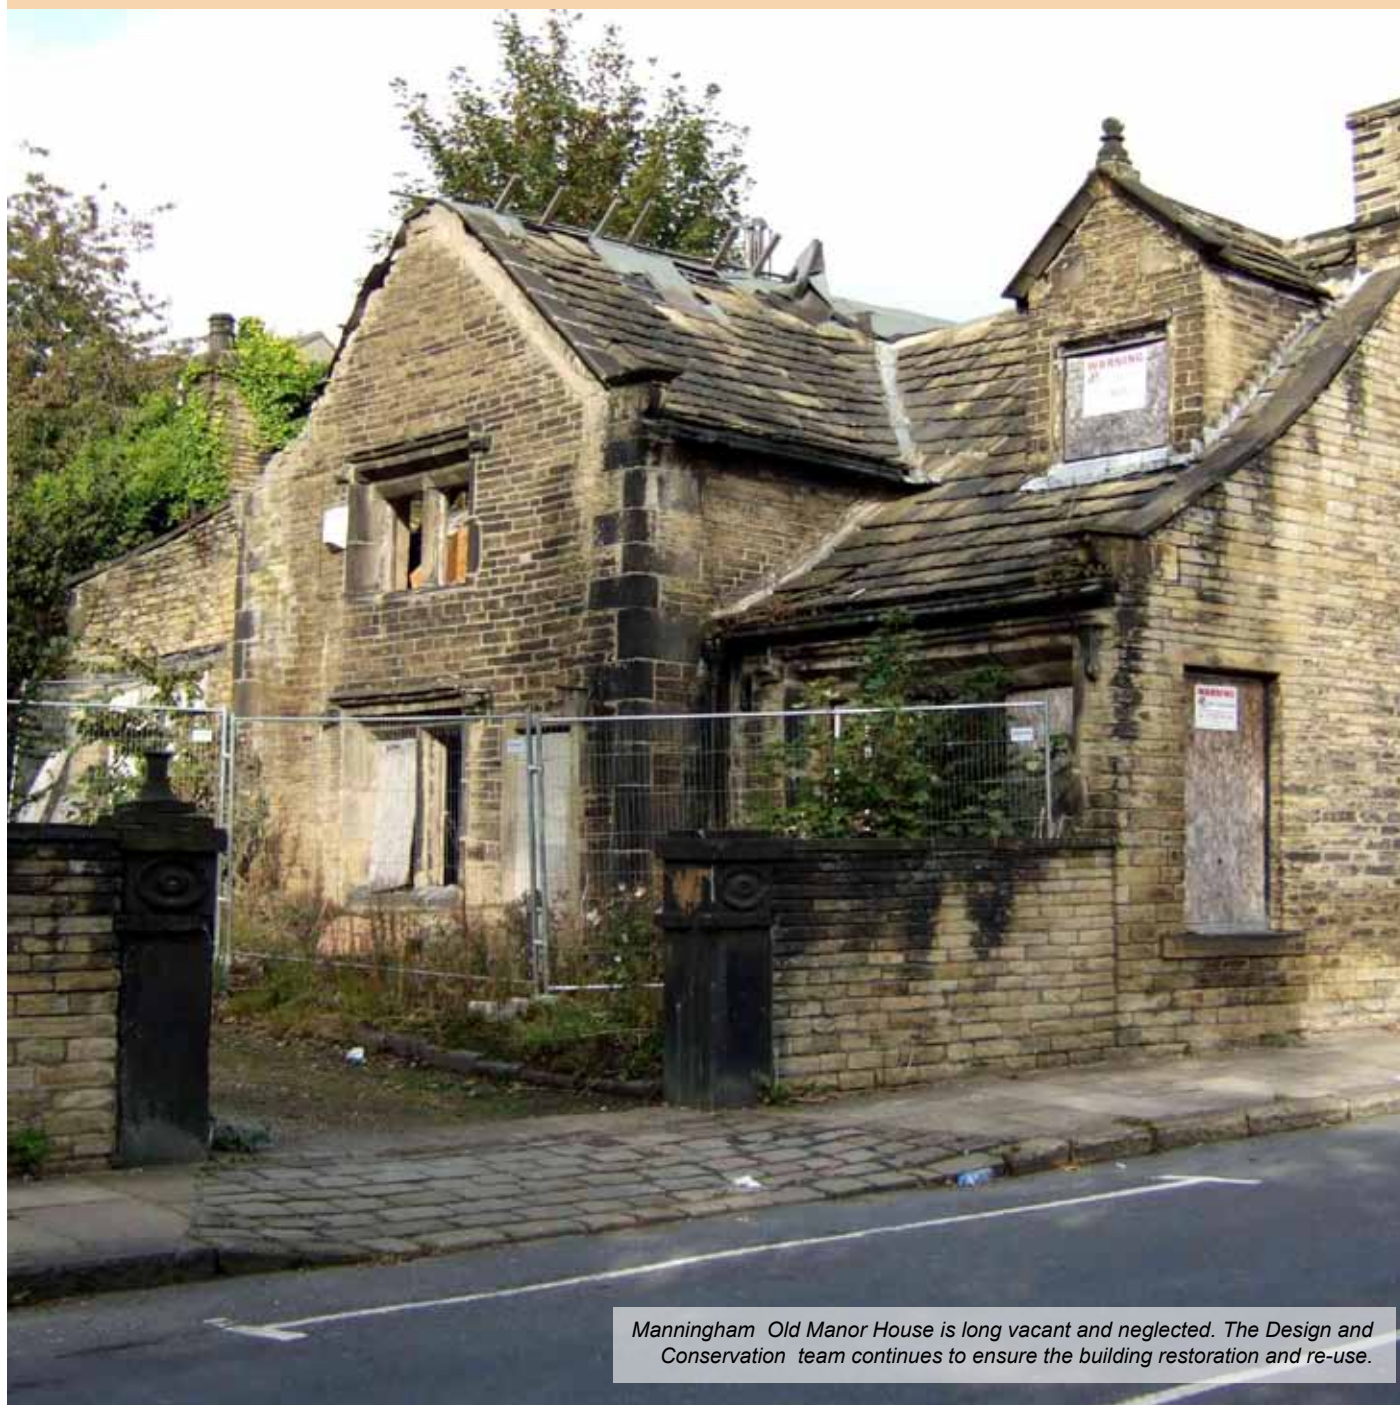
Manningham Old Manor House is long vacant and neglected. The Design and Conservation team continues to ensure the building restoration and re-use.
