Conservation Area Appraisal

Braithwaite

January 2008

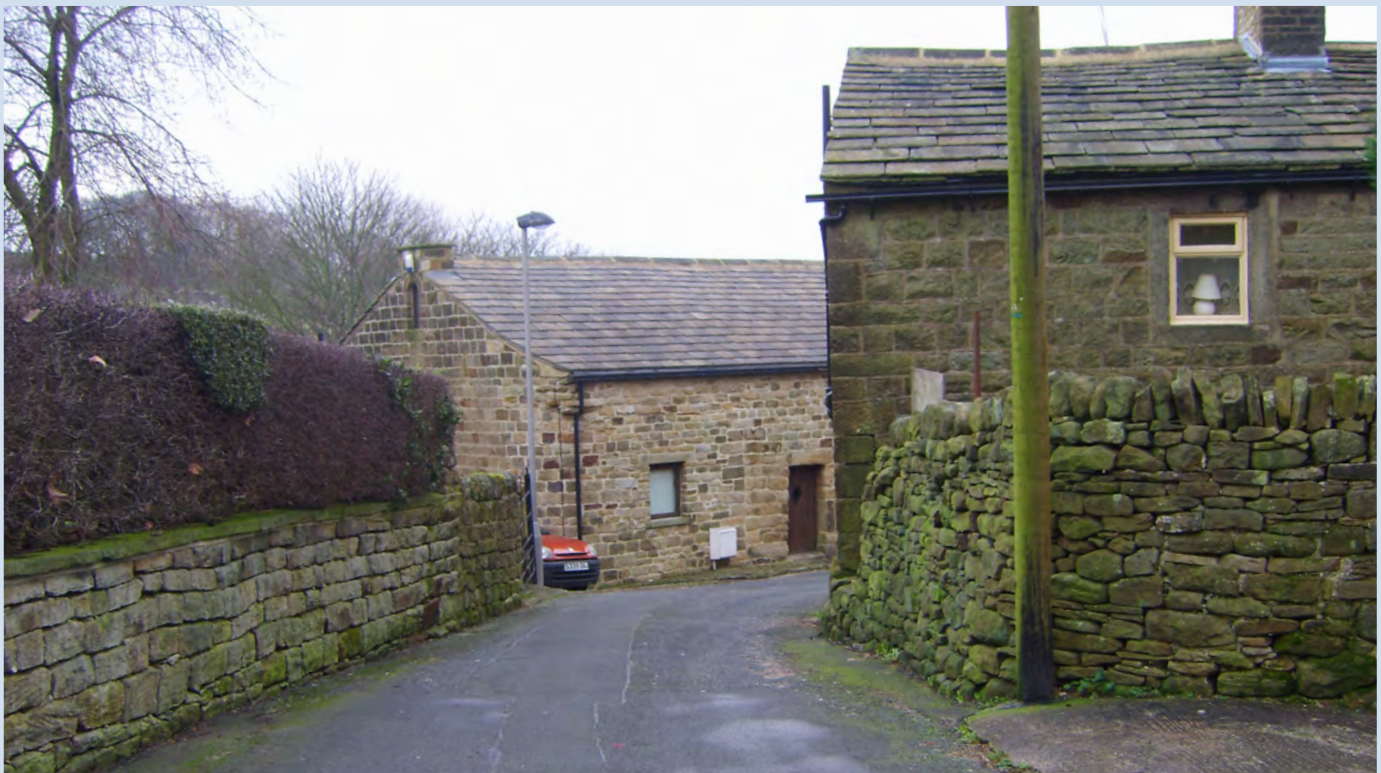
Laycock Lane creates interesting vistas as it twists and turns around the buildings.

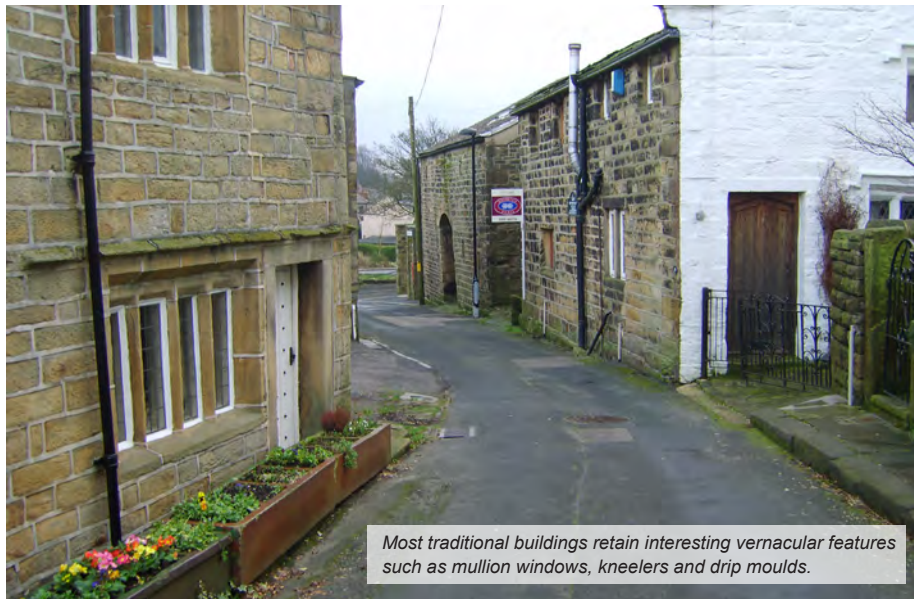
Most traditional buildings retain interesting vernacular features such as mullion windows, kneelers and drip moulds.

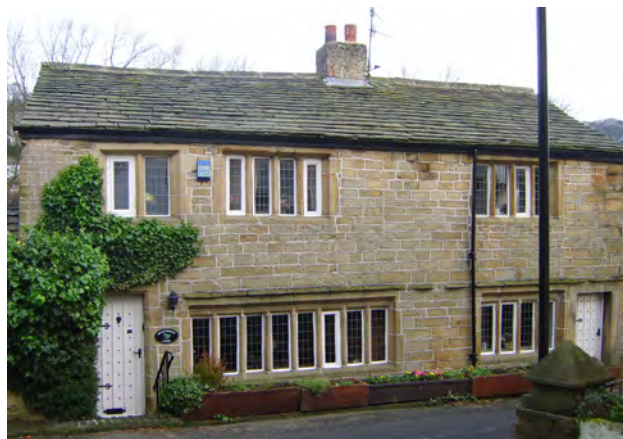
10 - 12 Braithwaite Village dates from the 17th century and is Grade II listed for its architectural interest.

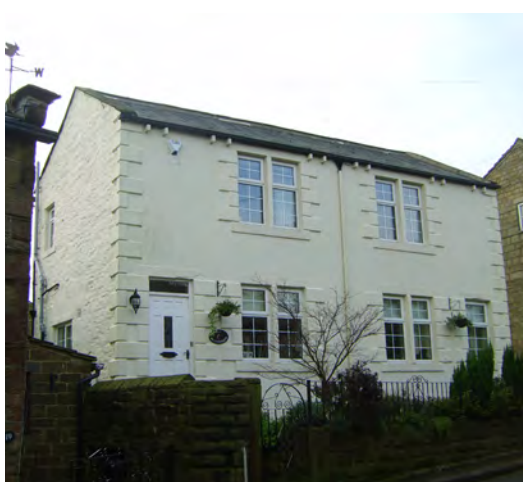
Painted stonework at 21 - 23 Braithwaite Village

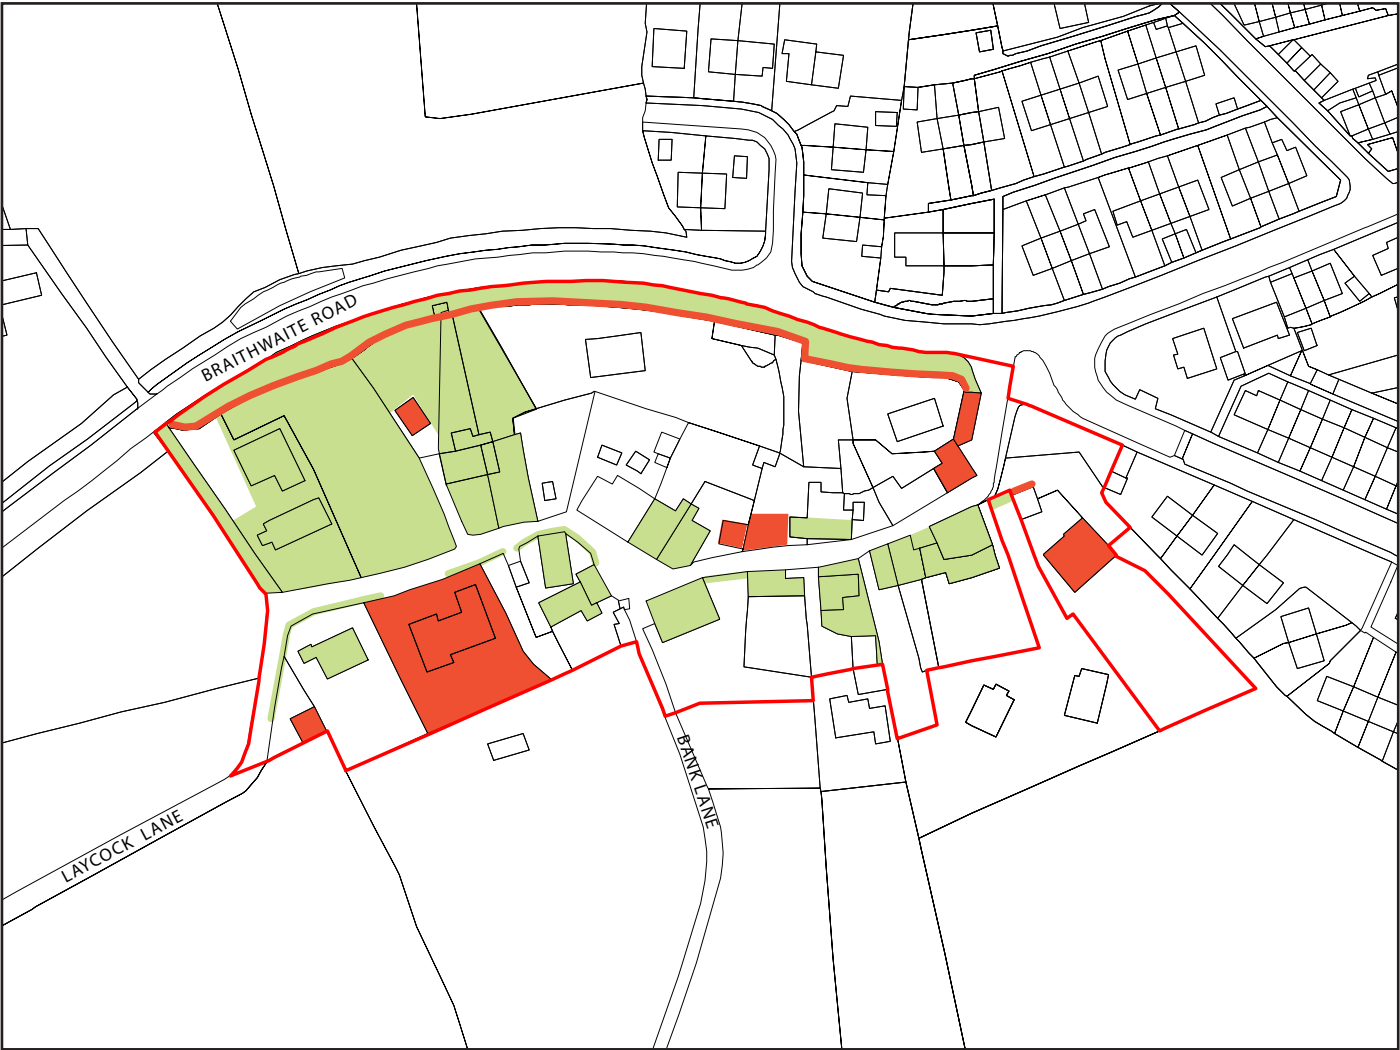
Character Contributions

NB The 'positive', 'negative' and 'neutral' areas relate to the contribution the site/building currently makes to the character of the Conservation Area. The classification in no way means that the site/building has no special architectural, historic or archaeological interest.

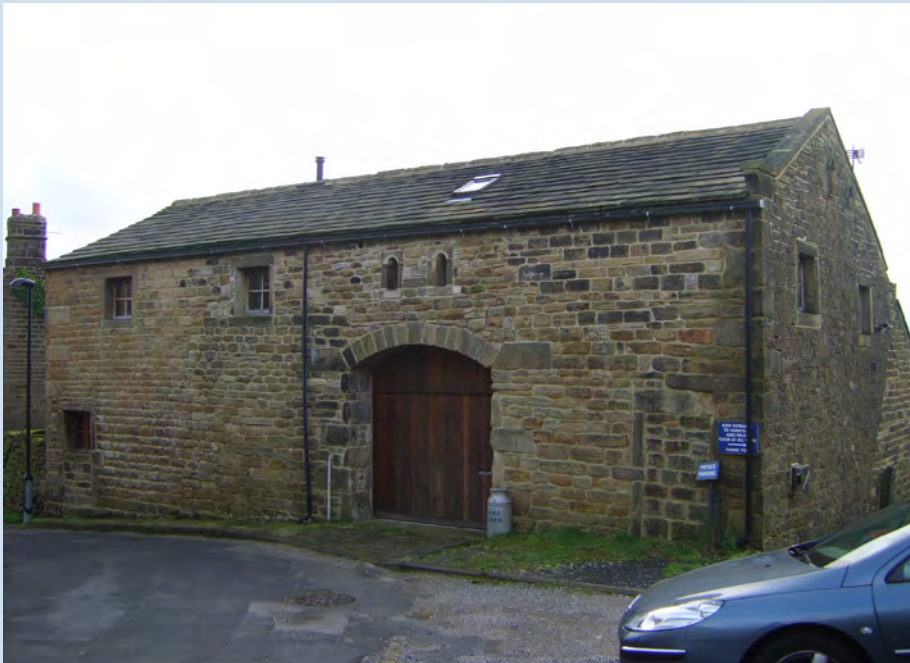
The barn **25A Braithwaite Village** has been converted to a dwelling which has brought the building back into use. Some new window openings have been created but are in an appropriate design and materials. Planning permission and listed building consent was granted in 1999 and 2000.

POSITIVE CHANGE

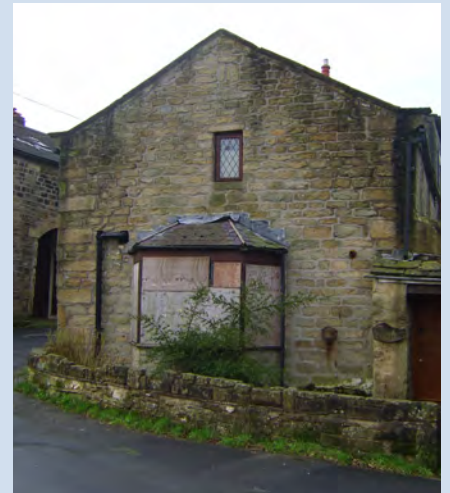
2 Braithwaite Village Swallow Cottage still remains vacant since the publication of the Conservation Area Assessment:

NEGATIVE CHANGE

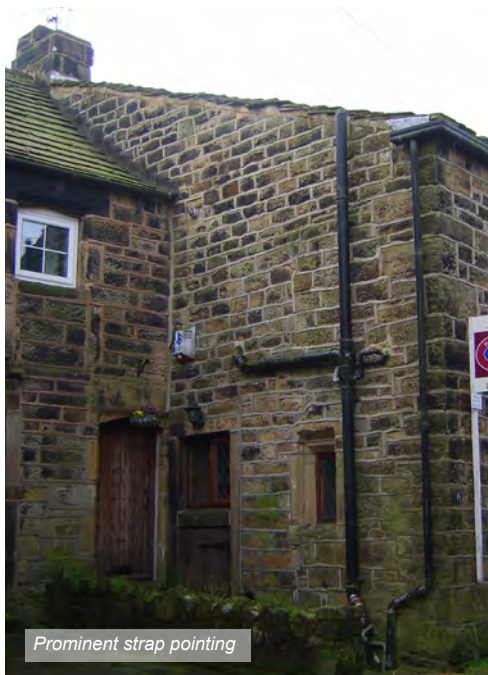
Prominent strap pointing

As part of the review of the conservation area a number of properties displaying inappropriate alterations and additions have been noted. Whilst a minority are considered to have a severely negative impact on the character of the conservation area, there are a number of properties displaying relatively minor visual detractors, such as reduced or removed chimneys, inappropriate rainwater goods, painted or inappropriately pointed elevations and modern windows and doors. The Council will look to ways of mitigating these works and will actively discourage the occurrence of similar situations arising within the conservation area in the future. Design guidance on the repair and maintenance of historic properties has recently been published and is available on the Council's website at www.bradford.gov.uk/repairs.

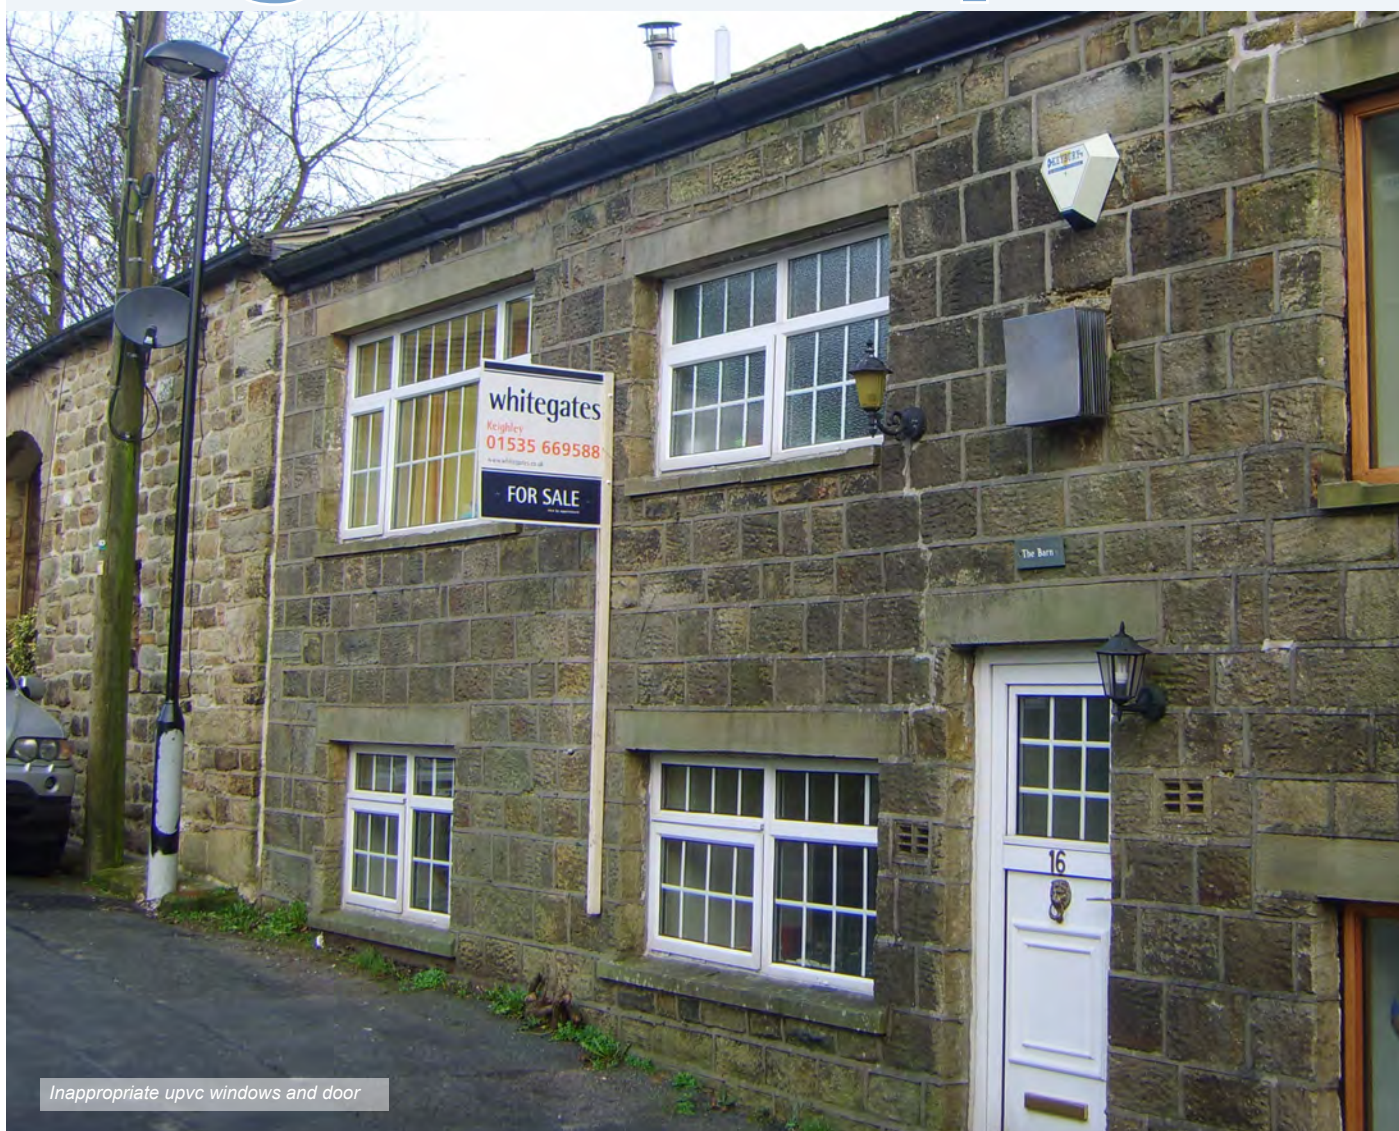
Inappropriate upvc windows and door
