Map 04: Brunthwaite Bridge and Howden Park

Character of the Area

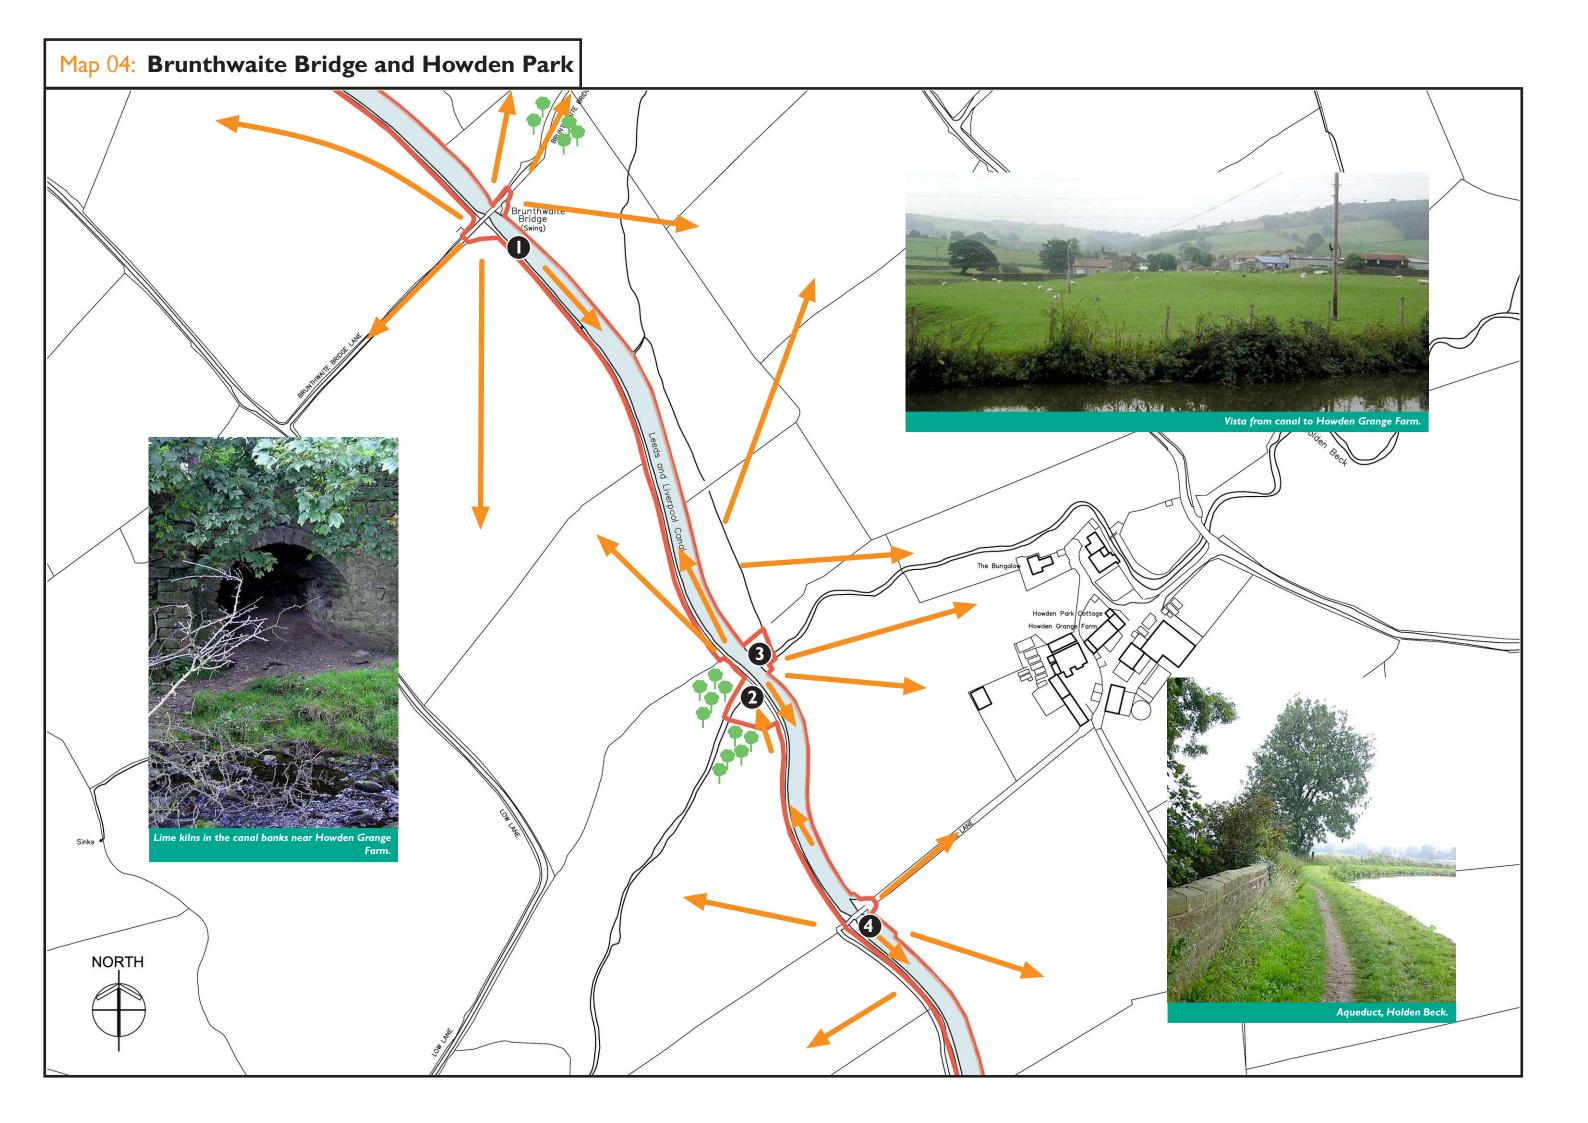
> Right: The lime kilns near Holden Beck are two of c.40 lime kilns which were built alongside the canal in the late 18th century. Limestone and coal would have been burnt in the kilns to produce lime, a fertiliser used for agriculture. The Grade 11 listed kilns are in good condition.

2. Lime Kilns, Holden Beck: Set into the stone retaining wall above the stream running beneath the canal is a pair of lime kilns. These are identifiable by their large, round-arched openings. The lime kilns have long since been defunct but still remain in relatively good condition, internally the kilns are lined with coursed natural stone and the openings are marked by wedgeshaped voussoirs. The date of construction of the kilns is unknown but probably dates to around the time of the initial construction of this section of canal in 1773.
