Conservation Area Appraisal

Middleton

February 2009

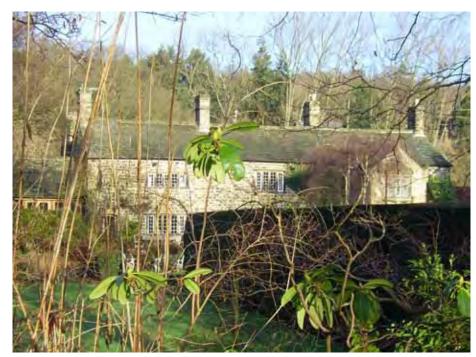
Low Hall is Grade II* listed and is the oldest building in the conservation area

The Grade II* listed Low Hall was built in the 17th century and is one of the oldest intact houses in this part of Wharfedale. Although there is no record of when buildings first occupied this site it is known that the present day Hall contains fragments of medieval stonework.

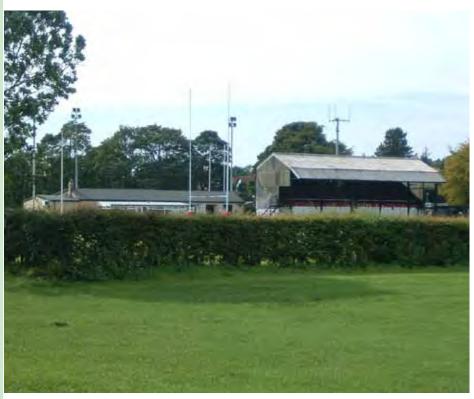
- Implementation of Ilkley Rugby Clubs plans to rebuild their clubhouse and grandstand will enhance the conservation area.
- Improvement of facilities at Ilkley Lido (subject to funding) may also bring about improvements.
- Better decisions by all stakeholders (including property owners, the Planning Service, Highways) aided by reference to the Conservation Area Assessment and this review. subsequent workshops and more communication with the Design and Conservation Team.
- The recently published "Repair and Maintenance Guidance" should help property owners make better informed decisions.
- There is an opportunity to improve the quality of some street furniture, such as the disused telephone box.

Improvements are planned to give Ilkley Rugby Club a lift

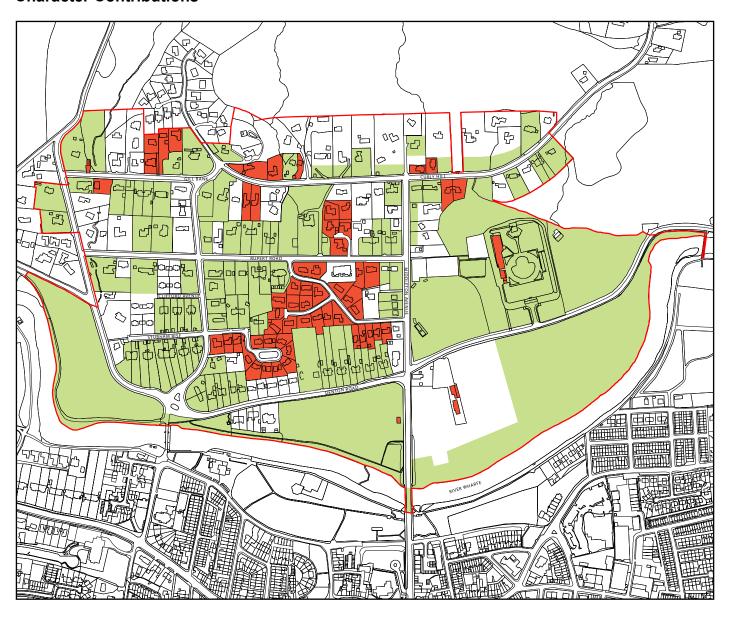
Character Contributions

NB The 'positive', 'negative' and 'neutral' areas relate to the contribution the site/ building currently makes to the character of the Conservation Area. The classification in no way means that the site/building has no special architectural, historic or archaelogical interest.

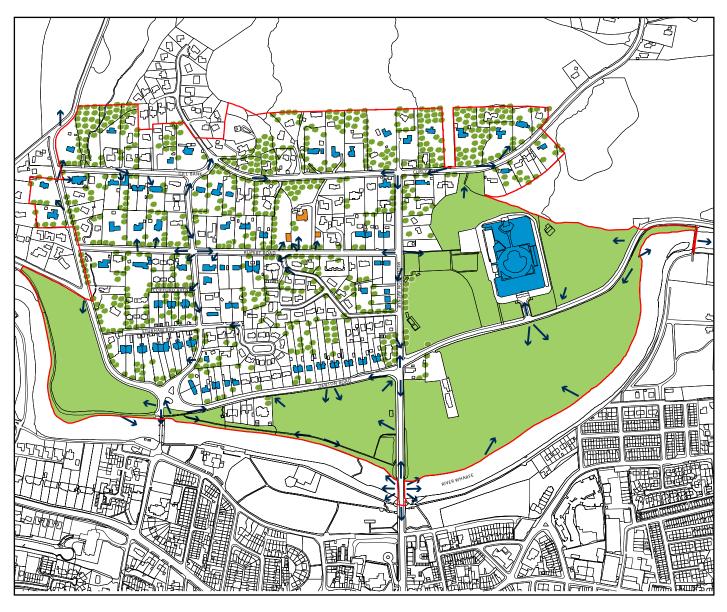
Open Spaces, Trees, Views, Listed and Key Unlisted Buildings

NB This map does not identify key trees individually, but merely indicates where there is at least one important tree.

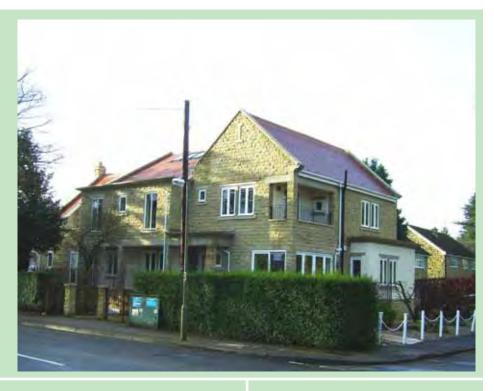
Gilstead Way has been demolished and replaced with a block of three apartments. The red clay tiles, natural stone and render used in the construction of the new building clearly reflect traditional materials used by the Wharfedale Estate Company.

NEUTRAL IMPACT

Lesson: Greater attention should have been given to the fenestration details and to the quality of the rainwater goods. A more appropriate boundary treatment would also have helped the building contribute positively to the conservation area.

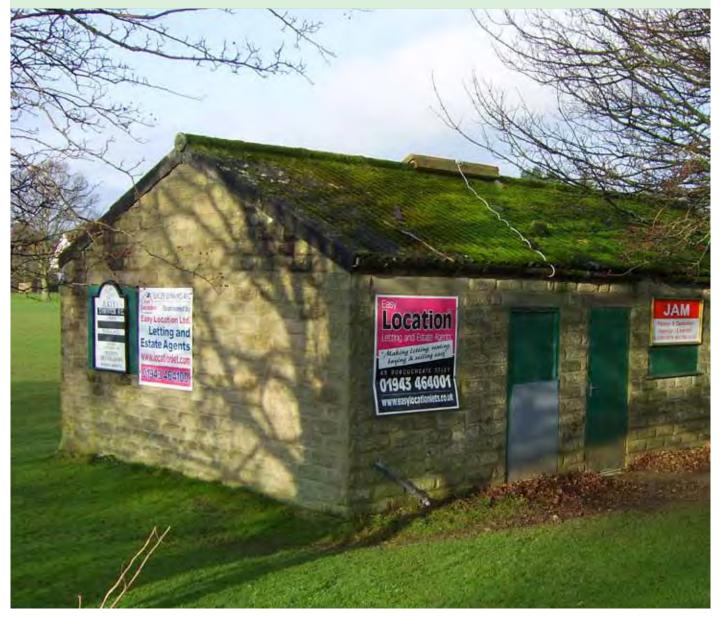
The untidy appearance of this building on West Holmes Field detracts from the quality of the area

The Council will look to ways of mitigating these works and will actively discourage the occurrence of similar situations arising within the conservation area in the future. Design guidance on the repair and maintenance of historic properties has recently been published by the Council.
