Conservation Area Appraisal

Oxenhope

Upper Town

May 2009

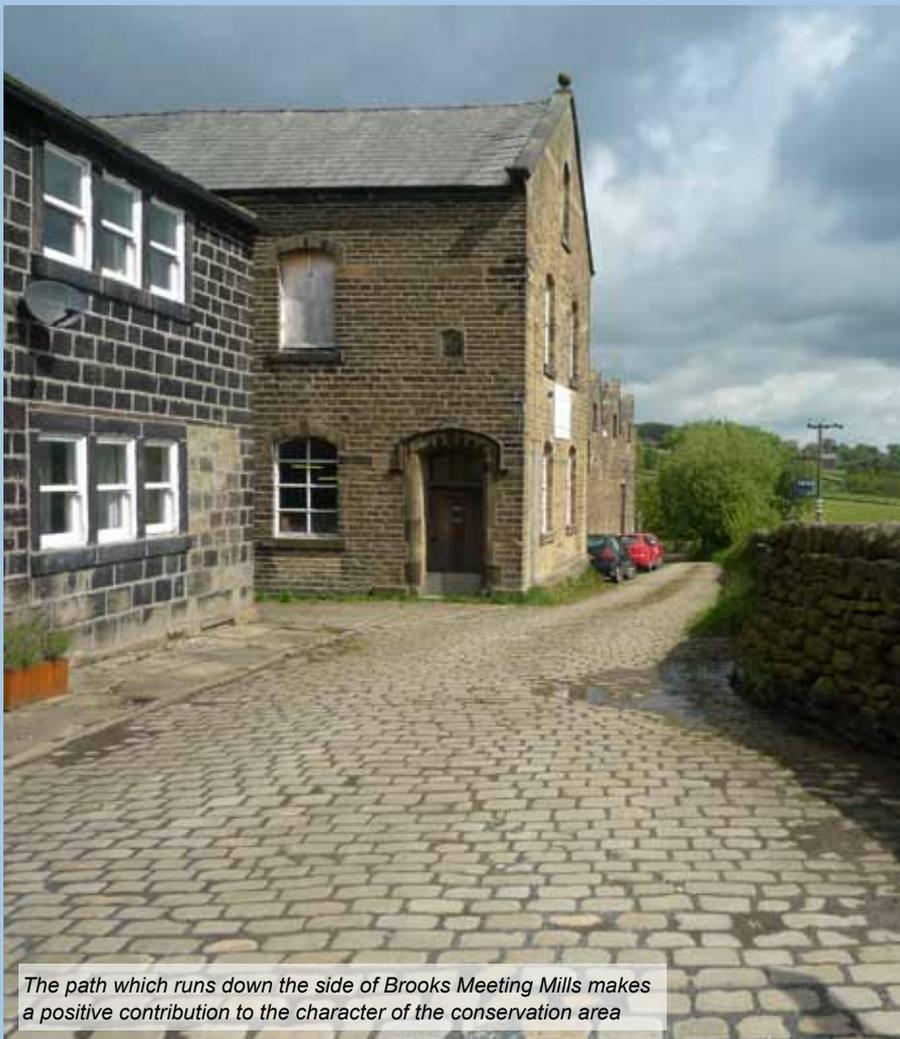
The path which runs down the side of Brooks Meeting Mills makes a positive contribution to the character of the conservation area

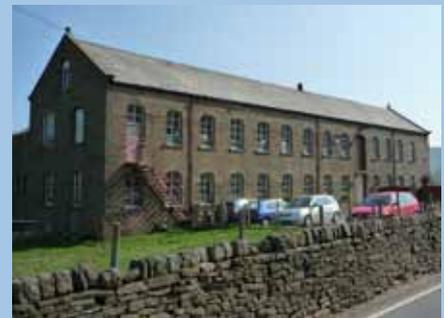
Top: Brooks Meeting Mill (key unlisted) was built in the 1880's and substantially extended in 1910. The older parts of the mill burnt down in 1961 and were not replaced.

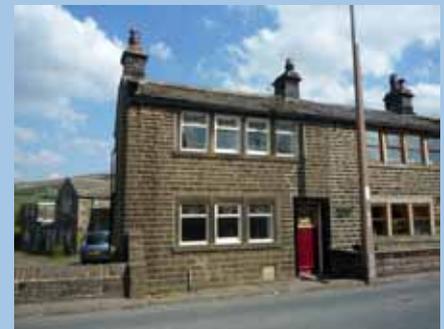
Middle: 21 Uppertown (Grade II listed) has the typical detailing of an early 19th century workers cottage in this area although it appears alterations to the door and windows were made in the 1930's.

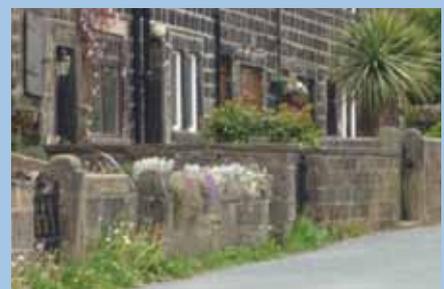
Above: Original boundary walls are an important characteristic of the area.

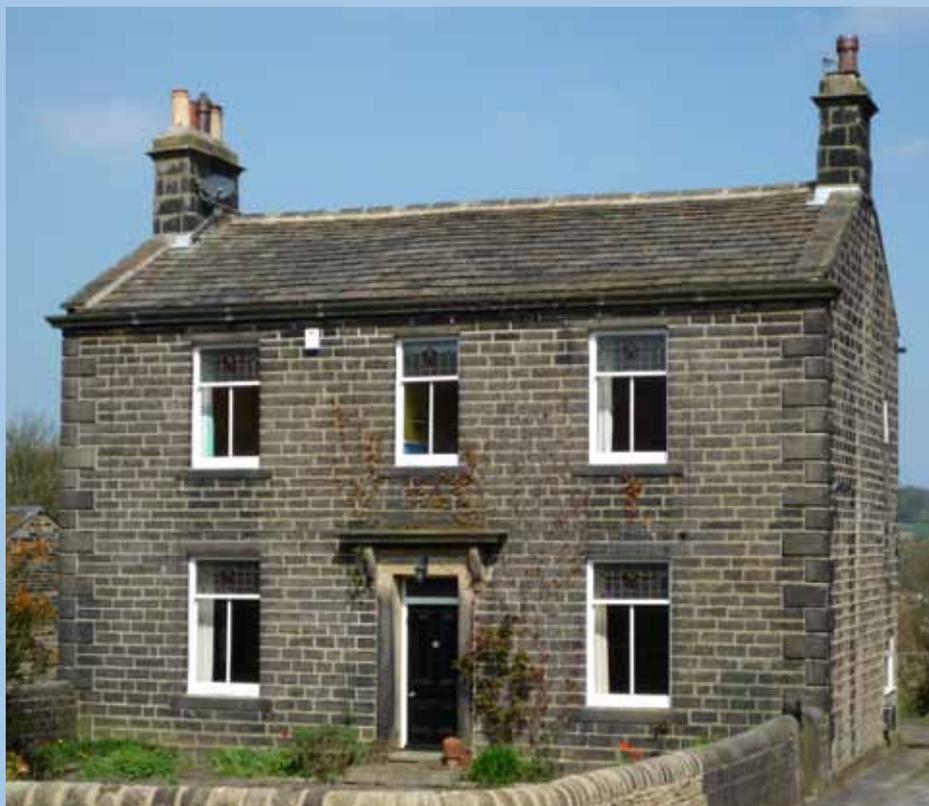
2-4 Shaw Lane (key unlisted) is an attractive Victorian property which retains many of its original features and details

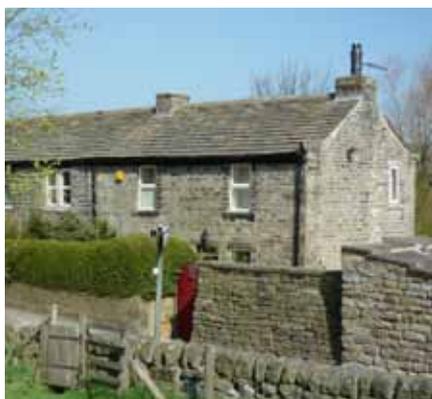
Chimneys should not be lowered as this harms the character of traditional buildings and areas.

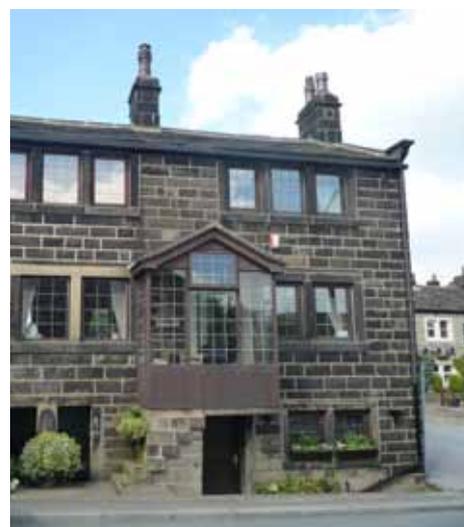
The character and appearance of this Grade II listed building has been harmed by the addition of a modern porch.

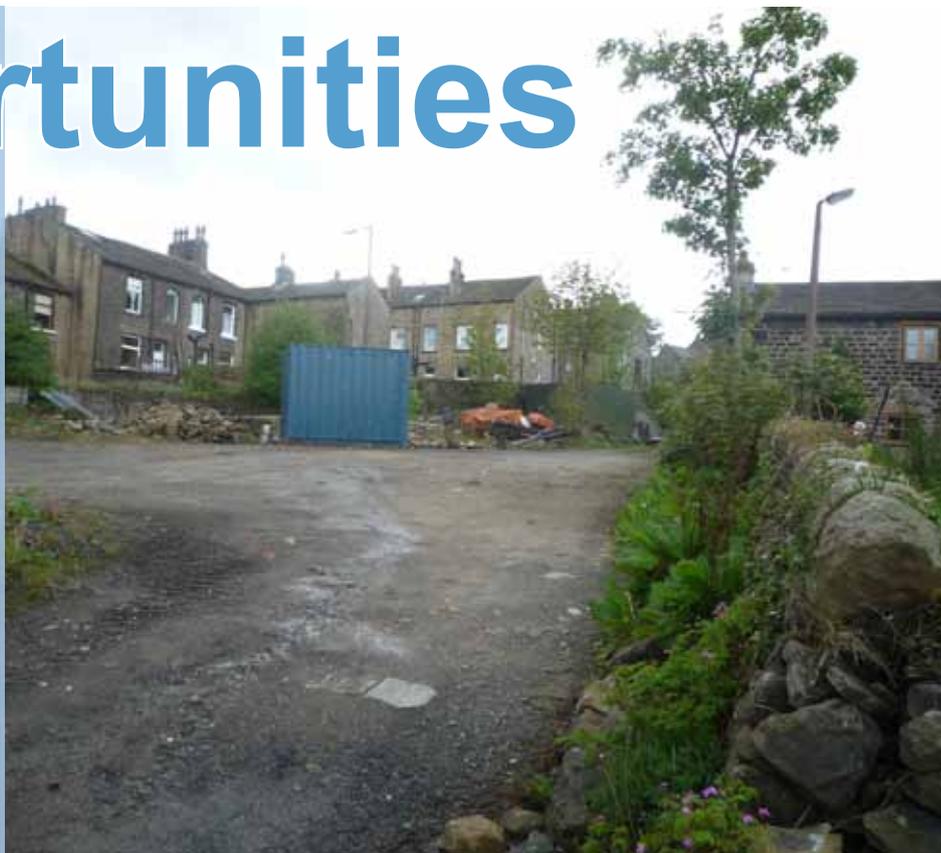
There is potential to enhance the conservation area by re-developing this site off Shaw Lane

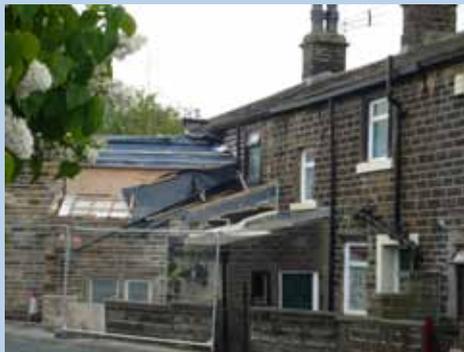
27 Upper Town received planning permission in 2007 to construct a single storey extension and rebuild existing outbuildings.

NEUTRAL CHANGE

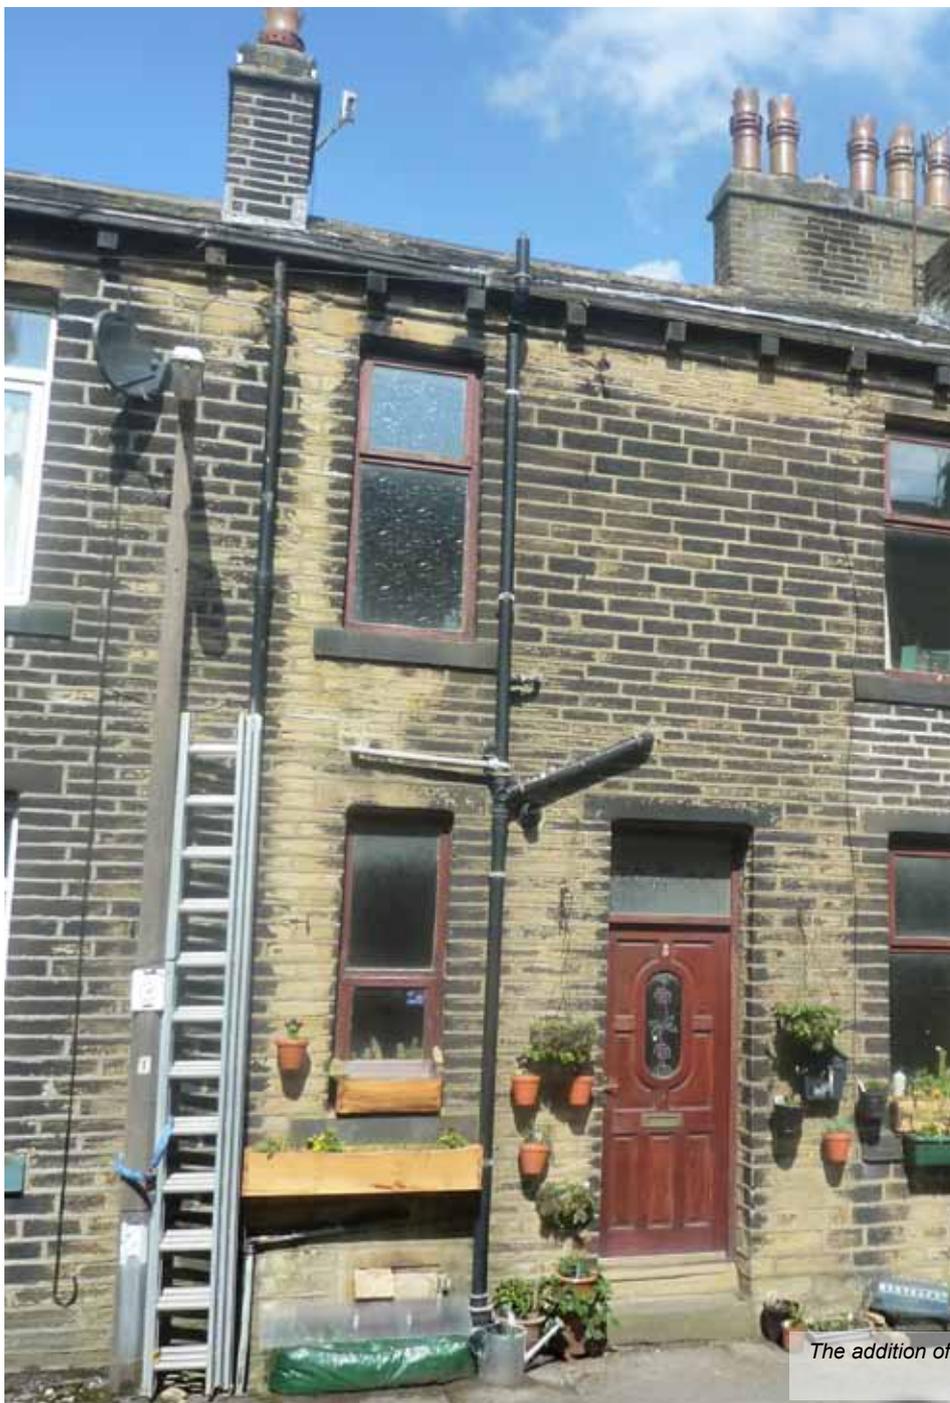
PVCu windows and doors detract from the character of the area

rainwater goods, inappropriately pointed elevations and modern windows and doors. The Council will look to ways of mitigating these works and will actively discourage the occurrence of similar situations arising within the conservation area
