Conservation Area Appraisal

Steeton

April 2008

City of Bradford MDC

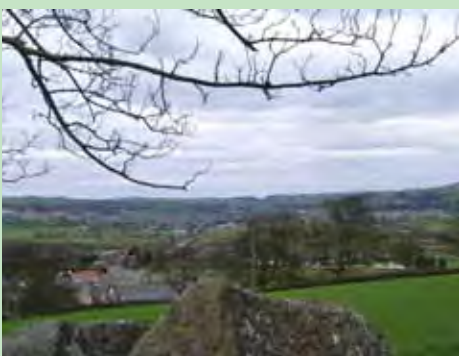
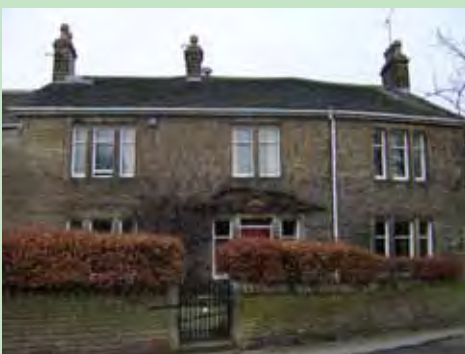
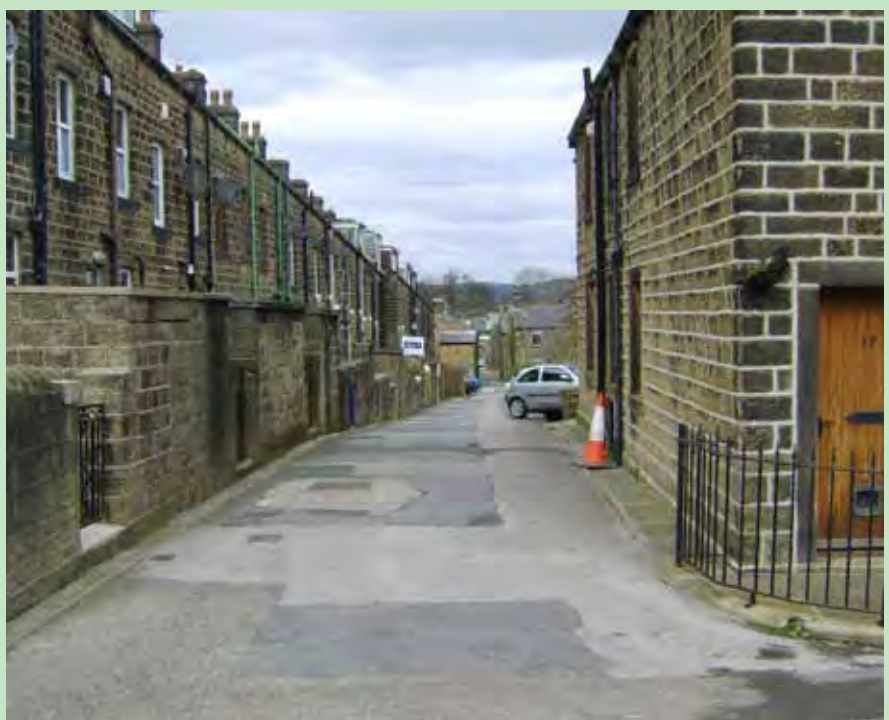
Clockwise from top left: The view across the valley to Silsden contributes to the sense of place in the conservation area. Uniform terraces such as Queen Street were mostly built for mill workers in the village. Holme House, Skipton Road is considered to be a key unlisted building in the conservation area.

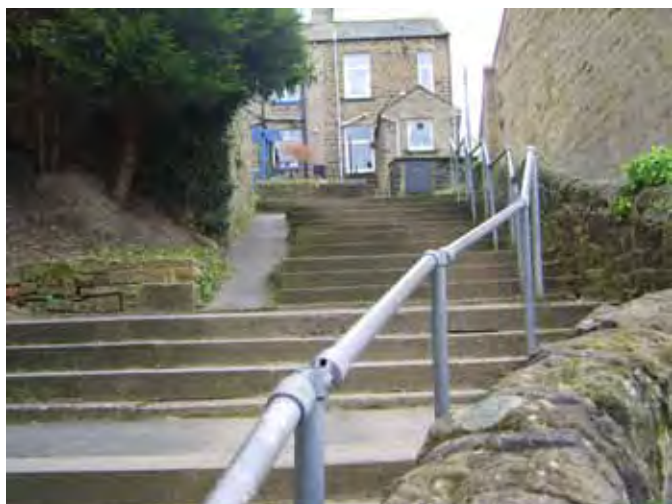
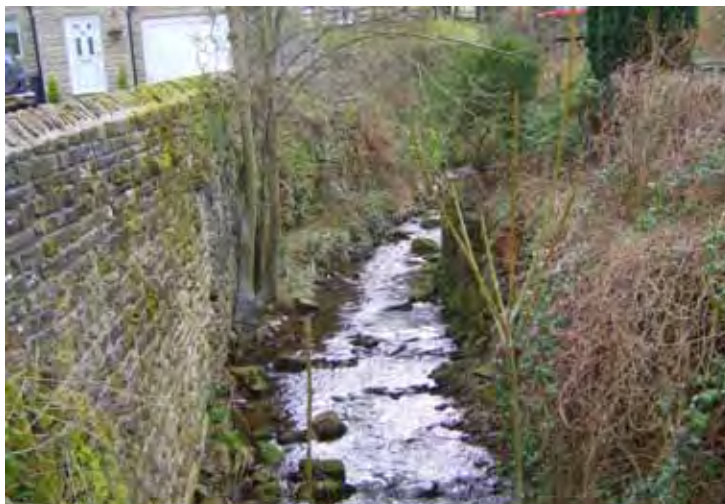
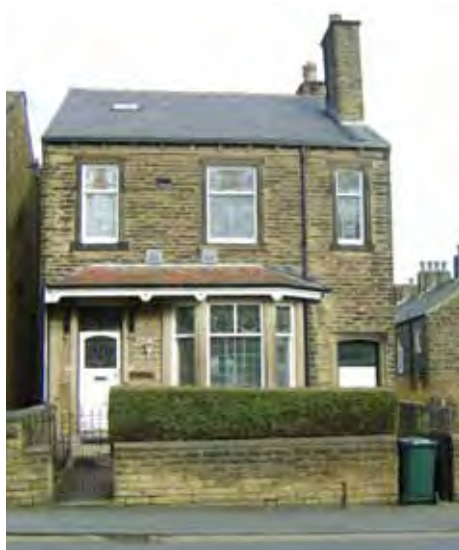
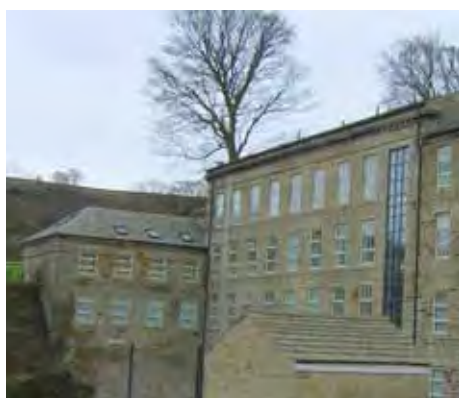
Clockwise from top left: Steep topography creates interesting vistas up to Falcon Cliffe. Historically Steeton beck has been important to the development of the settlement. Woodlands Mill is an important part of Steeton's industrial heritage. 13, Keighley Road retains many good period details.

Woodlands Mill was previously vacant and in very poor condition. In 1991 planning permission and LBC were granted for residential conversion of the mills and outbuildings. The property is now fully back in use.

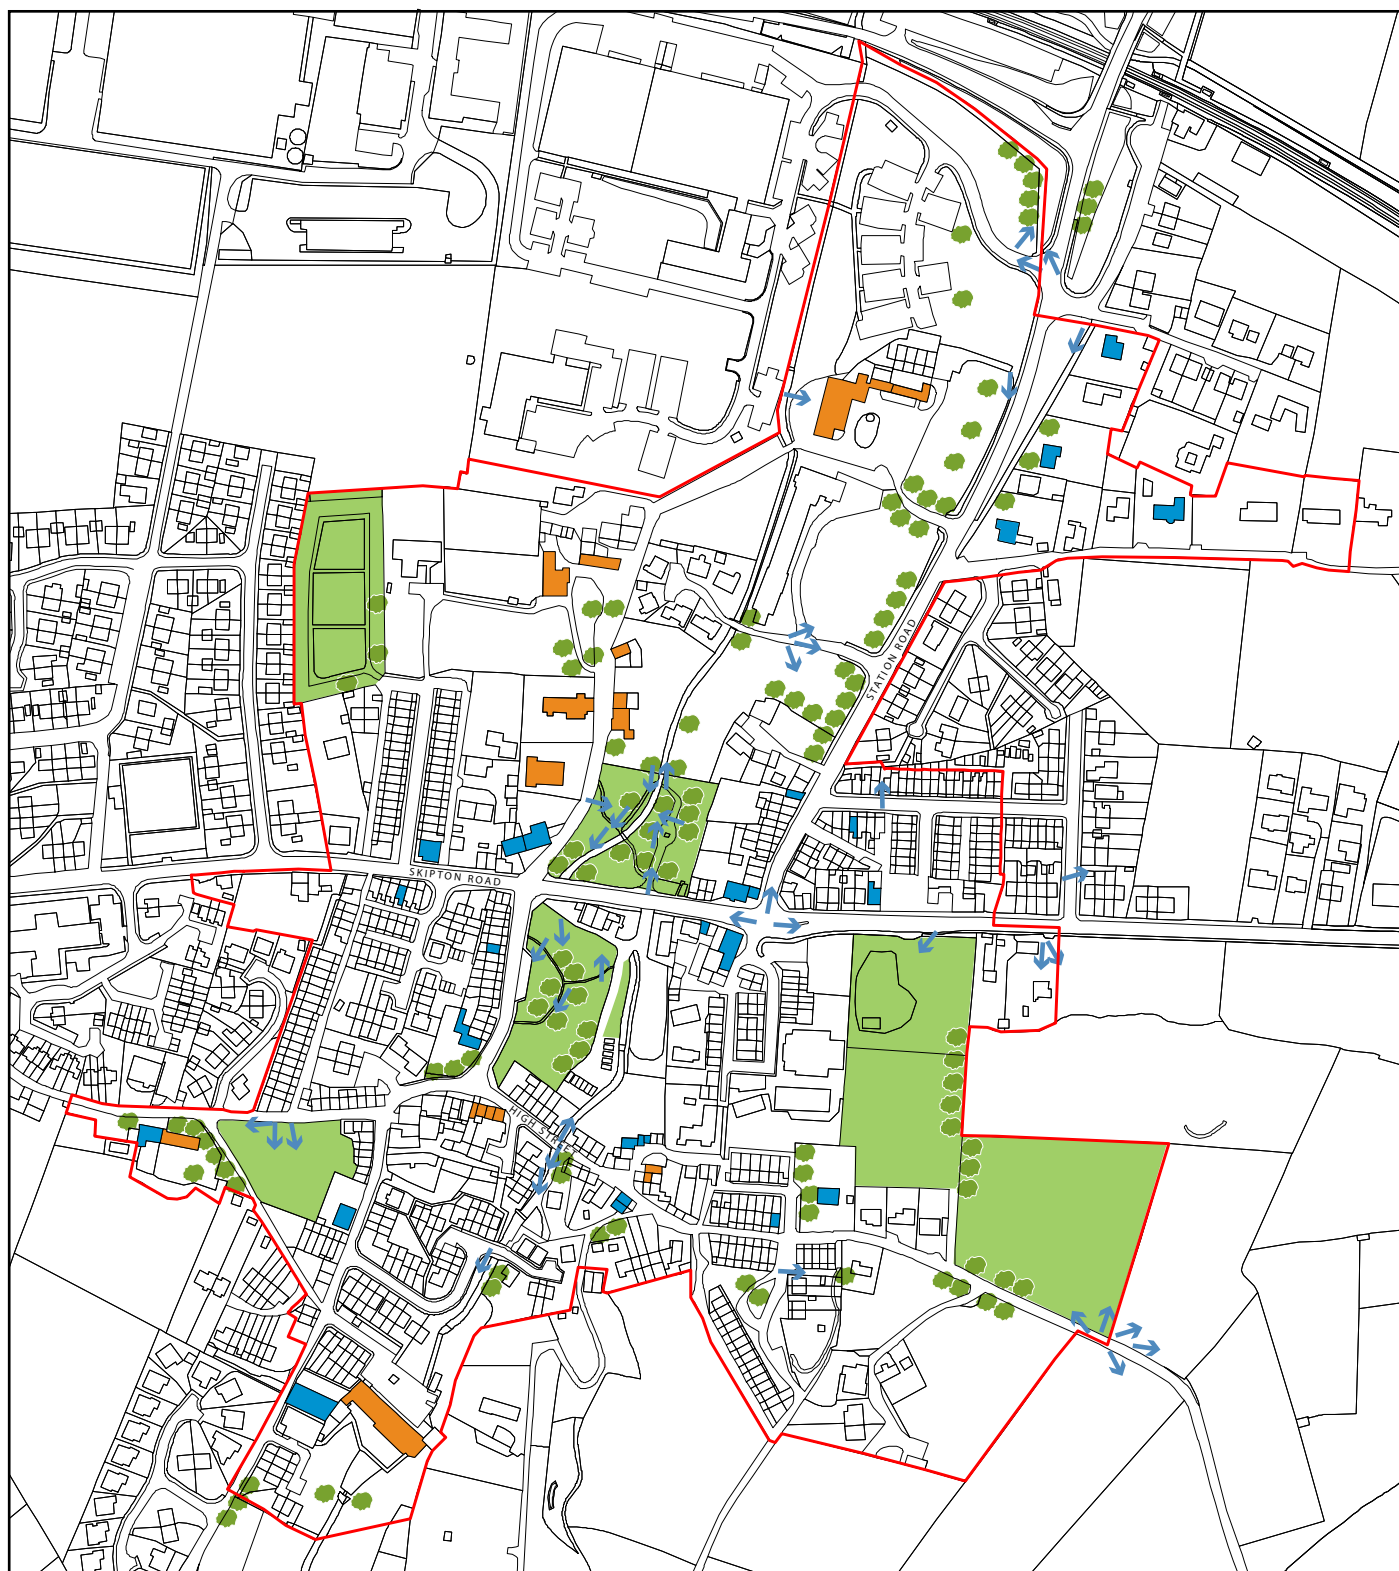
Open Spaces, Trees, Views, Listed and Key Unlisted Buildings

NB This map does not identify key trees individually, but merely indicates where there is at least one important tree.

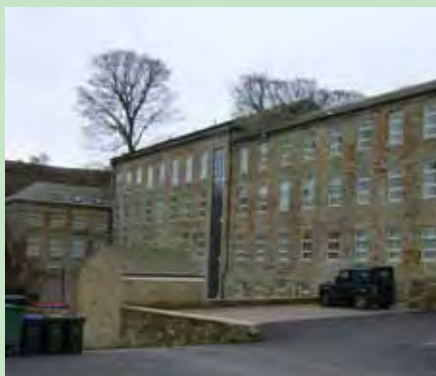
POSITIVE CHANGE

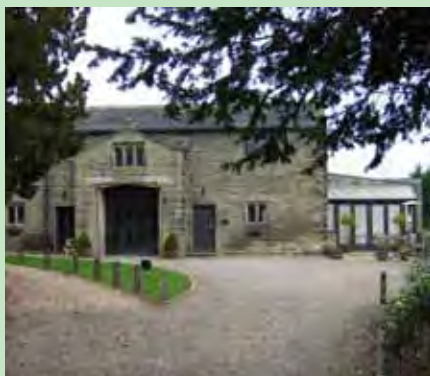
The Coach House on Stephens Road has been brought back into use. In 2000 and 2002 planning permission and LBC were granted for conversion of coach house to a cottage and house with a new conservatory and garage, lowering of boundary wall and erection of new stone wall and timber fence on new boundary line.

POSITIVE CHANGE

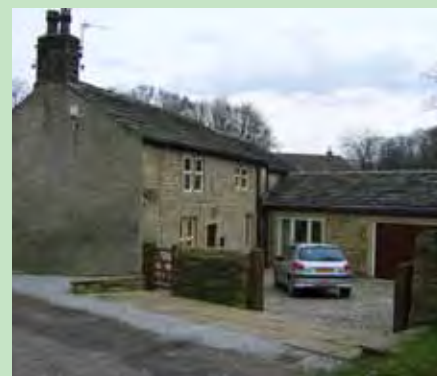
In 2001 and 2002 planning permission and LBC was granted for an extension to the property at **Steeton Hall Farm**, St Stephens. The extension has been built in appropriate materials and respects the character and appearance of the listed building.

NEUTRAL CHANGE

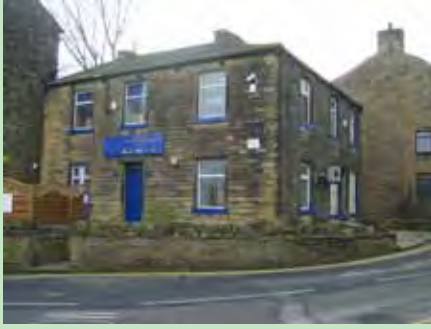
Sailor & Soldier Club on Barrows Lane, the heads and cills of the windows have been painted. A new modern timber fence has been constructed in front of the building.

NEGATIVE CHANGE

LESSON: Owners should consider the impact of their alterations on the character and appearance of the conservation area. The Repairs and Maintenance Guidance contains helpful advice. Enforcement action could be taken to remove the fence.
